"2007" SEMINAR

Chrysler RWD
TCC Hunting
&
5R55W/S
Converter Noises
By
Mike Souza

DODGE & JEEP RWD VEHICLES

TCC CYCLING

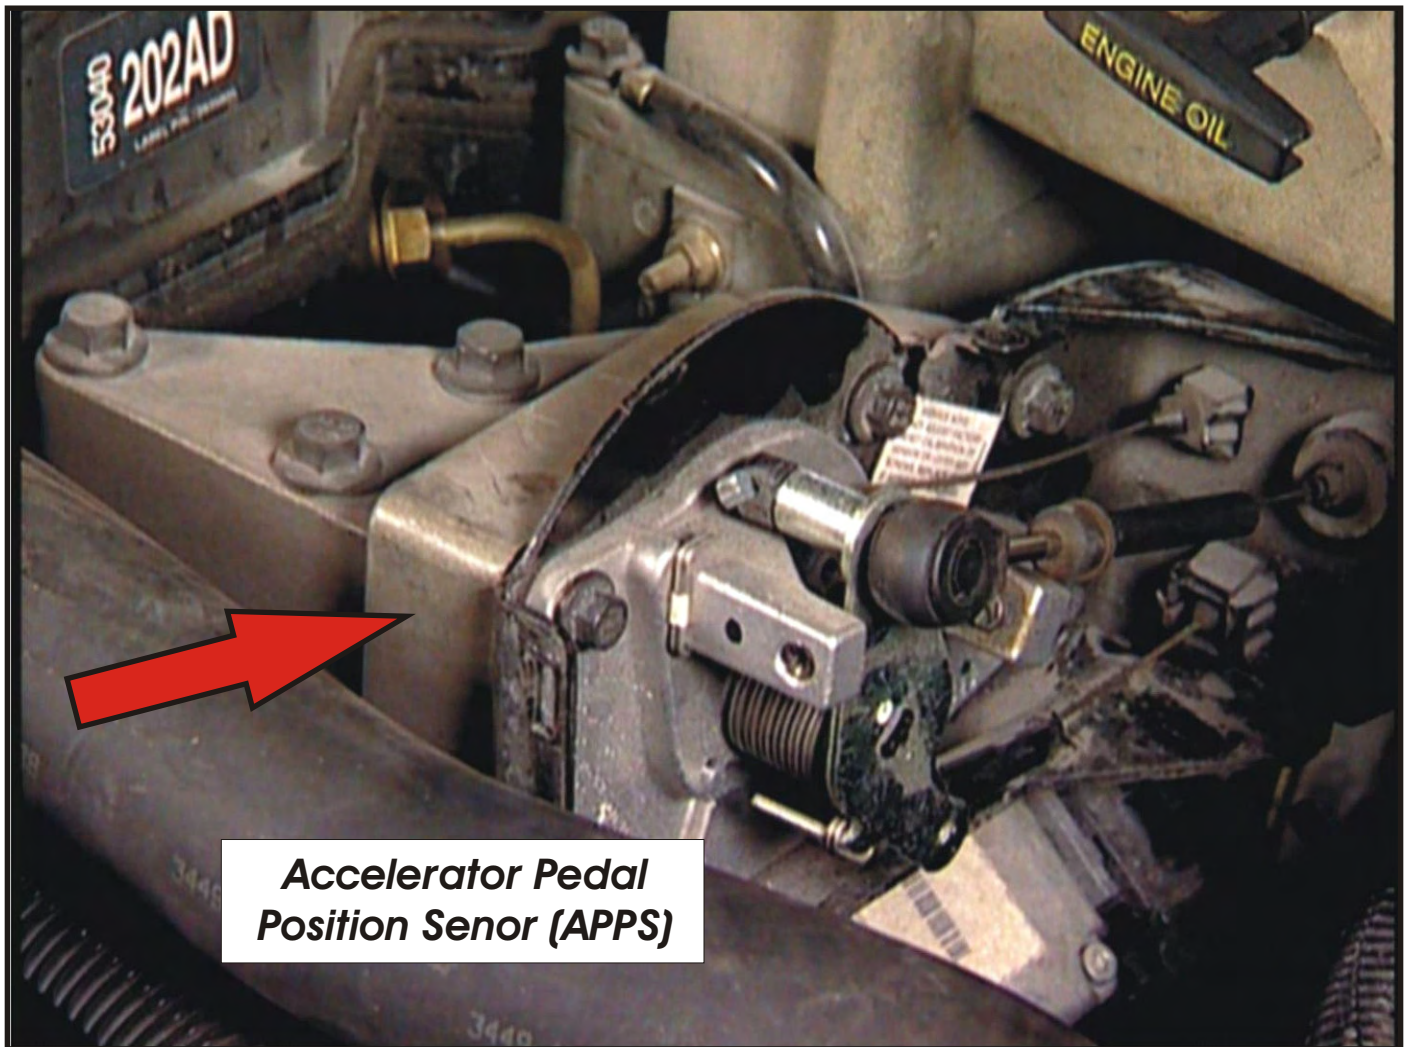
Figure 2

- (1) PCM too sensitive to Noise From APP Sensor (24 Valve Diesel Only) (Figure 1).
- (2) PCM too Sensitive to Noise From Alternator (Both) (Figures 2-4).

- (1) Install Noise Filter In APPS signal Wire. Wrap Alternator battery voltage supply wire in
- (2) aluminum foil, Disconnect wire as a test first (Figures 2-4).
Relocate Lift Pump farther away from ECM (Figure 5).
- (3) Replace Fuel Filter (Figure 6).
- (4) Replace Cummins ECM (Figure 7).
- (5) Repair ECM Connector, resize terminal ends (Figure 8).
- (6) APPS/ECM Relearn Procedure: KOEO, Slowly depress throttle pedal to floor and then
- (7) slowly release it once. Turn key off before restart (Figure 9).
Replace throttle lever and bushings (Figure 10-12).

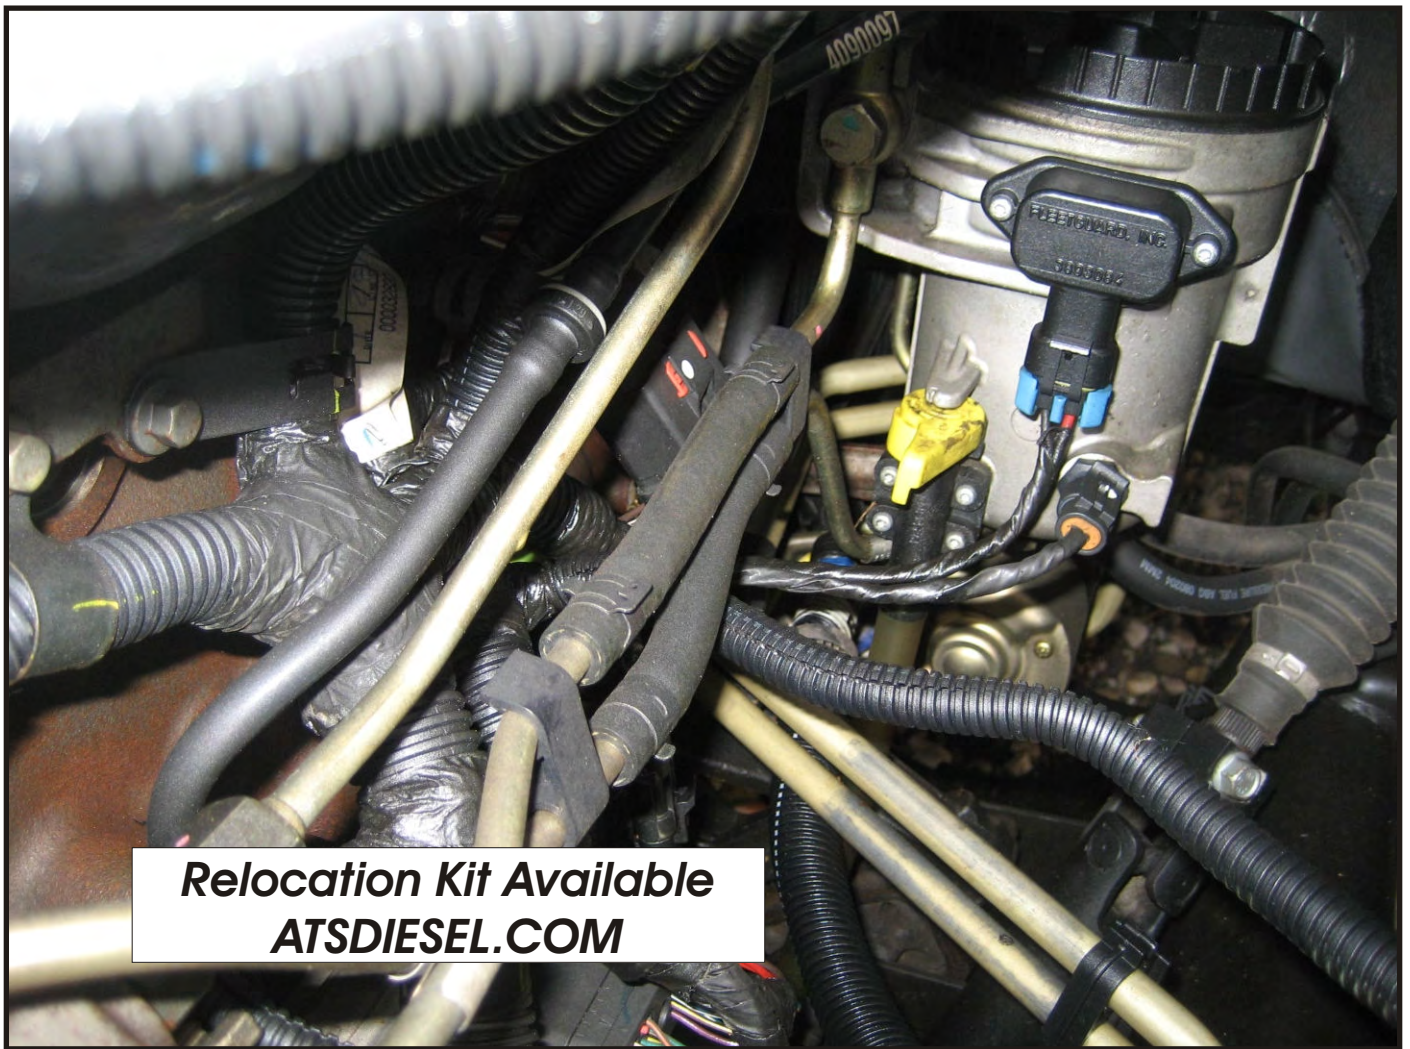
Figure 5

- (3) Lift Pump Interference (Diesel Only) (Figure 5).
- (4) Water In Fuel, warning lamp will be illuminated, (Diesel Only) (Figure 6).
- (5) Faulty ECM (Diesel Only) (Figure 7).

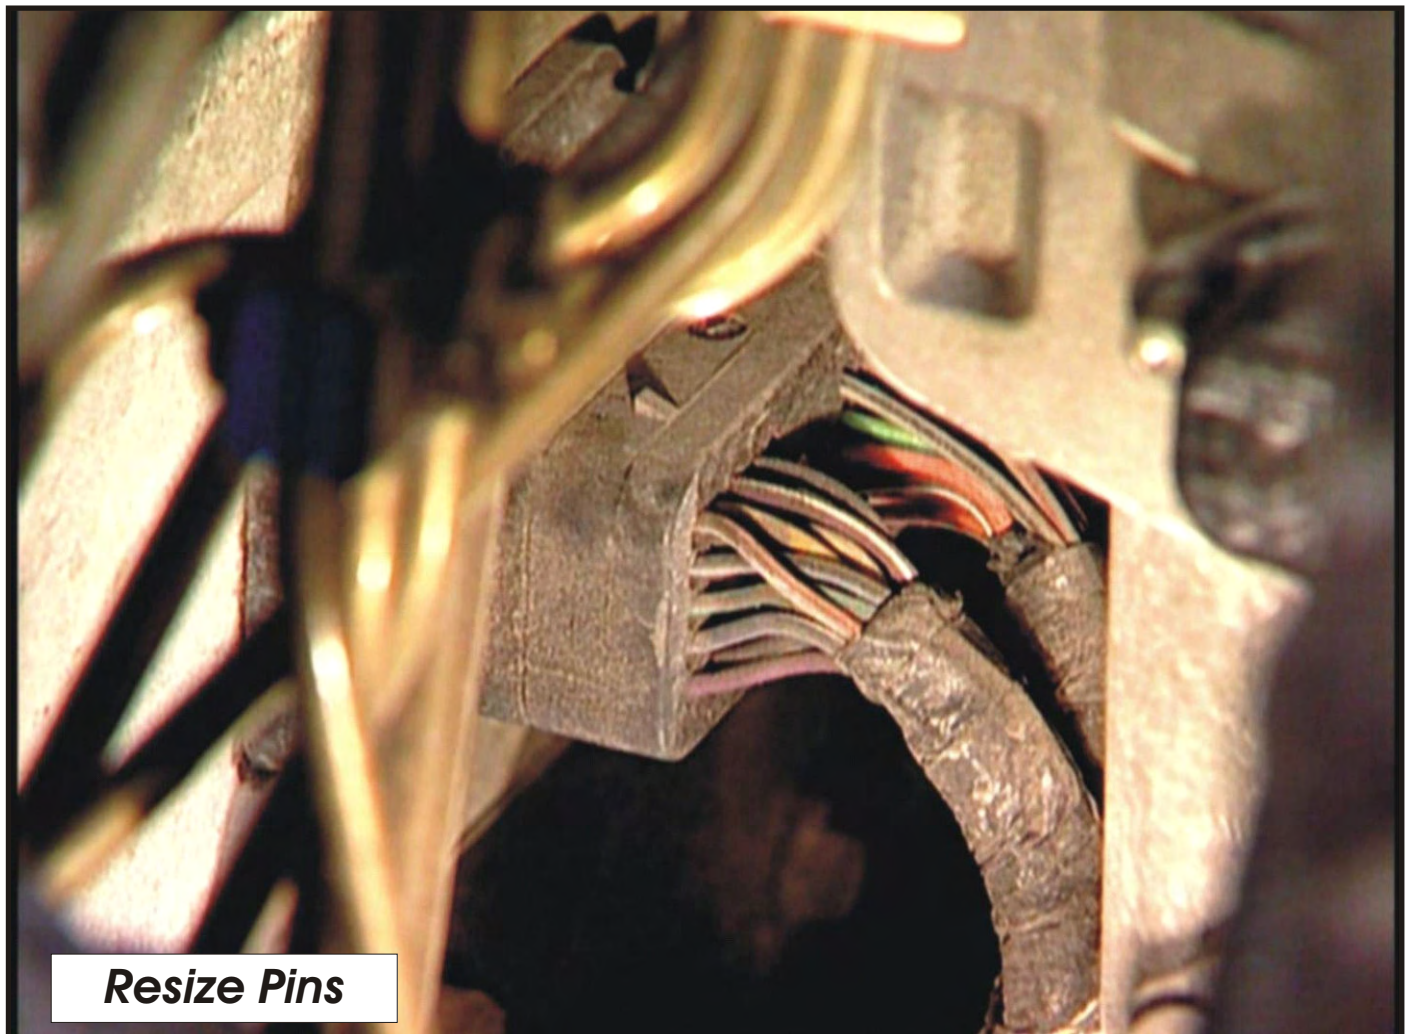
Figure 8

- (6) Loose or poor ECM Connector (Diesel Only) (Figure 8).
- (7) APP Sensor Relearn (24 Valve Diesel Only) (Figure 9).
- (8) TPS Cam or Bushings Worn (12 Valve Diesel Only) (Figure 10-12).

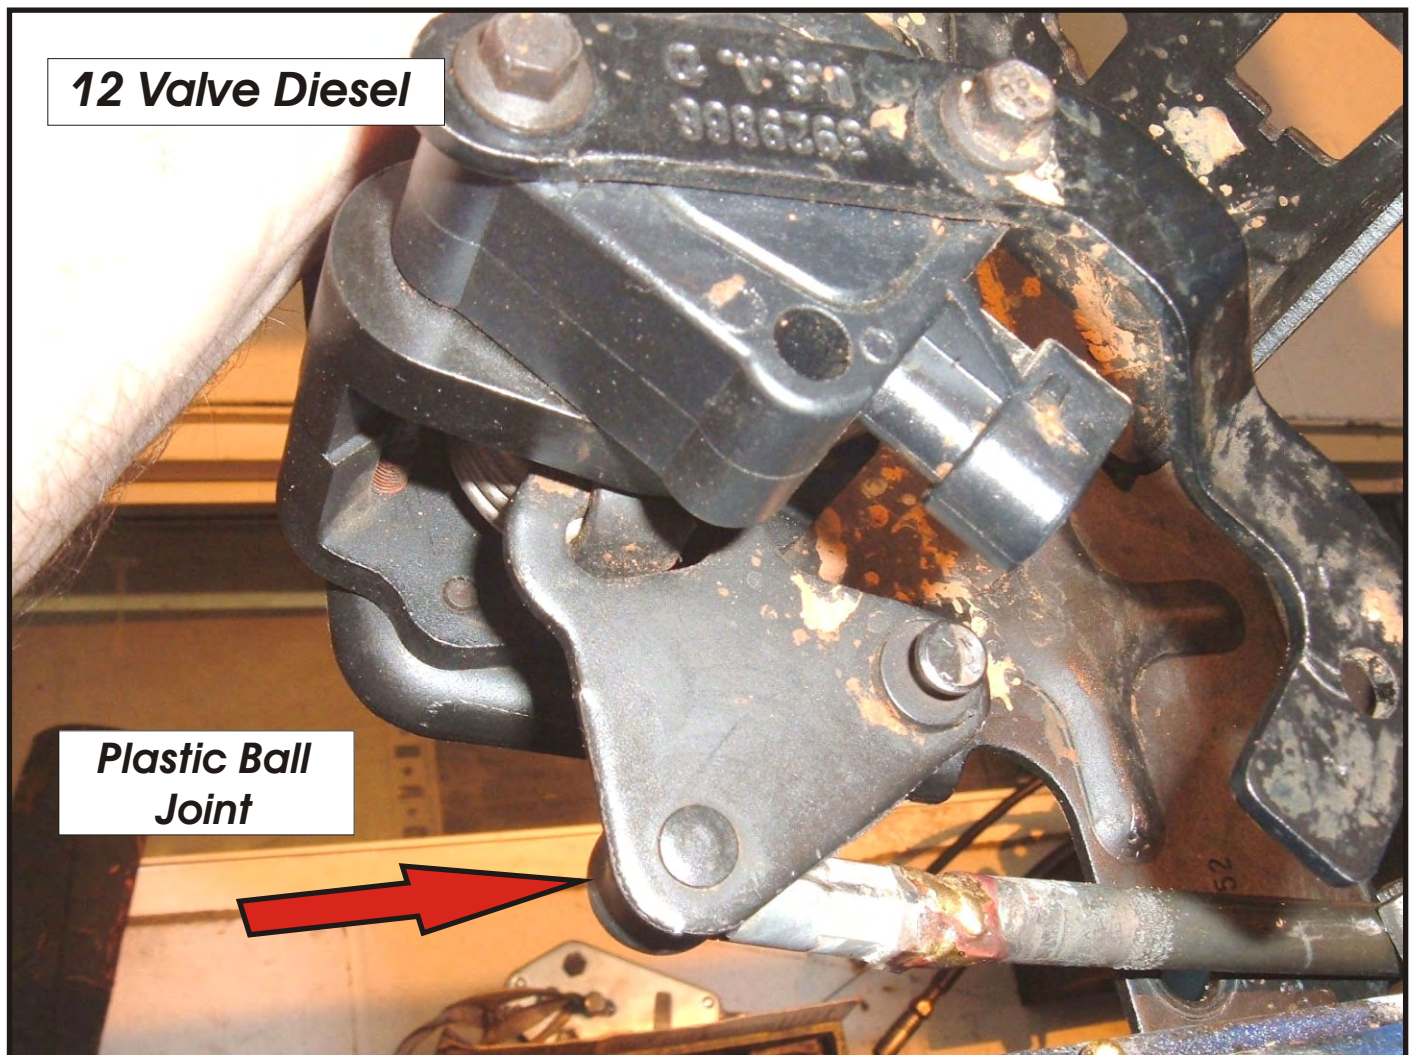
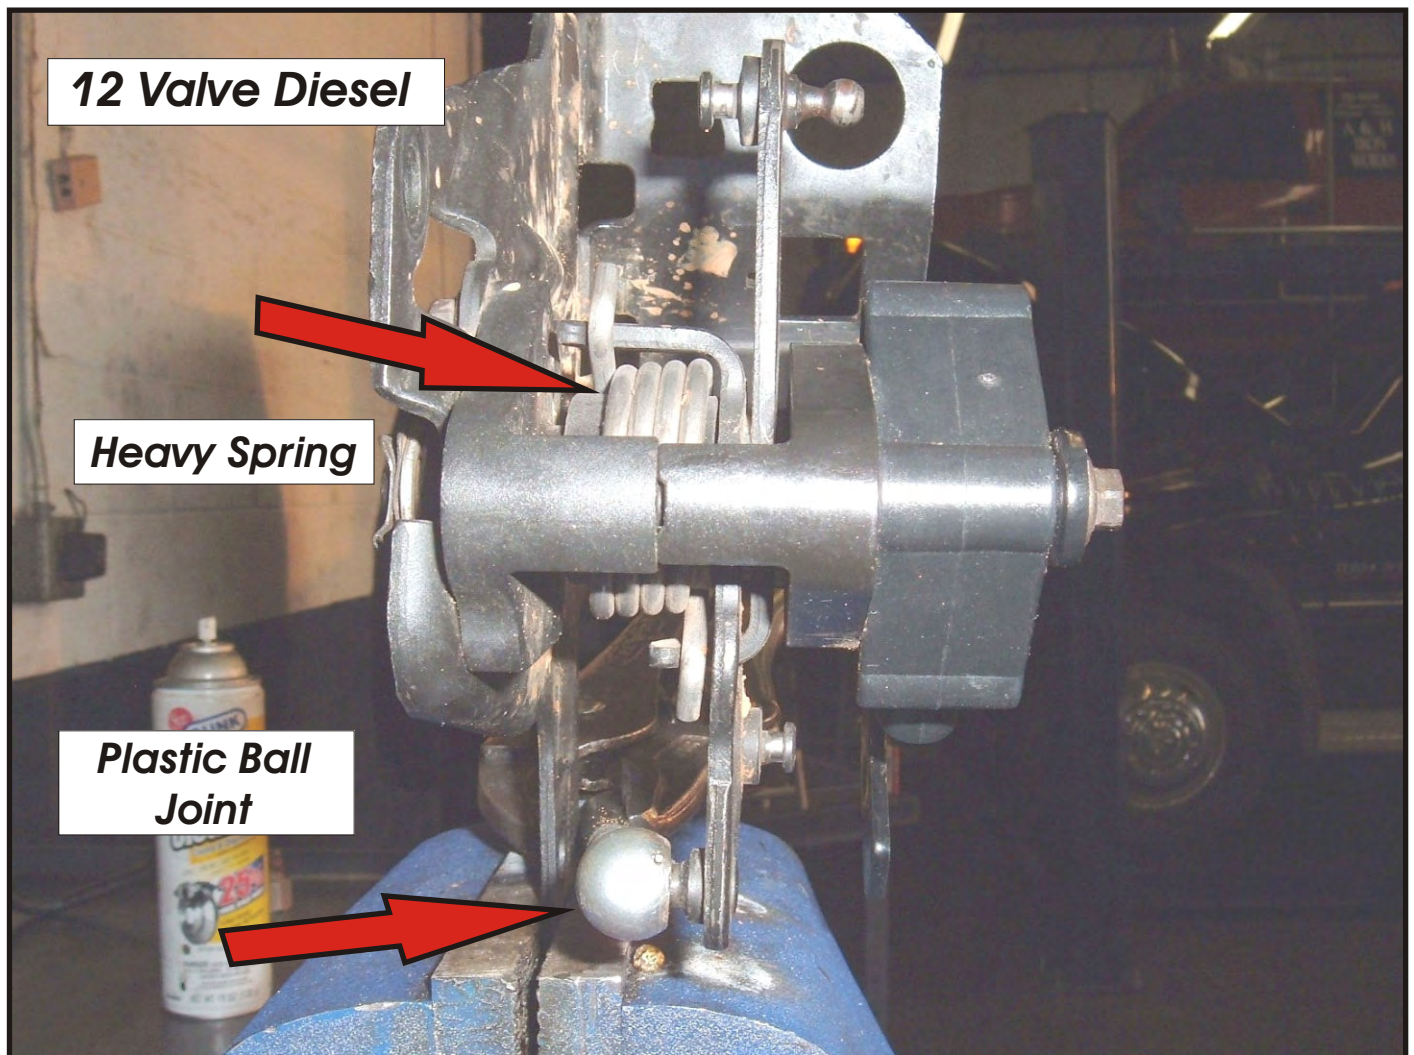
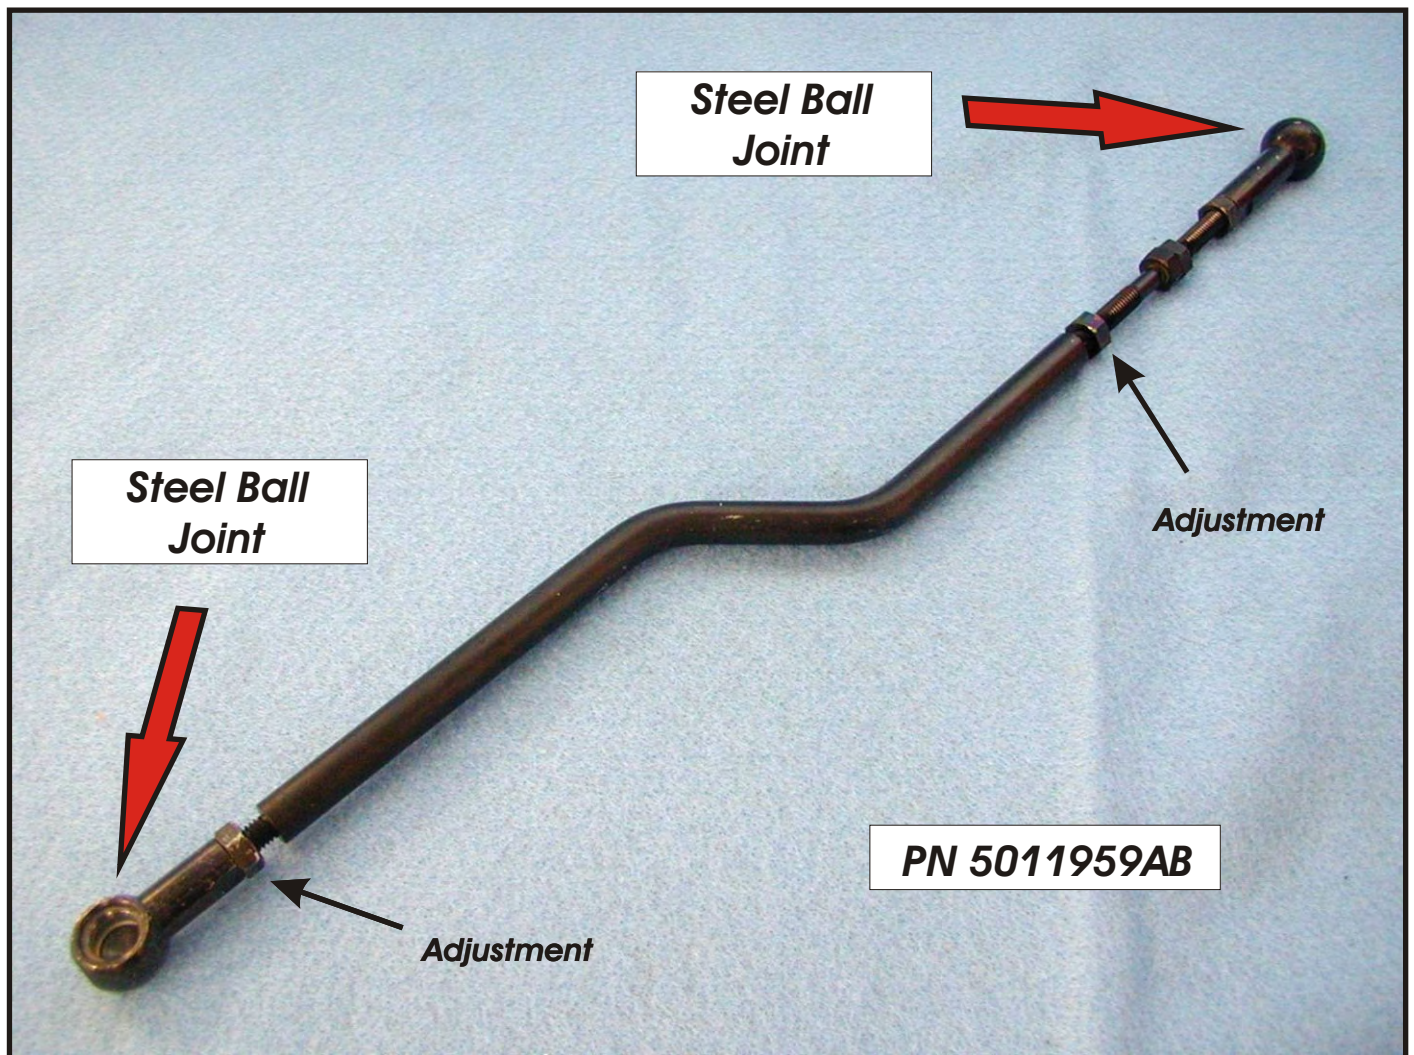
- (9) Plastic Throttle Rod Ball Joints Are Worn (12 valve Diesel Only) (Figures 13-15).
- (10) Faulty TPS or TPS Circuit Problems (Both) (Figure 16).
- (11) Low Coolant Level (Both) (Figure 17).

- (9) Replace with steel rods, PN5011959AB (Figures 13-15).
- (10) Repair TPS circuits or replace TPS (Figure 16).
- (11) Repair coolant leaks and bring coolant to correct level (Low coolant lamp may be illuminated if so equipped) (Figure 17).

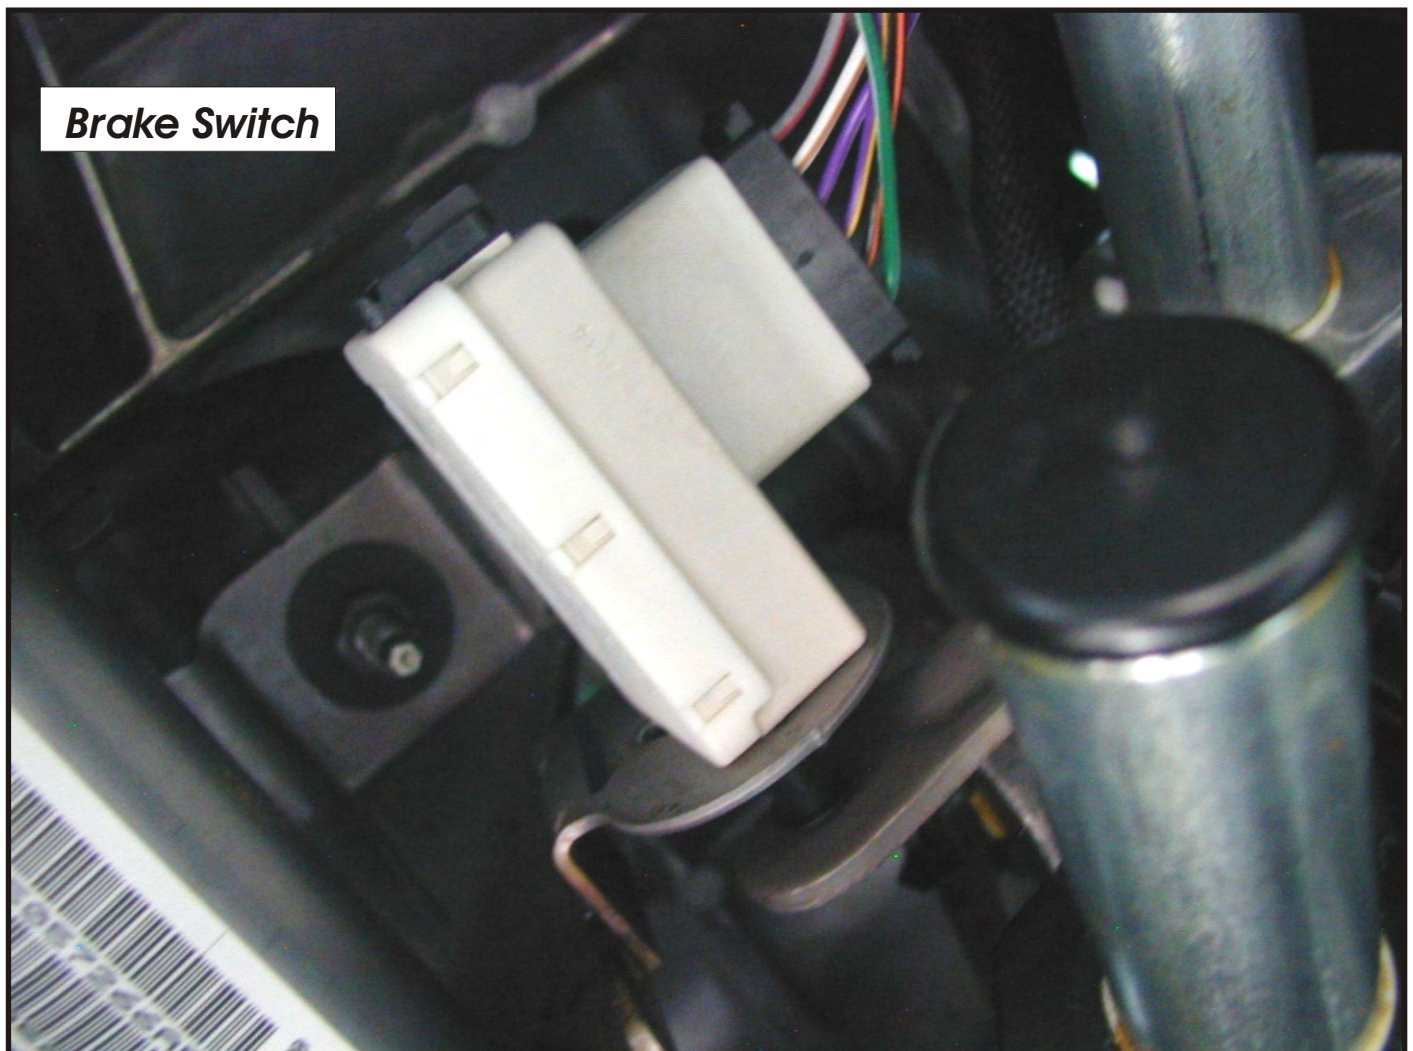
Figure 18

- (12) A Faulty or Loose Brake Switch (Both) (Figure 18).
- (13) Dirty Battery Cables, Especially at the Engine End of the Negative Battery Cable (Both) (Figure 19 & 20).

- (12) Replace Brake Switch or repair brake switch bracket (Figure 18).
- (13) Clean or replace battery cables and polish the negative cables engine attachment point regardless of how good it looks (Figure 19 & 20).

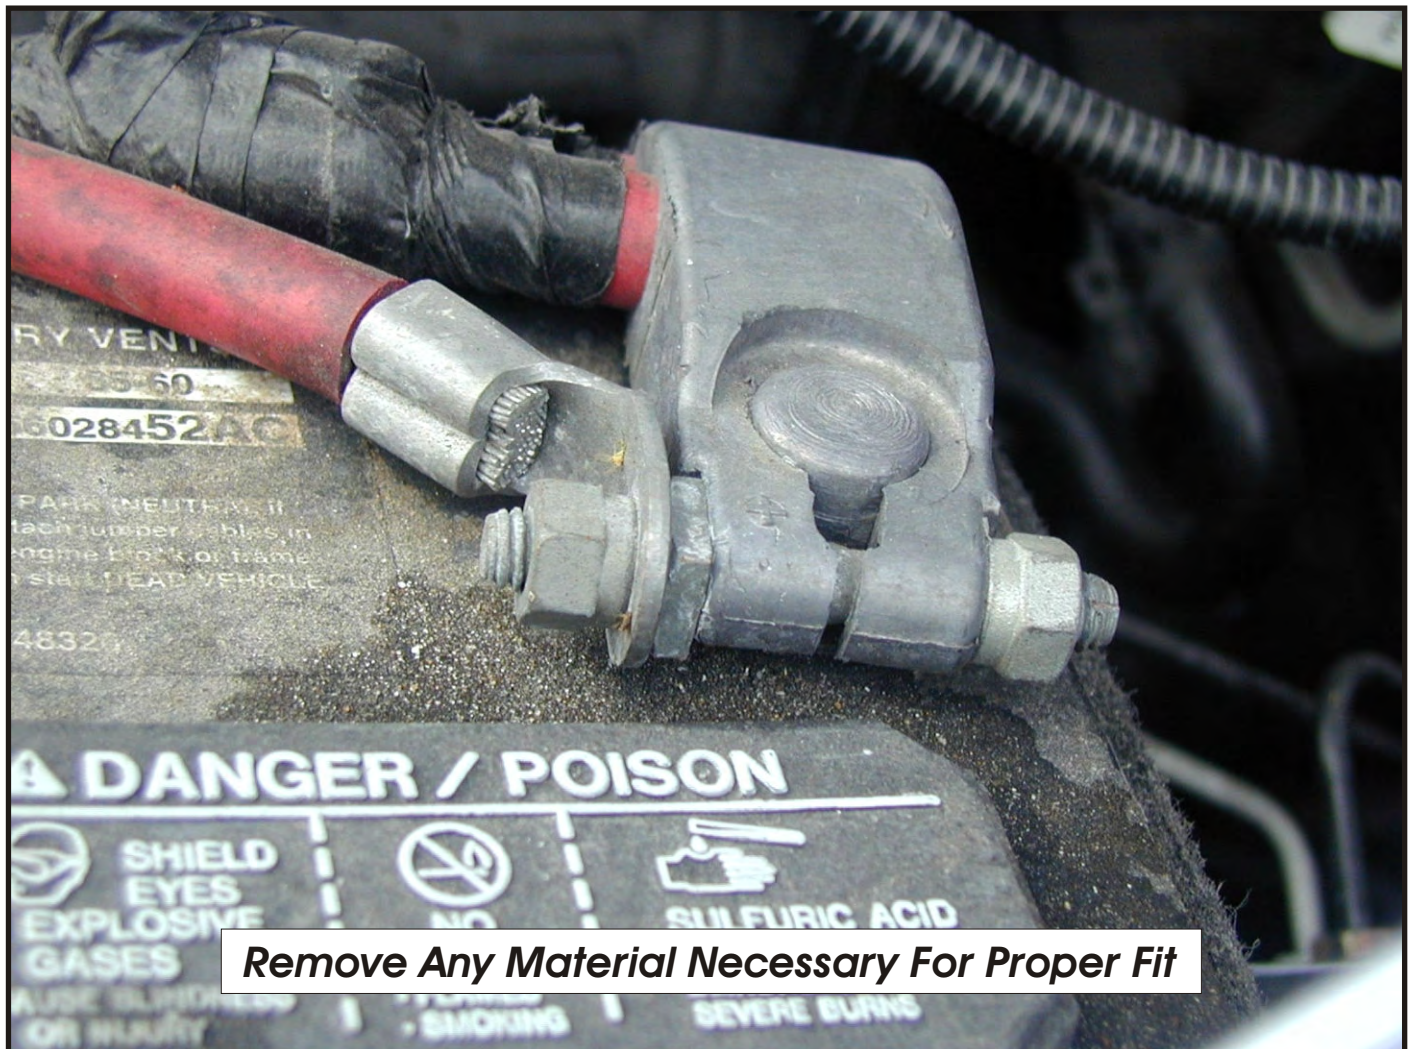
Figure 21

- (14) New Battery Cable Ends That are Too Loose on the Post (Both) (Figure 21).
- (15) Faulty Spark Plugs or Plug Wires (Gas Only) (Figure 22).
- (16) Erratic VSS (Both) (Figure 23).

- (14) Remove the necessary material to insure cable end fits tightly (Figure 21).
- (15) Replace spark plugs and ignition wires (Figure 22).
- (16) Repair VSS in Differential or ABS computer problem (Figure 23).

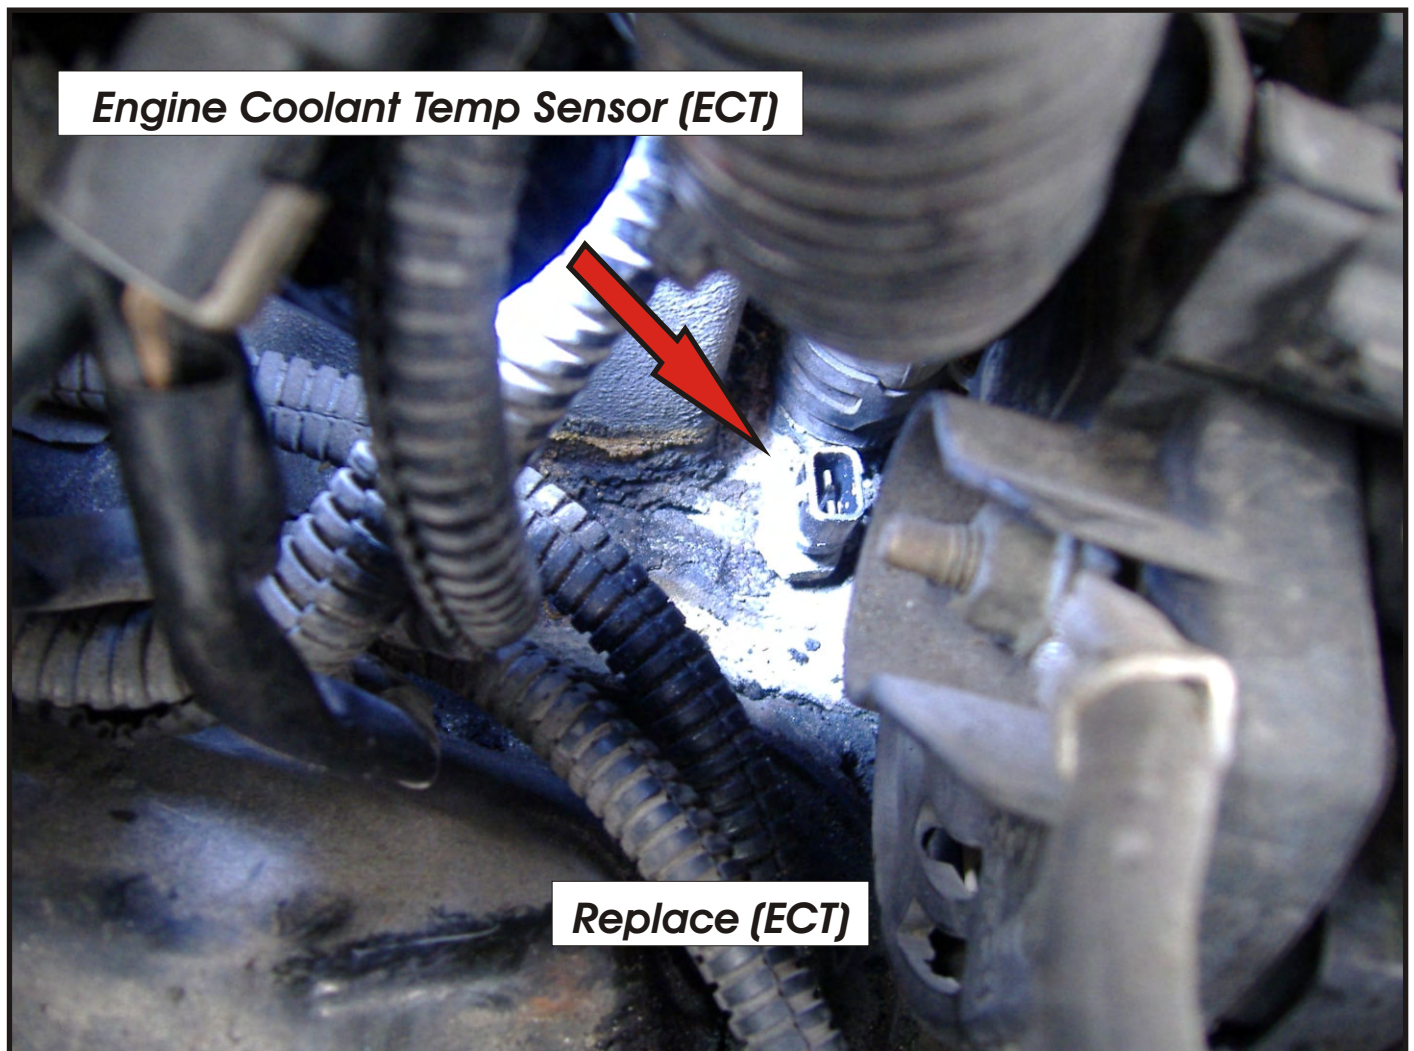
Figure 24

- (17) Faulty Engine Coolant Temperature Sensor (Both) (Figure 24).
- (18) Engine Running Too Cool (Both) (Figure 25).
- (19) A Faulty Transmission Temperature Sensor (Both) (Figure 26).

- (17) Repair or replace ECT Sensor (Figure 24).
- (18) Replace faulty thermostat (Figure 25).
- (19) Repair TFT Sensor circuits or replace TFT Sensor (Figure 26).

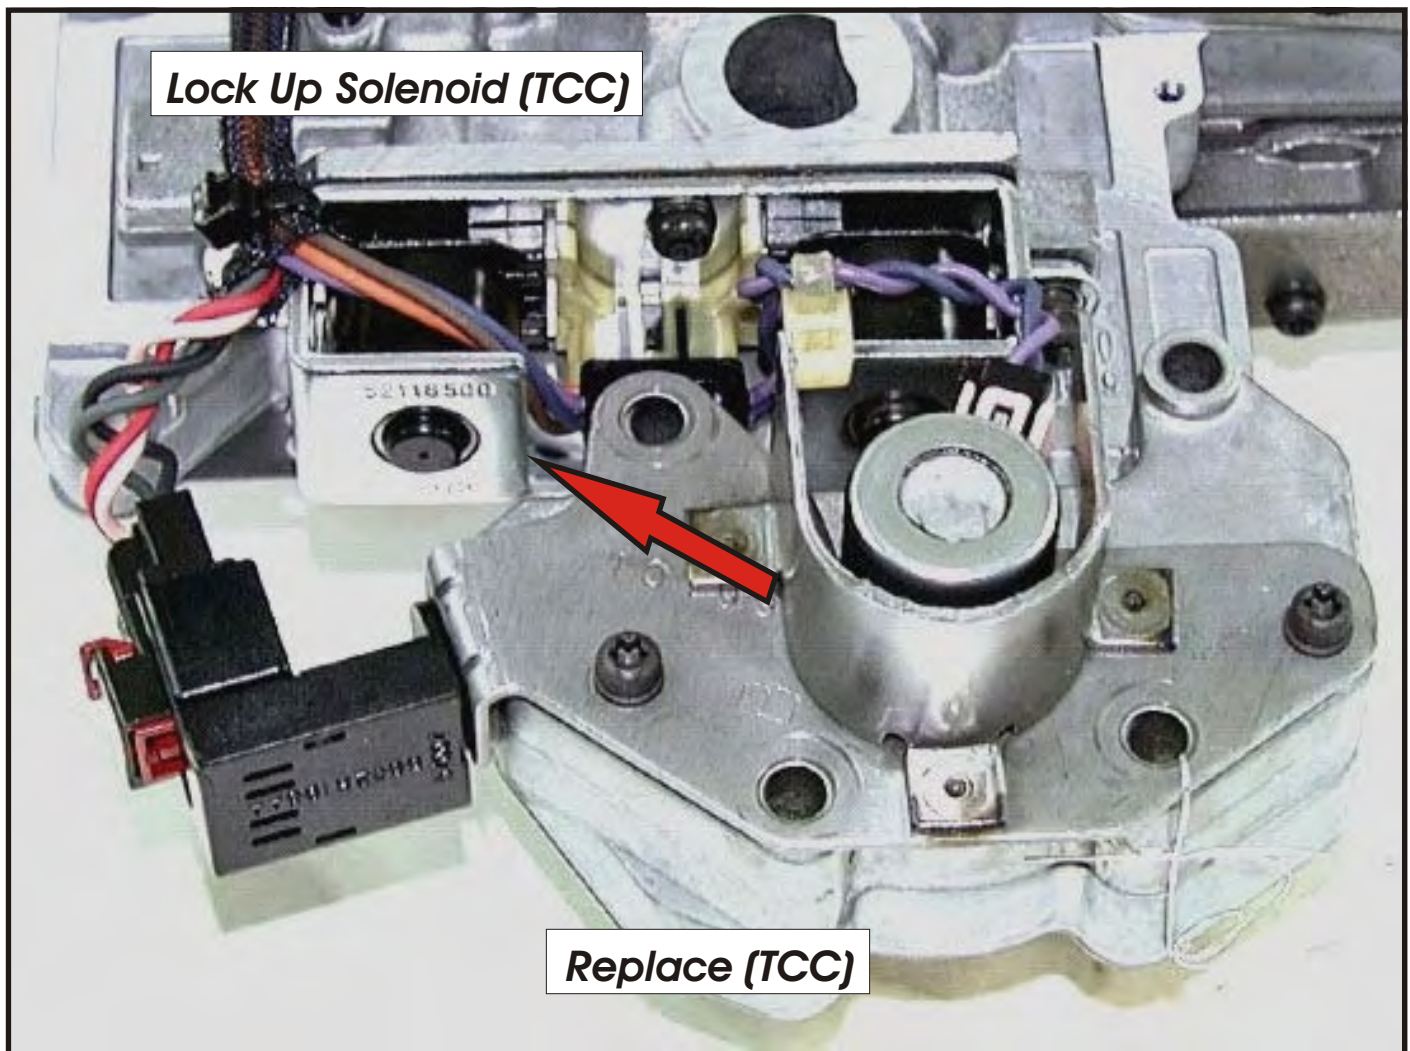
Figure 27

- (20) A Faulty TCC Solenoid (Both) (Figure 27).
- (21) A Faulty Park/Neutral Switch (Both) (Figures 28 & 29).
- (22) Use of a Generic Scan Tool (Both) (Figure 30).

- (20) Replace TCC Solenoid, (Has been known not to store P0743) (Figure 27).
- (21) Replace Park/Neutral Switch (Figures 28 & 29).
- (22) Disconnect scan tool and drive vehicle or try a different scan tool (Figure 30).

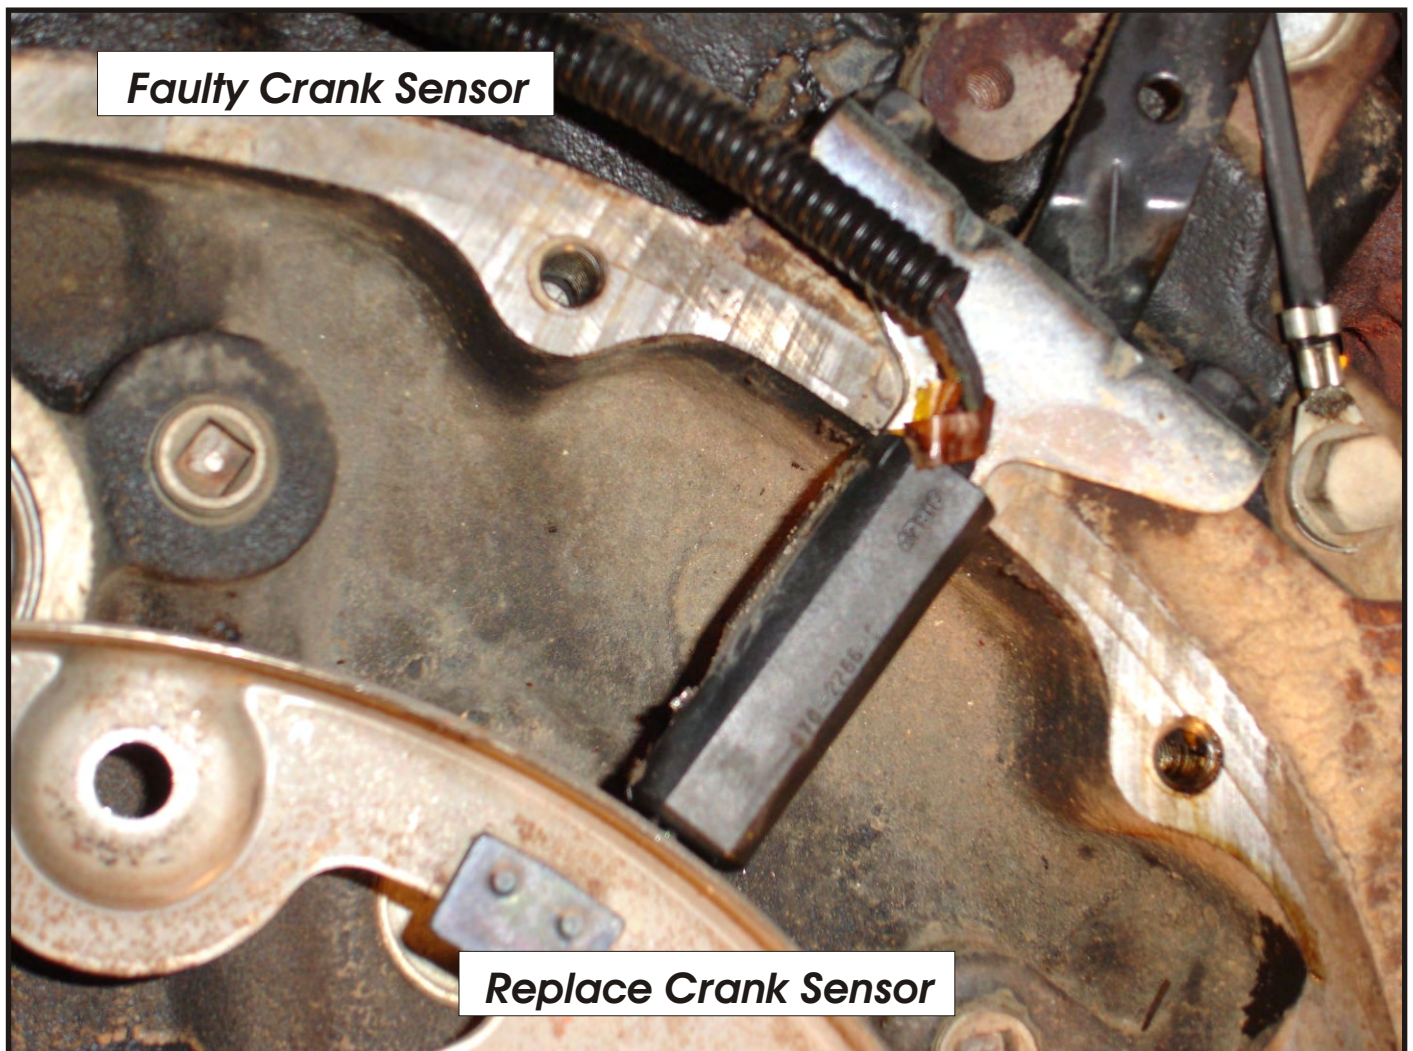
Figure 31

- (23) A Faulty Crankshaft Position Sensor (Gas) (Figure 31).
- (24) A restricted Fuel Filter (Both) (Figure 32).
- (25) A dirty air filter (Both) (Figure 33).

- (23) Replace Crank Sensor (Figure 31).
- (24) Replace fuel filter (Figure 32).
- (25) Replace air filter (Figure 33).
- (26) Replace timing chain (Figure 34).

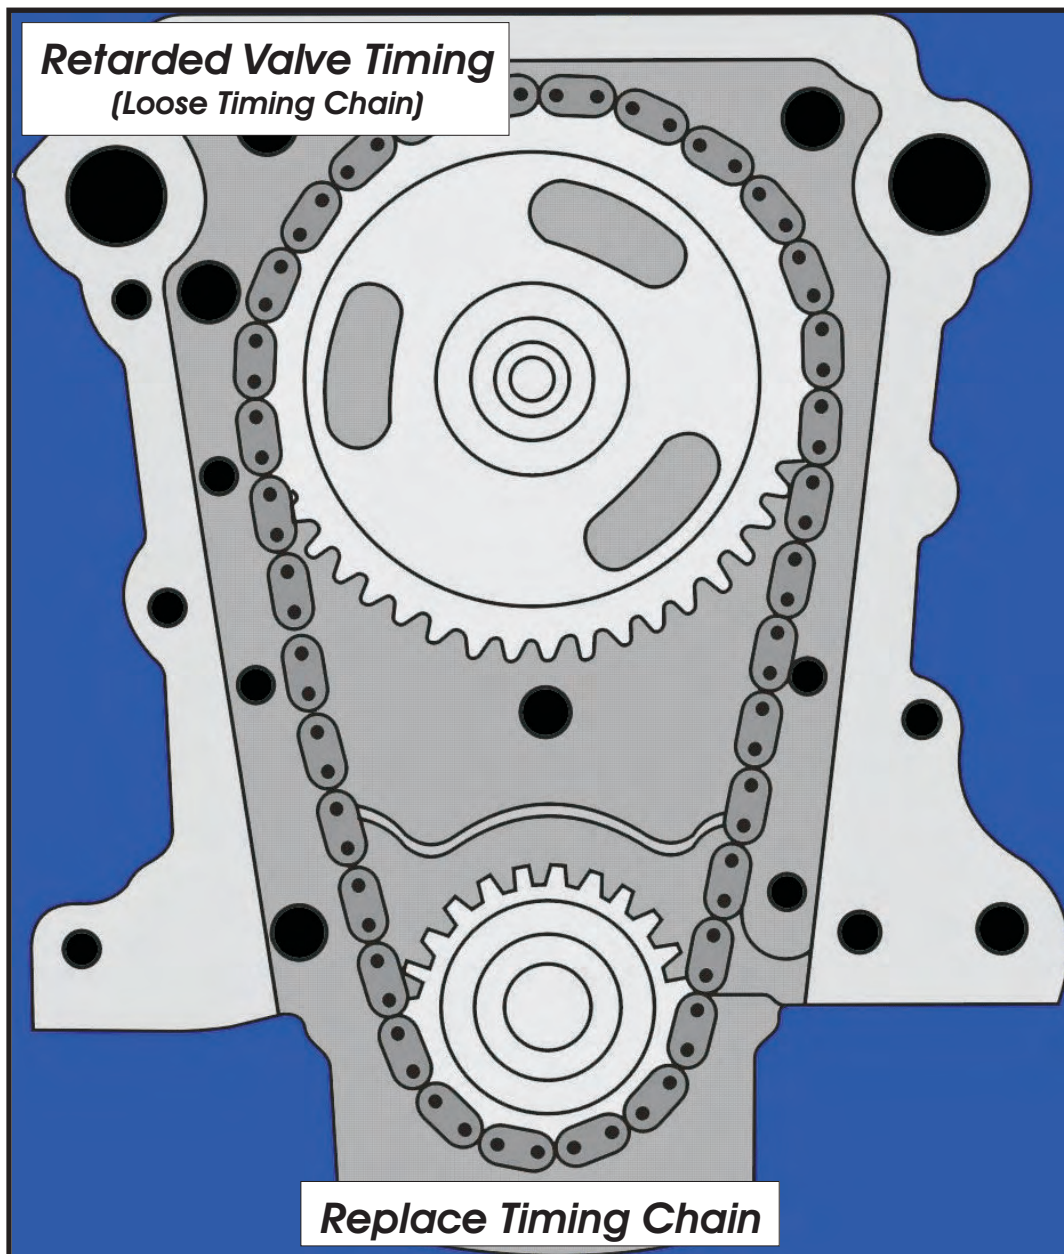
Figure 34

- (26) Retarded valve timing (Sloppy timing Chain) (Both) (Figure 34).

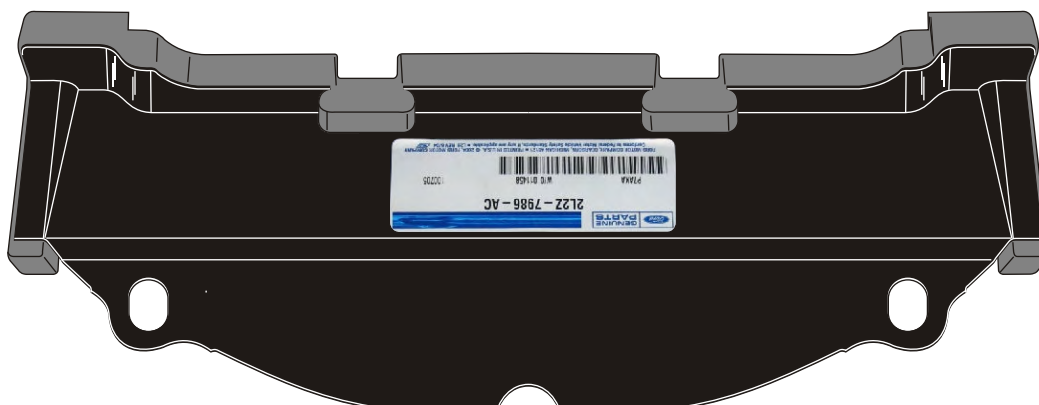
Figure 1

COMPLAINT: Explorer and Mountaineer models equipped with the 5R55W/S transmissions may exhibit a ticking or rattling noise coming from the bellhousing of the transmission. This noise can be commonly mistaken as a cracked flywheel or a mis-alignment of the flex-plate to the torque converter.

CAUSE: The cause may be, the plate between the engine block and the bellhousing is flexing, with increased engine rpm, causing the noise.

CORRECTION: Ford Motor Company has released a new style inspection plate, which is located at the bottom of the bellhousing, that has foam rubber to insulate the plate between the engine and transmission to keep it from flexing. Replace the inspection plate with new design as shown in Figure 1.

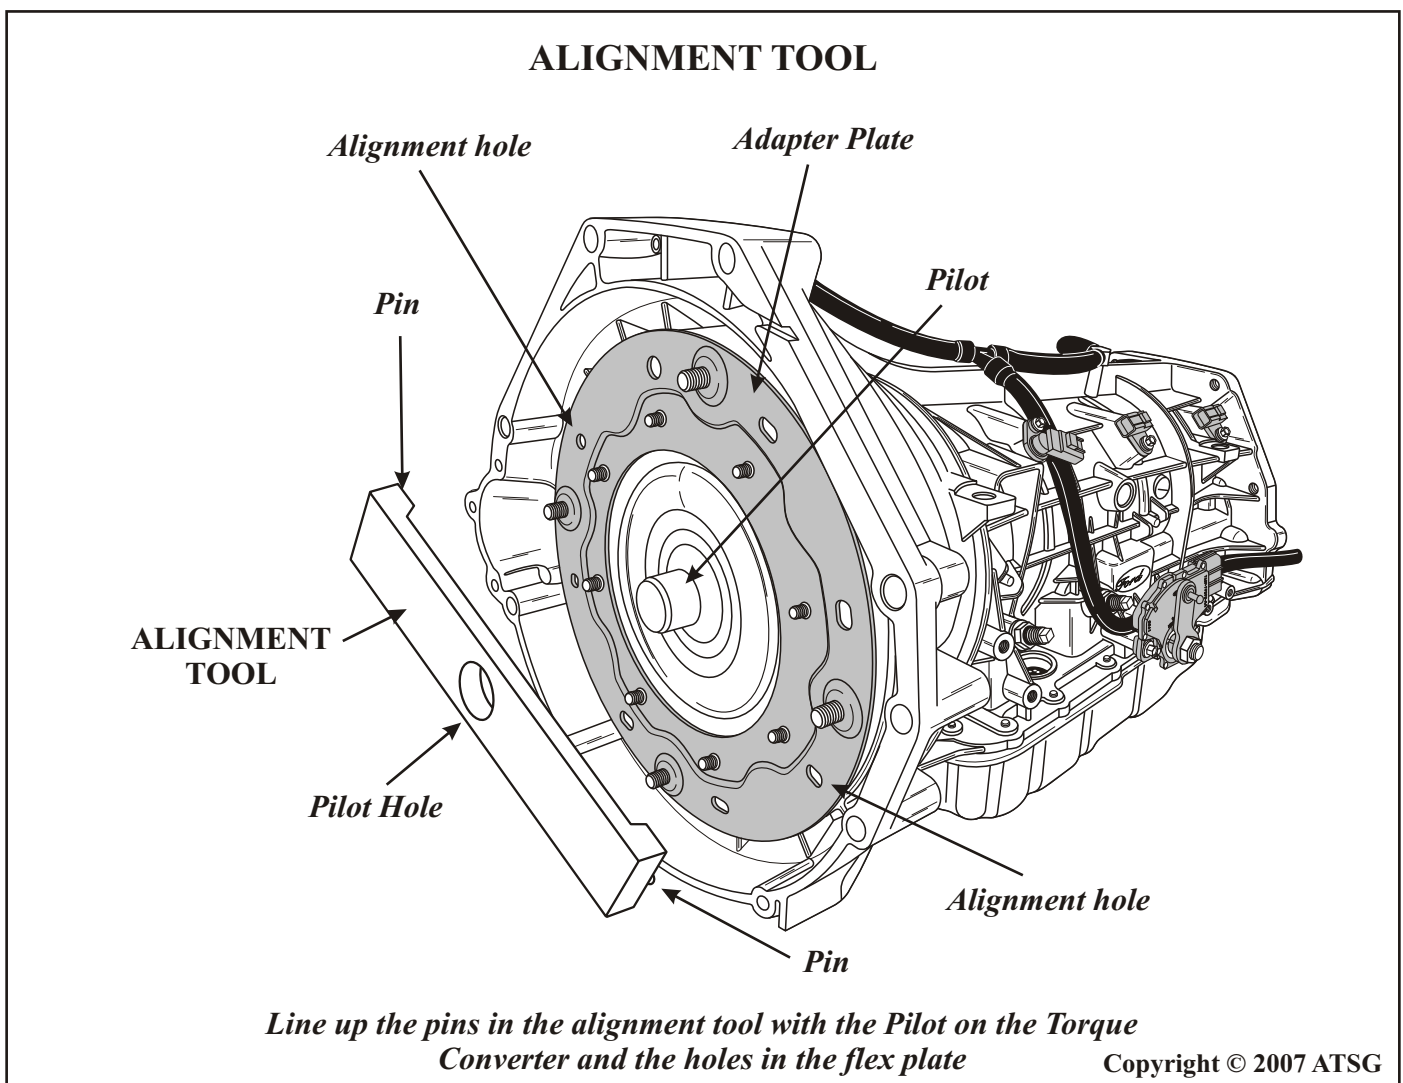
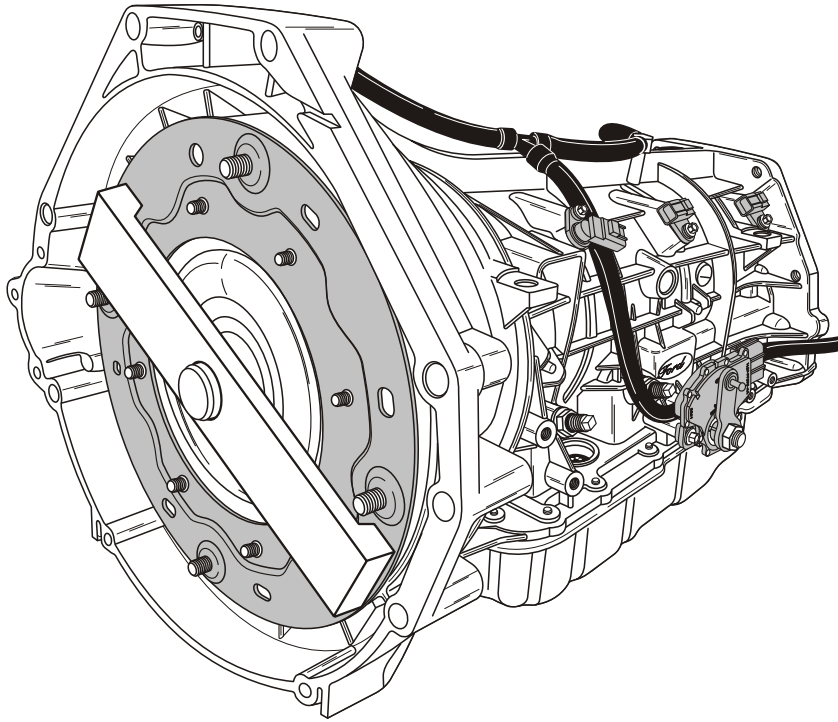
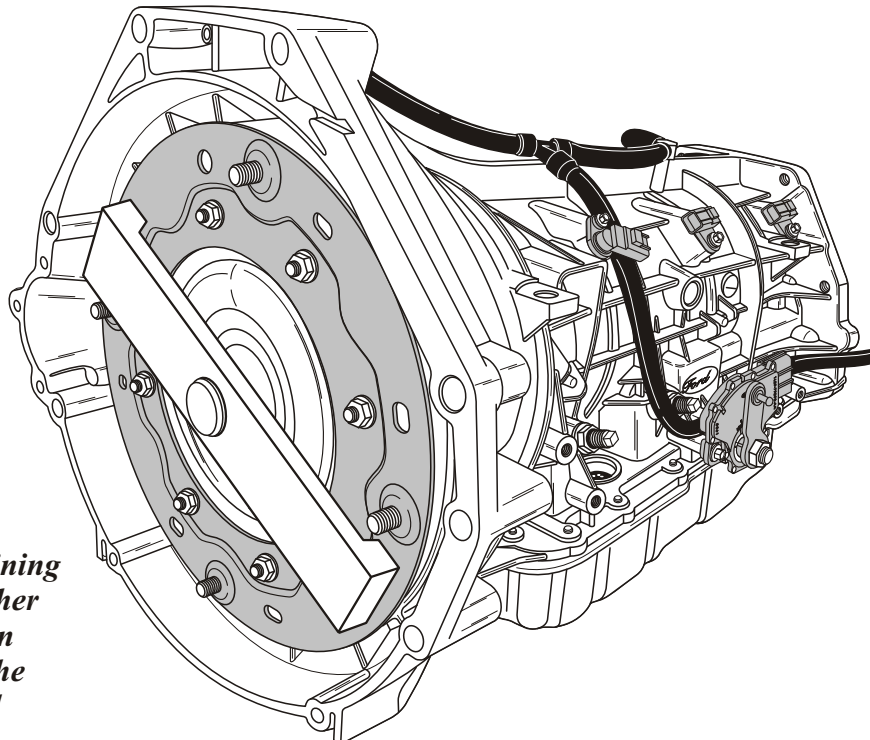
COMPLAINT: After Overhaul, vehicles equipped with the 5R55W/S may exhibit a metallic ticking noise coming from the bellhousing of the transmission, similar to the sound of a cracked flex plate or flywheel.

CAUSE: The cause may be, the adapter plate and the Torque Converter are not aligned correctly.

CORRECTION: Use the Factory alignment tool, Ford Flex Plate Aligner #307-403, or an alignment tool from many aftermarket distributors to align the pilot of the Torque Converter to the adapter plate before tightening the retaining nuts.
Refer to Figure 1 to see which holes, in the adapter plate and the Torque Converter Pilot, to align with the tool. Refer to Figure 2 to see the Tool installed. Figure 3 shows a view with the tool installed and the tightening of the retaining nuts.

Install and torque the remaining 2 retaining nuts after all other nuts have been installed and the tool removed

Torque adapter plate retaining nuts to 33 ft.lb.
