"2007" SEMINAR

Chrysler RWD
TCC Hunting
&
5R55W/S
Converter Noises
By
Mike Souza

DODGE & JEEP RWD VEHICLES

TCC CYCLING

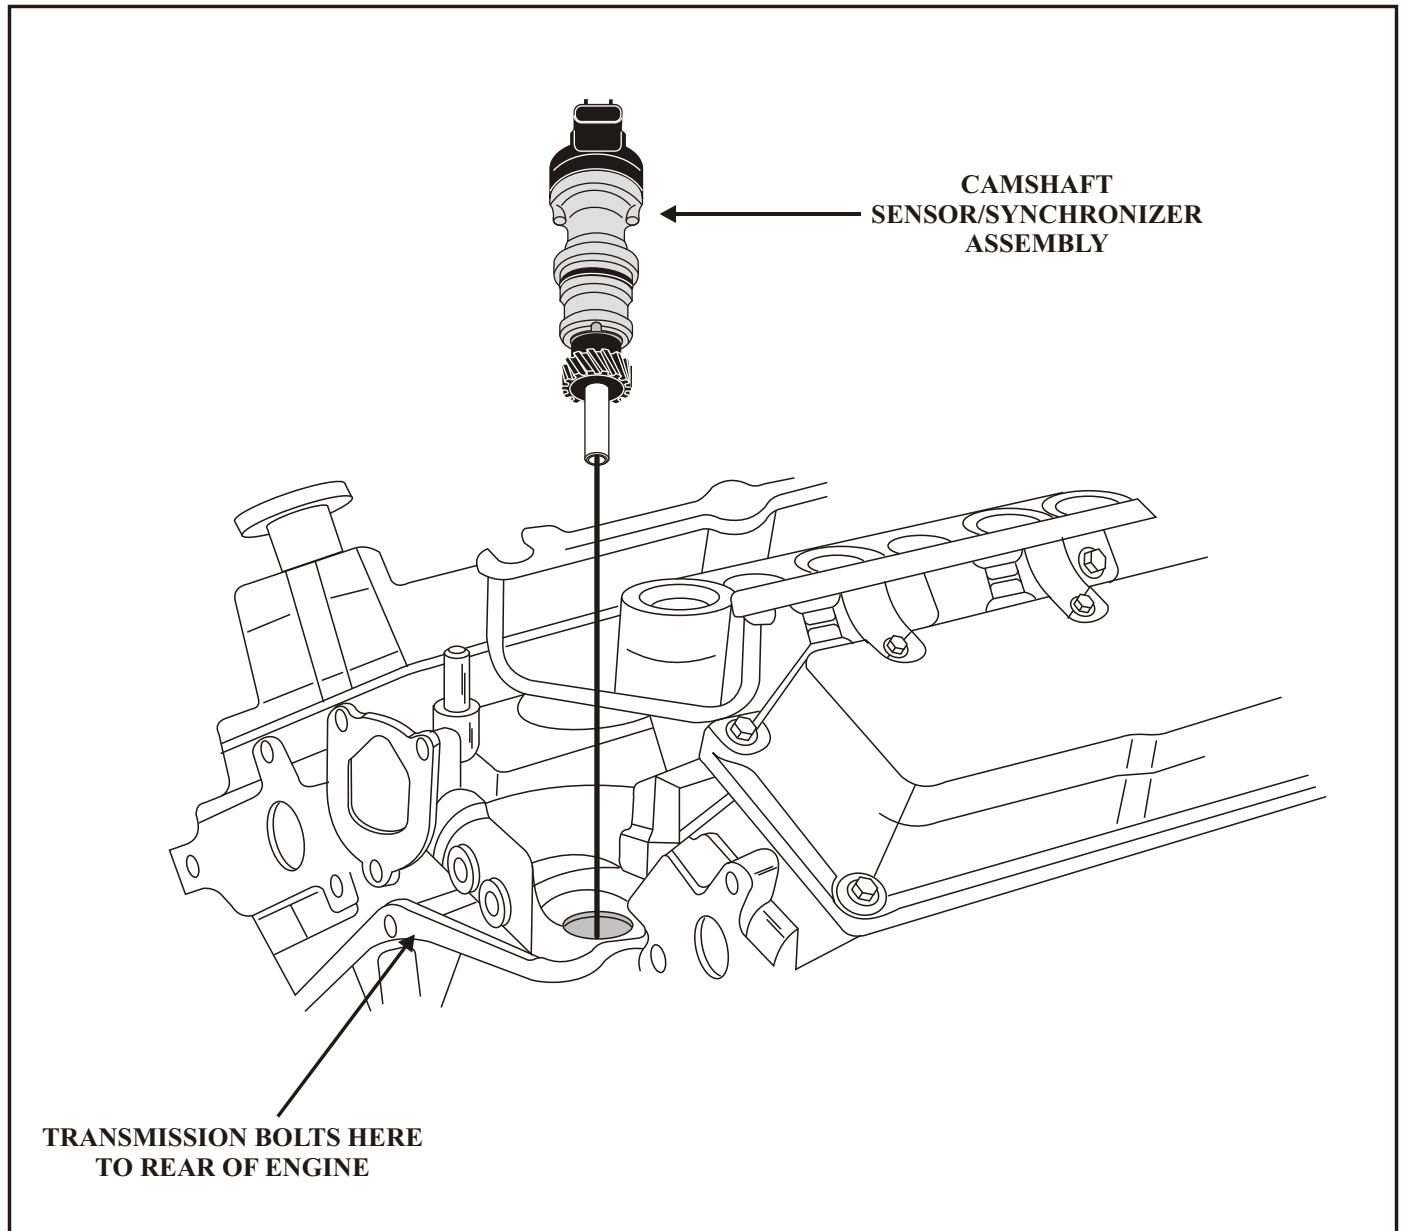
Figure 1

COMPLAINT: Buzzing or whining noise coming from bell housing or torque converter area on a Ford Explorer or Mercury Mountaineer.

CAUSE: Camshaft Position Sensor/Synchronizer assembly bearing failure due to lack of lubrication. The synchronizer assembly lube hole becomes clogged cutting off oil to the area between the synchronizer body and shaft causing it to run dry.

CORRECTION: Replace with an OE assembly from Ford Motor Co. The Camshaft Position sensor is located on top of the Camshaft Synchronizer in the back of the engine block centered just in front the of the transmission bell housing held in by two bolts (See Figure 1). The PCM uses this sensor to control Fuel Injector timing. When this sensor begins to fail it can cause a loud whining or buzzing noise. Because of its location you may think the converter is the problem on an Explorer or Mountaineer. This one has tricked several technicians into spending countless man-hours changing torque converters, EPC solenoids and pumps trying to correct the source of the noise. Line pressure should be checked before changing the EPC solenoid or pump. A steady pressure gauge needle with a reading of 60 to 75 psi will very that the solenoid and pump is working correctly. If the gauge is reading low and the needle is very erratic verify that the filter is not restricted (such as the pan hitting the filter inlet), or sucking air around a damaged filter seal. You may or may not notice any engine performance problems or find any codes stored. *A good test is to place your finger on top of the sensor with the engine running to feel if the vibration or buzz is coming from a bad sensor.* Remove the sensor/synchronizer assembly and dis-assemble it. Check for signs of rust and scoring, (Refer to Figures 2 and 3). Replacing this sensor/synchronizer assembly on an Explorer or Mountaineer is much easier with the transmission removed because of the tight area in which the sensor is located.

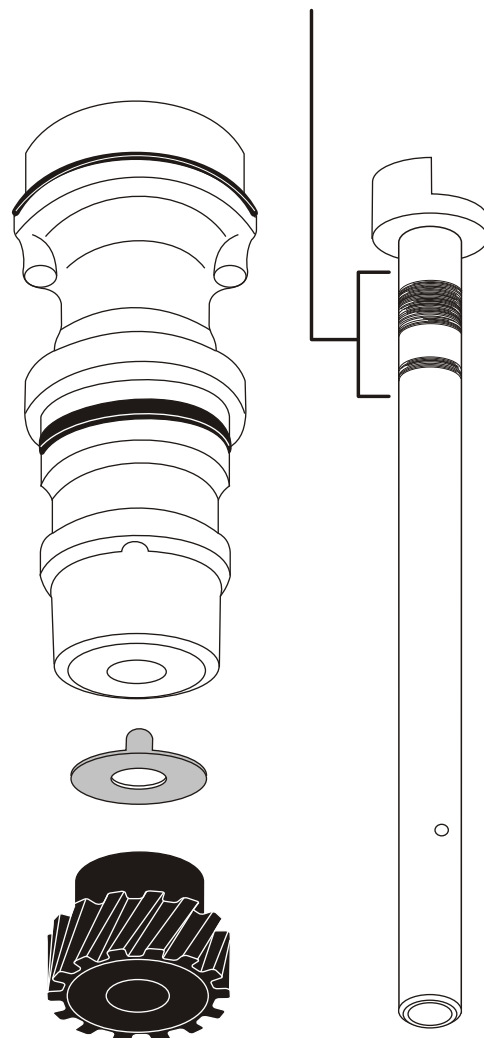
Figure 3

WEAR & SCORING BETWEEN THE SYNCHRONIZER BODY & SHAFT CAUSE NOISE

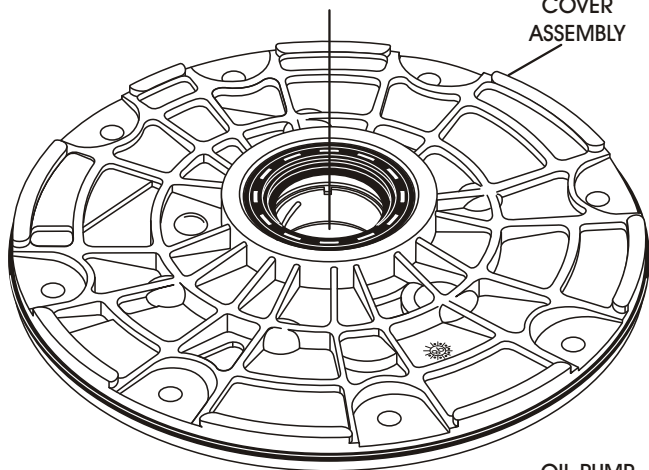
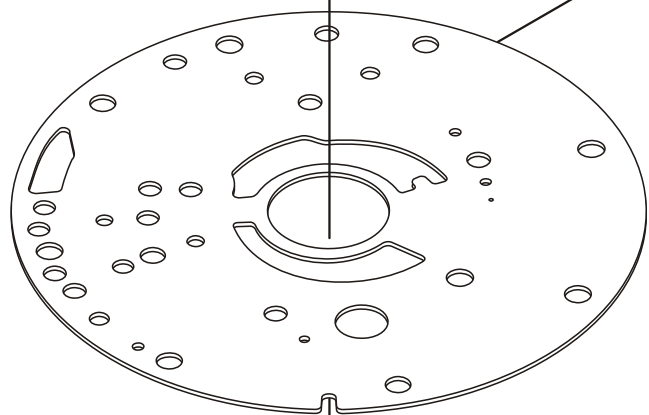
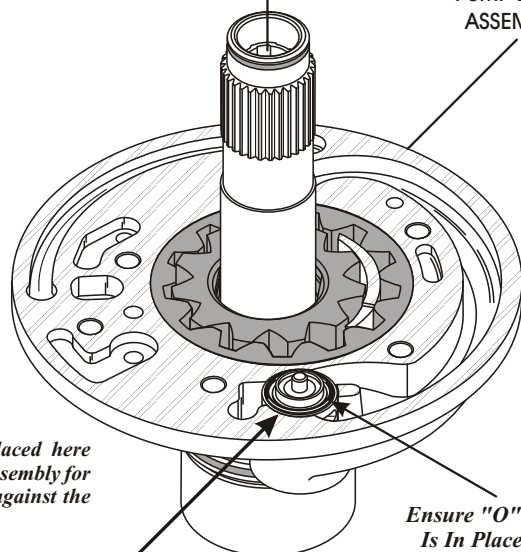
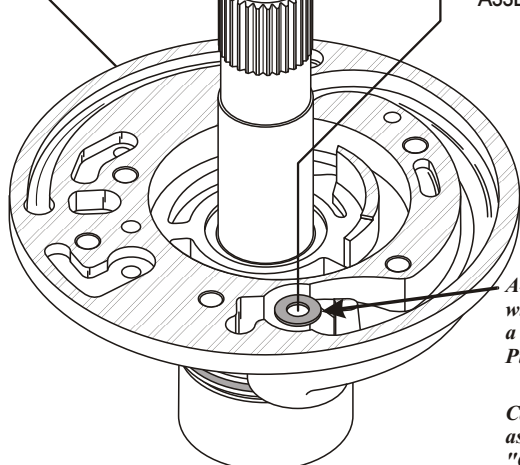
Figure 1

CAUSE: The cause may be, the Line Pressure Relief Valve Assembly (Flow Control Valve) located in the pump stator, as shown in Figure 1, slightly sticking due to premature bore wear in the relief valve sleeve. Figure 2 shows the area prone to wear causing the valve to stick in the worn bore, and may get lodged onto the ridge at the end of the worn area causing an intermittent no movement condition.

CAUTION: The Pump Relief Valve Assembly "Must" Have The "O" Ring In Place As Shown Below

A4LD pump washer placed here will raise Relief Valve Assembly for a better "O" ring seal against the Pump Spacer Plate.

Caution: Do not raise the sleeve assembly above the pump surface, "Only" the "O" ring.
