TCRA 2010 Seminar

Everything Gets Blamed On The Converter

Mike Souza

ATRA Technical Advisor

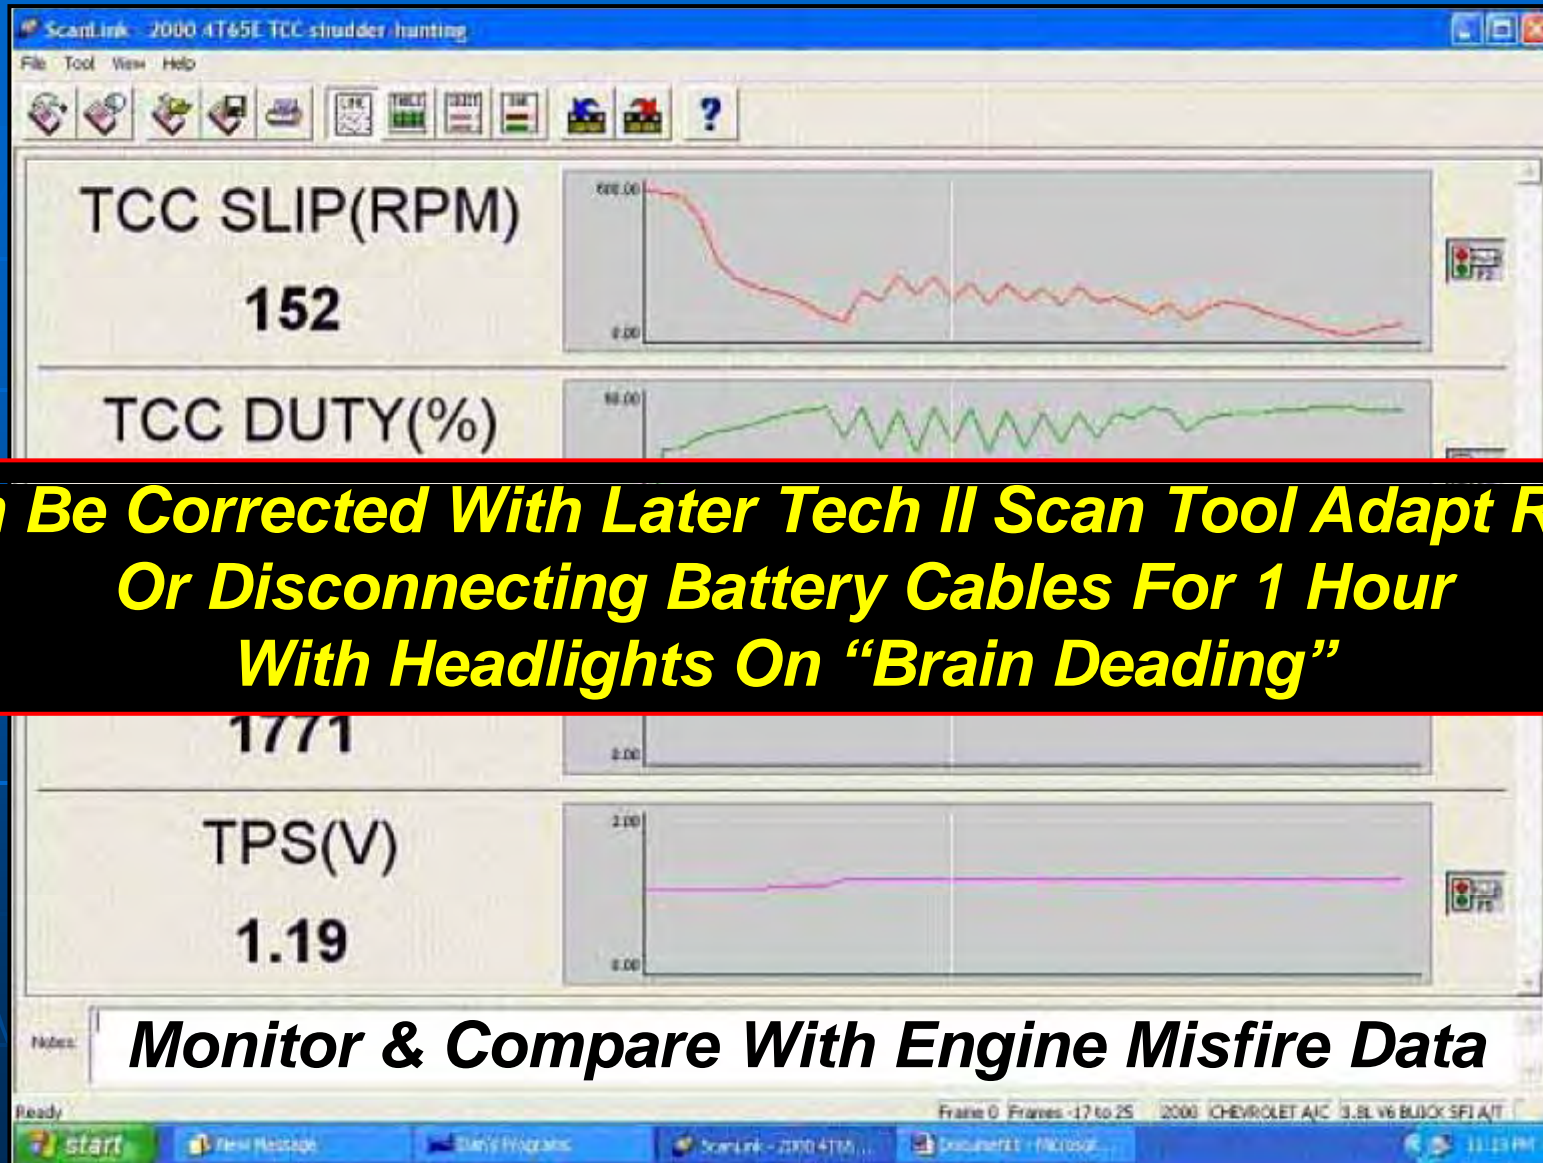
TCC Surging Or Slipping

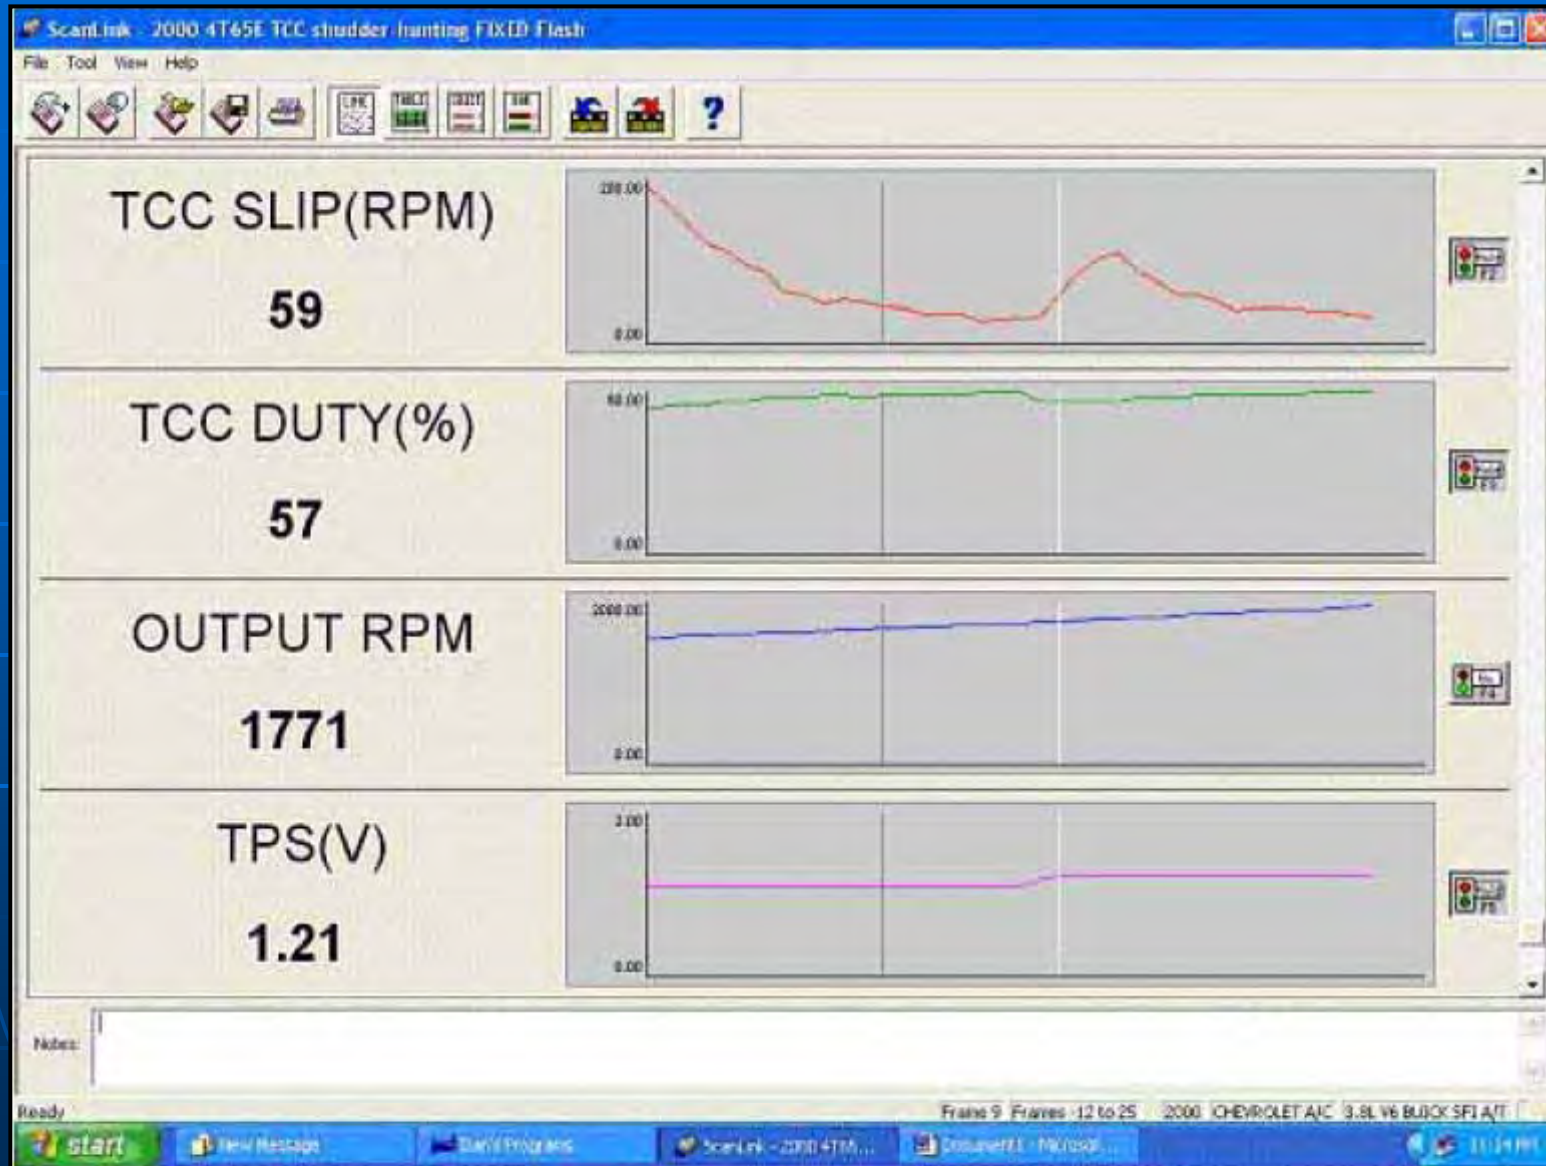
TCC Working Correctly

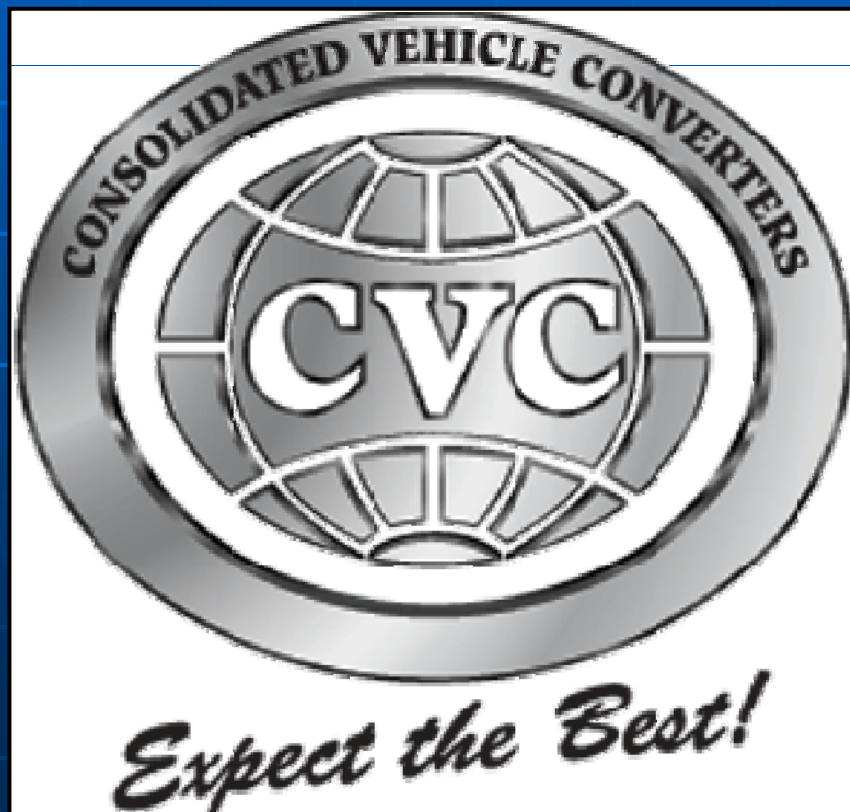
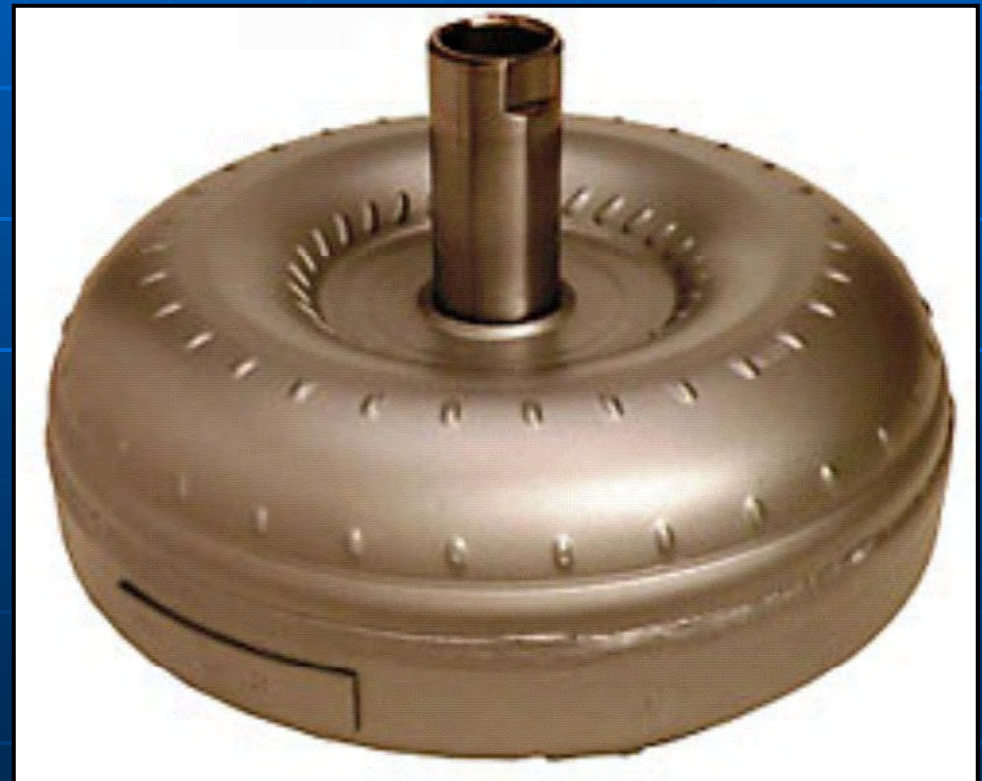
Blamed This Problem On A CVC Converter

***When In Fact The
CVC Converter
(Consolidated Vehicle Converters)
Was The Only Part That Was Not
Destroyed!***

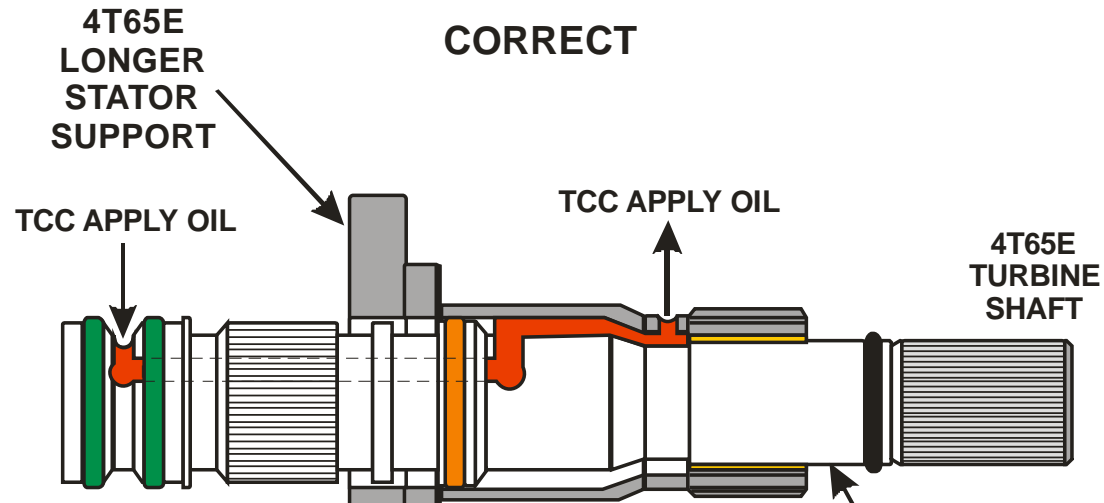
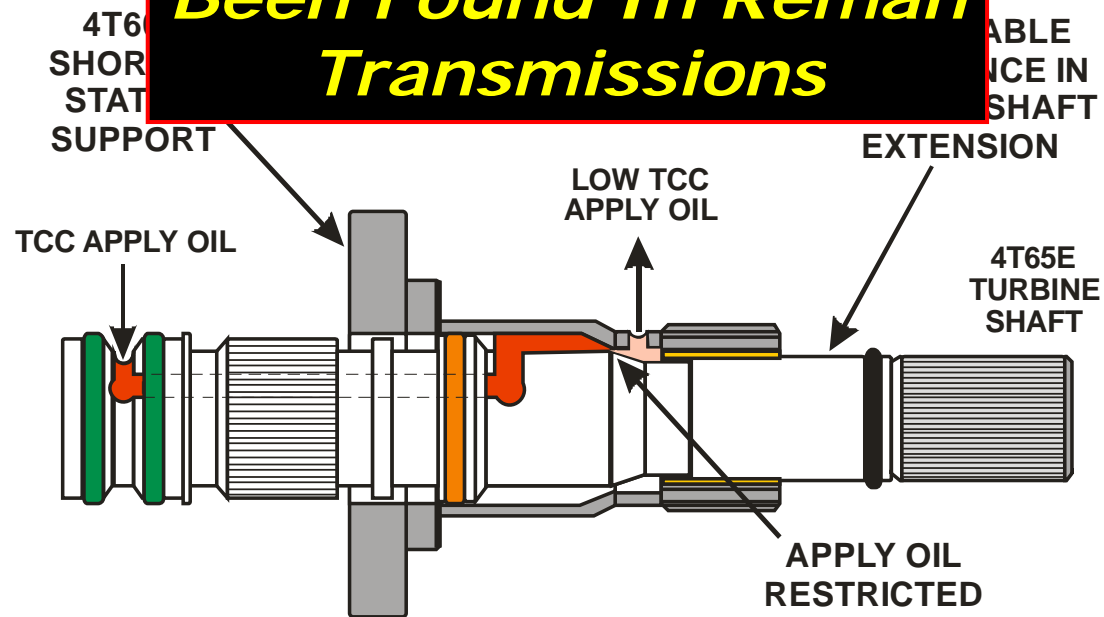
4T65E P0741 After Overhaul

***This Mis-Match Has
Been Found In Reman
Transmissions***

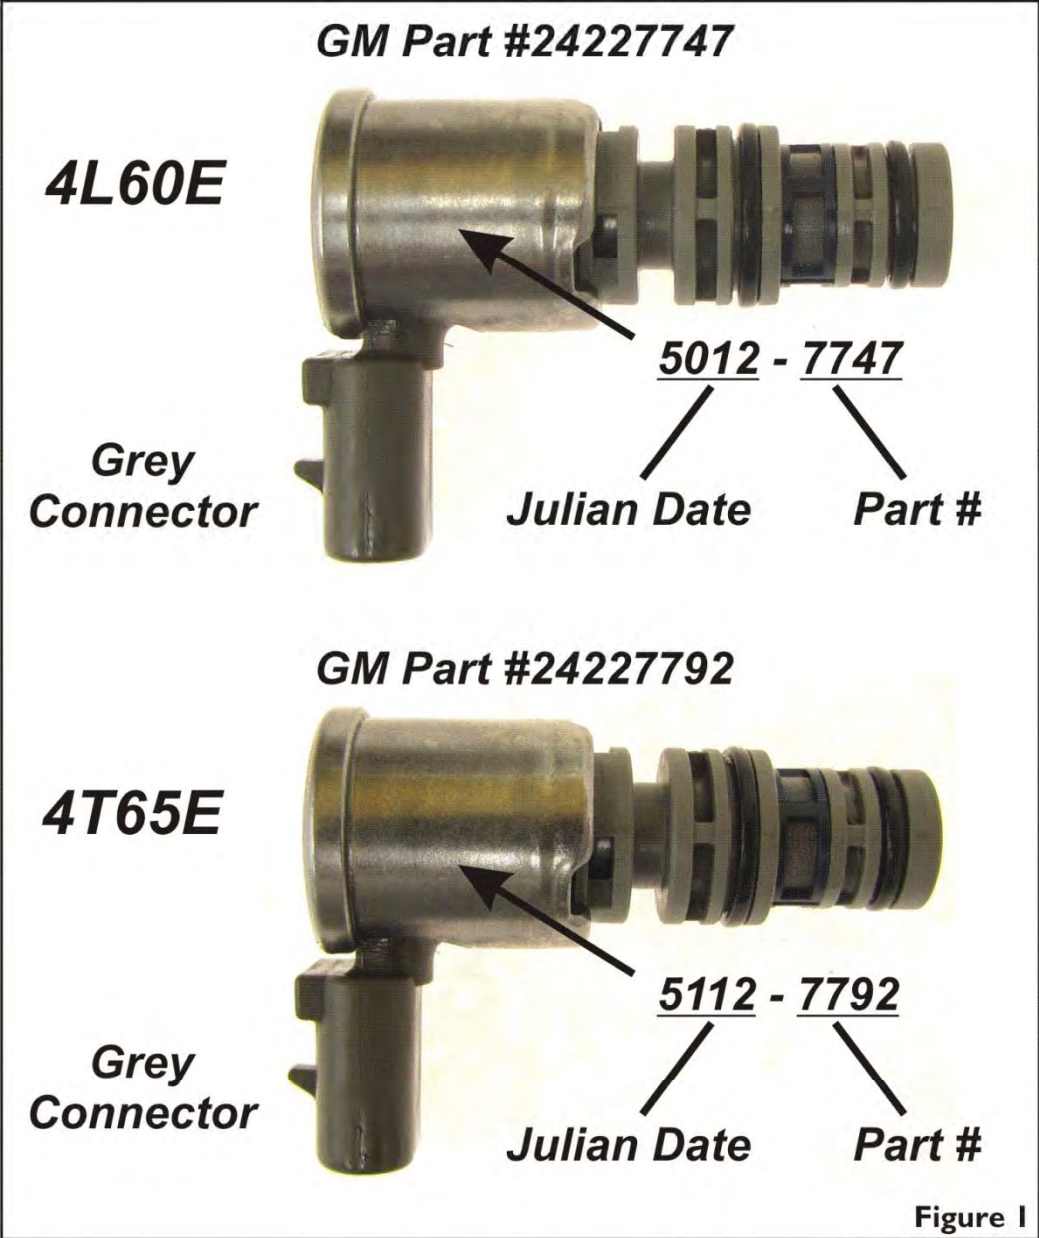
4T65E Code P0742 "TCC Stuck On" After Rebuild

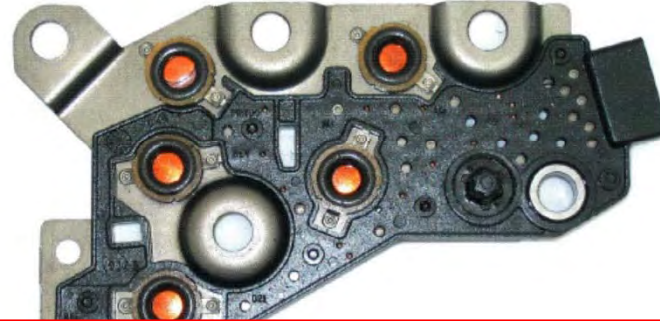
Always Check Switch For Debris And/Or Damage

*Early
4T65E
& All
4T40/45E*

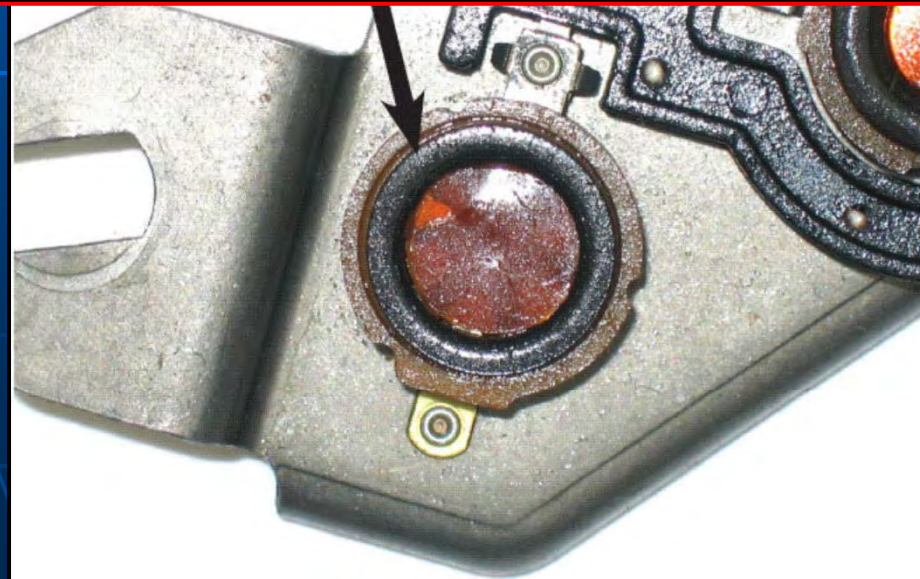
***Quick Check; Disconnect Trans Harness Place
Shifter In Drive If Engine Stumbles Or Stalls
Change Solenoid With "4T65E Type Only"***

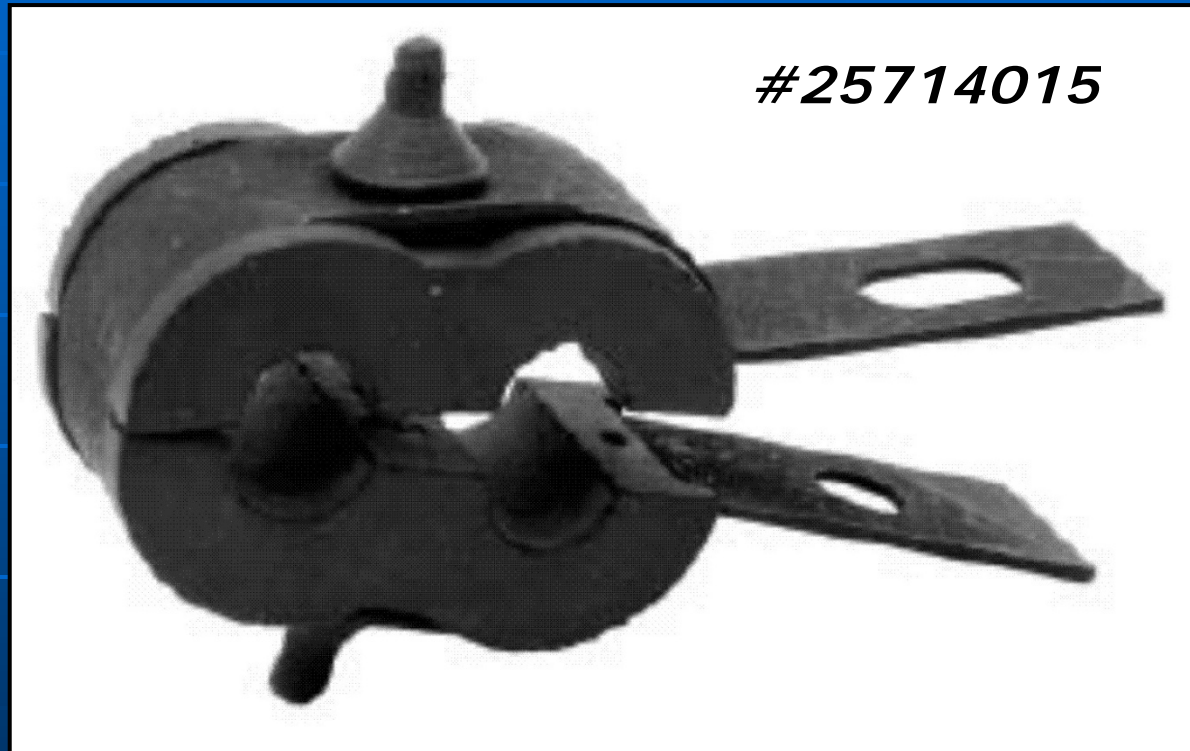
***4T65E May Moan Or Growl After TCC Applies
Update Cooler Line Retaining Bracket***

***Bracket Mounts To The Support Bar Behind
The Passenger-Side Cooling Fan.***

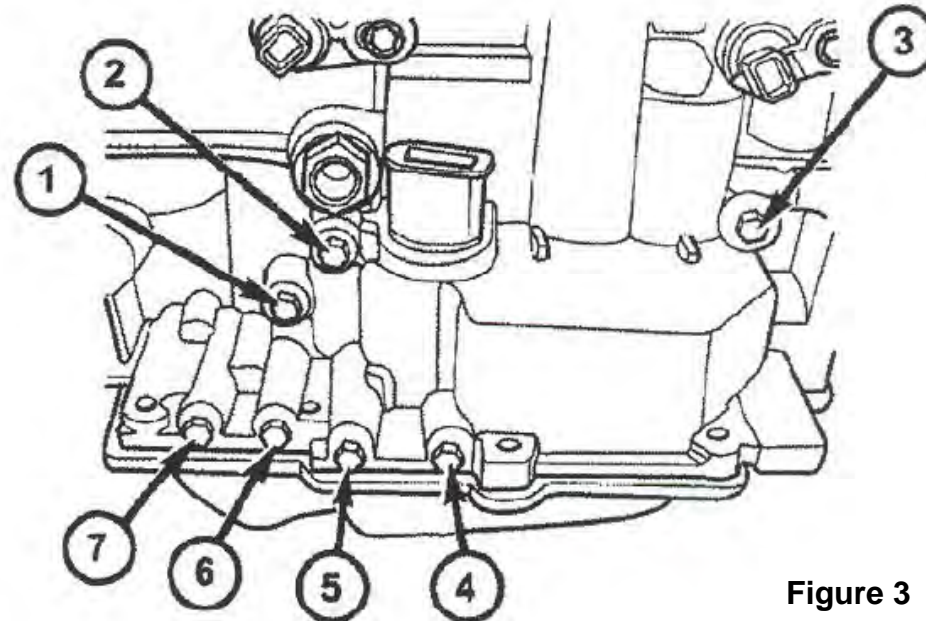
**Check Underdrive & Low/Reverse Pressure
Cold & Compare Results When Hot**

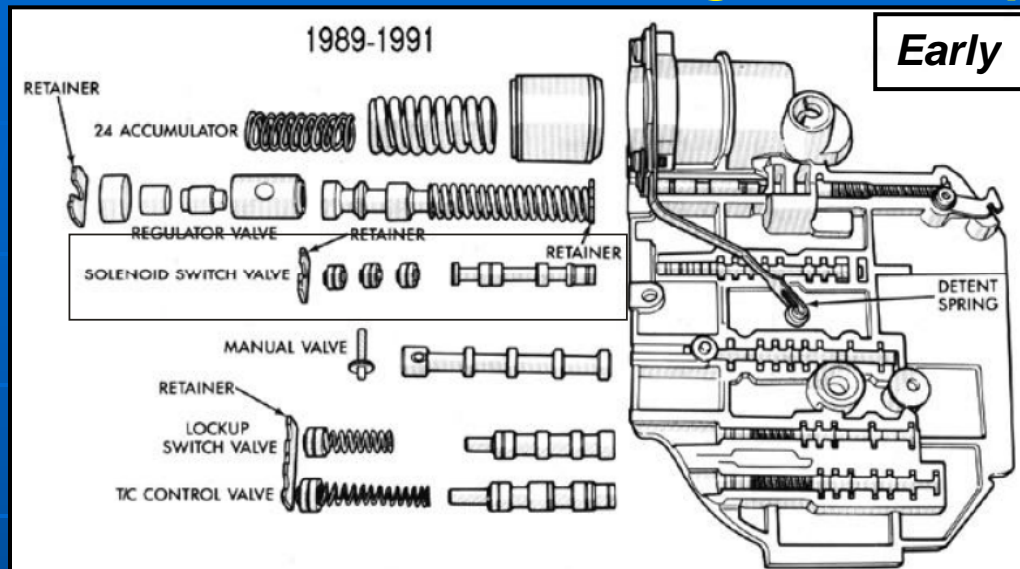
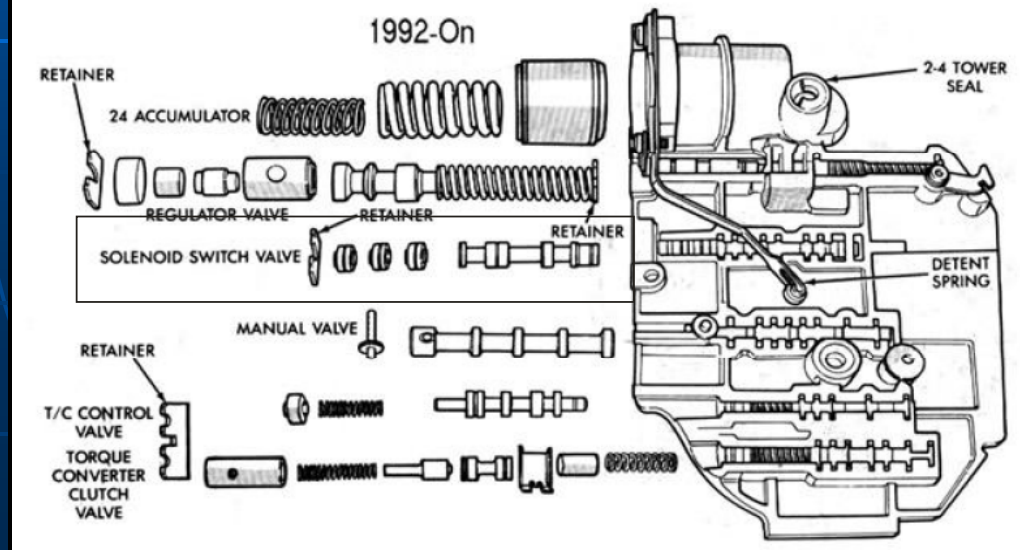
Stumble Or Stall Coming To A Stop

Stuck Solenoid Switch Valve

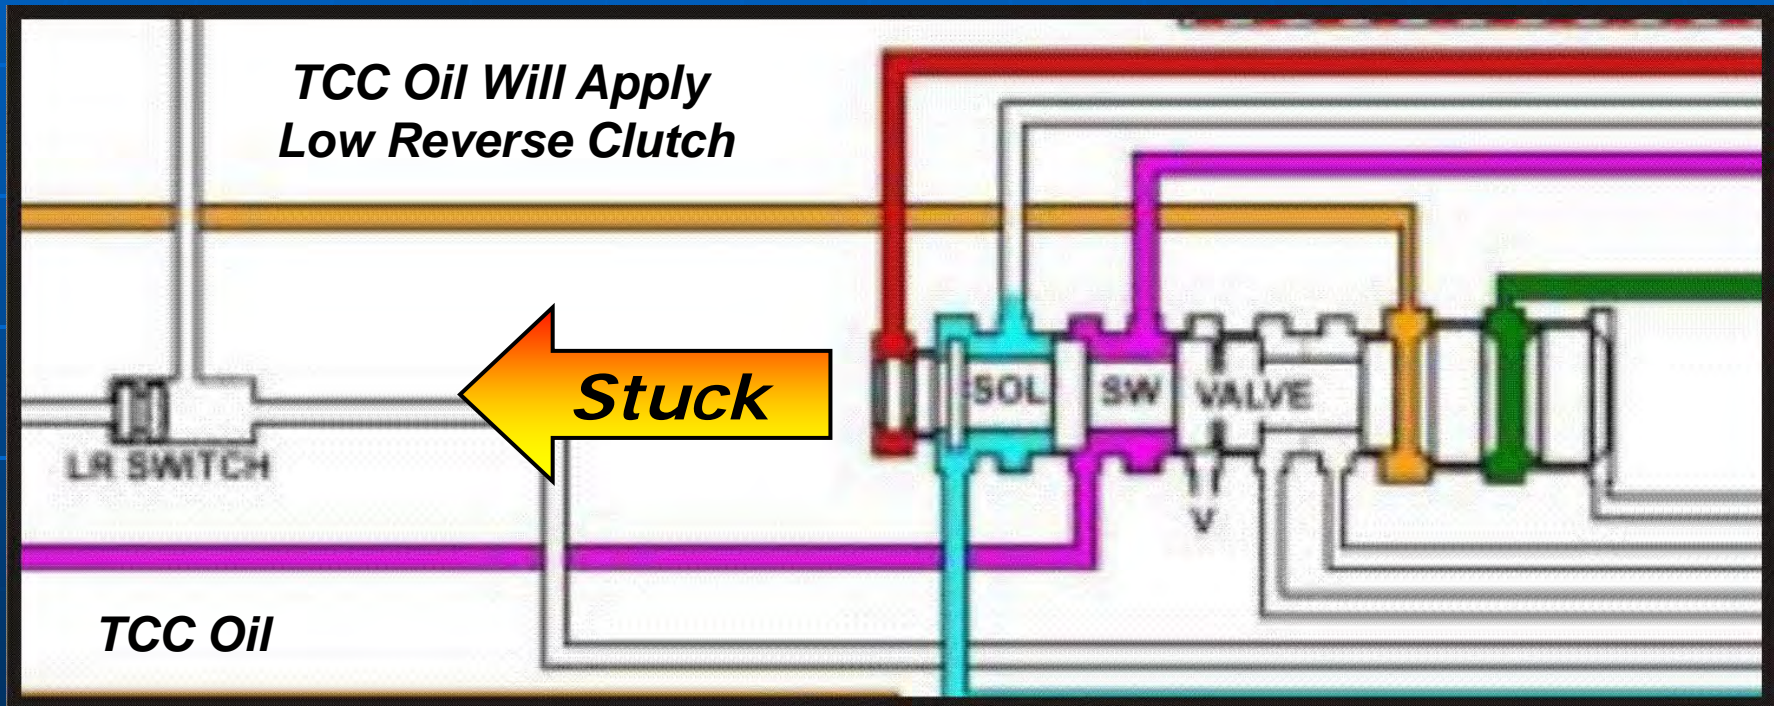
***So There is a Switch Stuck in P Position During Drive
When The L/R Solenoid Comes Back On In 1st Gear
It Will Apply The Torque Converter
And Stumble Or Stall The Engine***

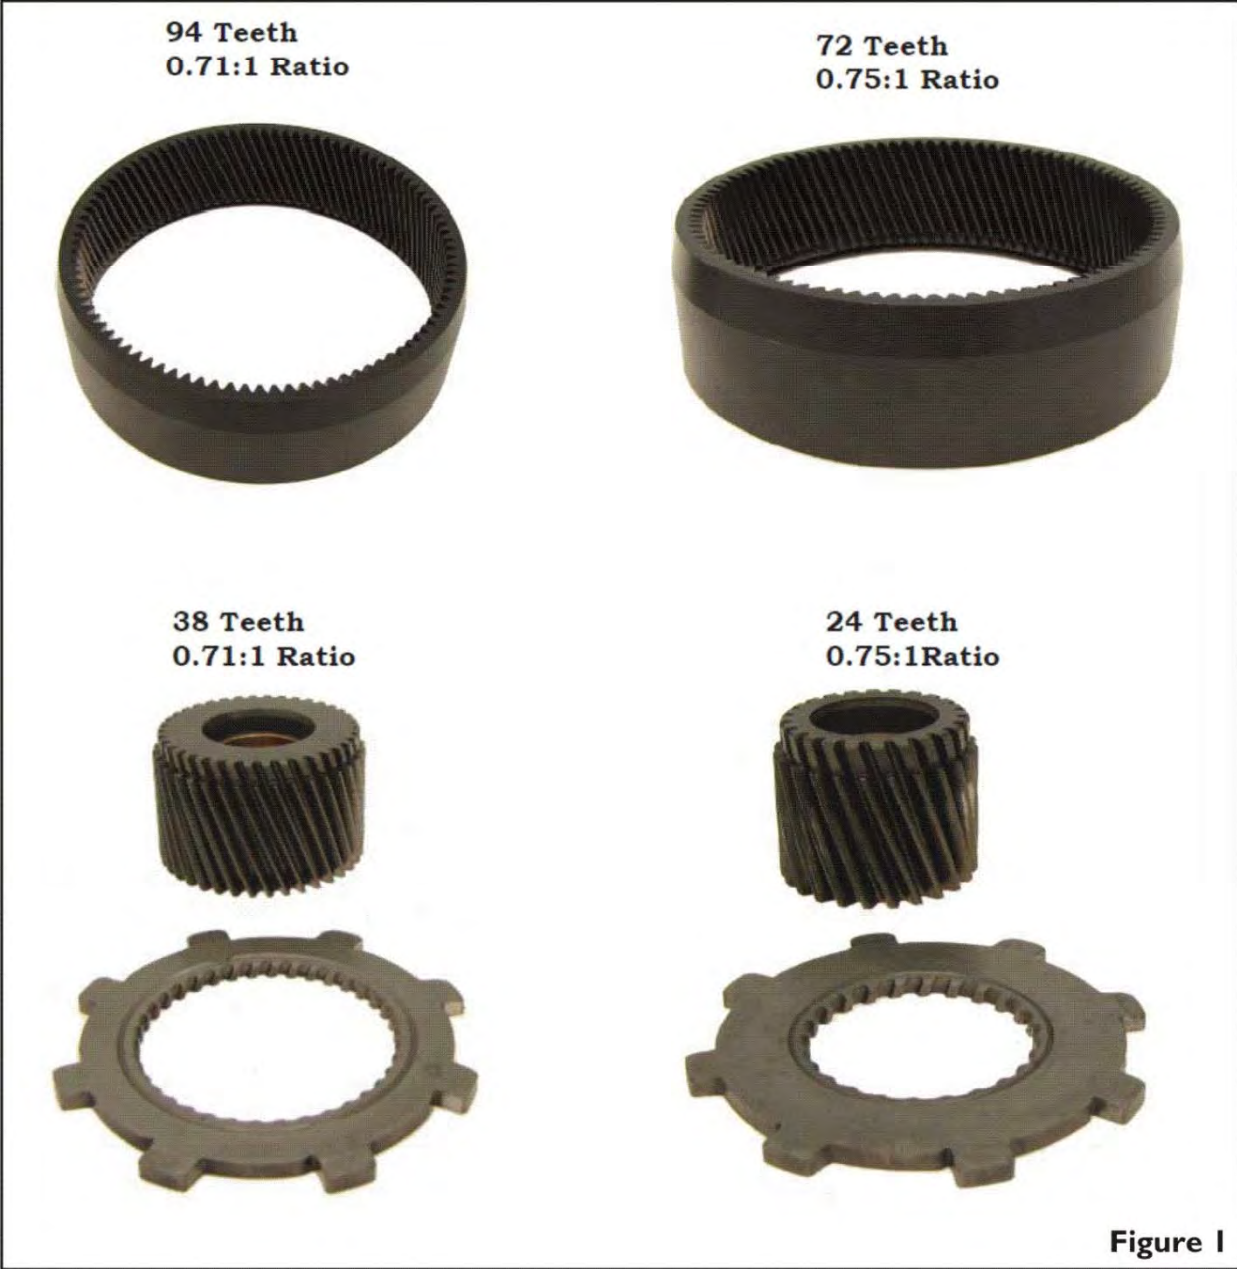
5R55W/S/N With TCC slip code P0741 Wrong O/D Planets

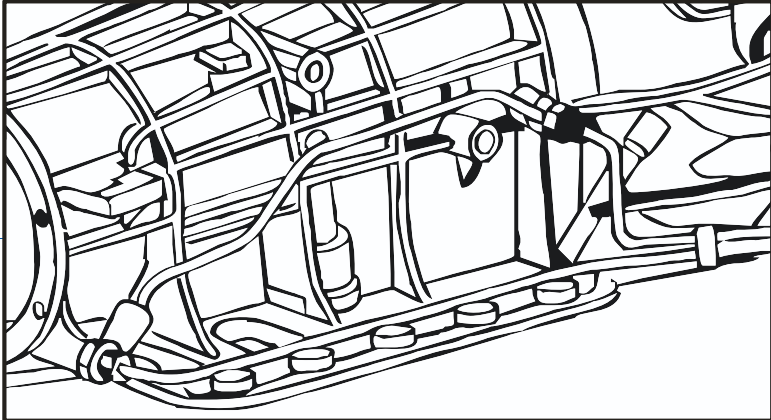
Bypass Tube Assembly

E4OD/4R100 Transmission Fluid & Converter Over Heating

Bypass Tube "Stuck Open"
