Converter Conundrums

The top 3 converter vs. transmission issues of 2010

TCRA 2010

Presented by:
Bob Warnke

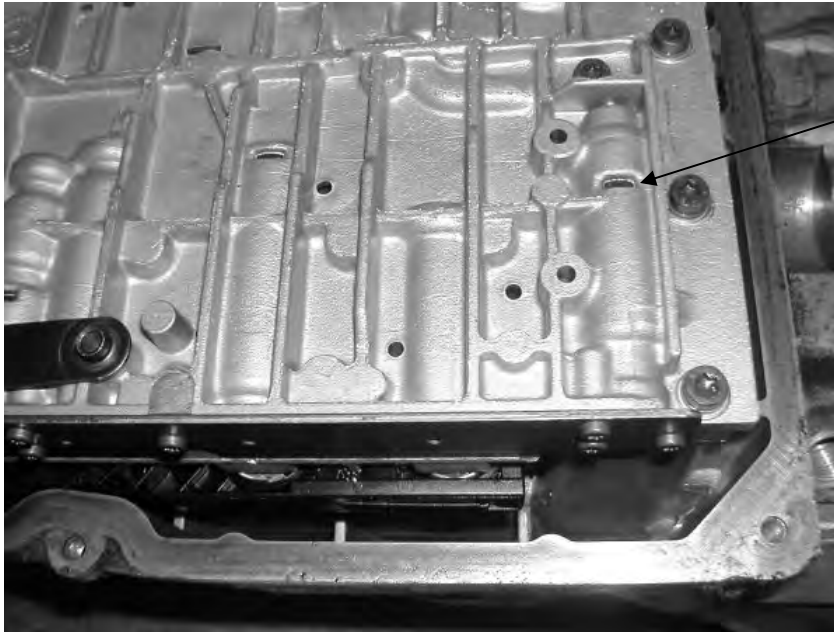
TCC Exhaust

Air pressure will charge the TCC Piston from opposite side.

The TCC apply circuit can be air tested, (30-60 psi.) with the unit in the vehicle and the valve body in place. Charge the exhaust hole. The air supplied will push remaining fluid into the converter TCC piston. Minimal leakage should come out cooler lines or other valve body locations.

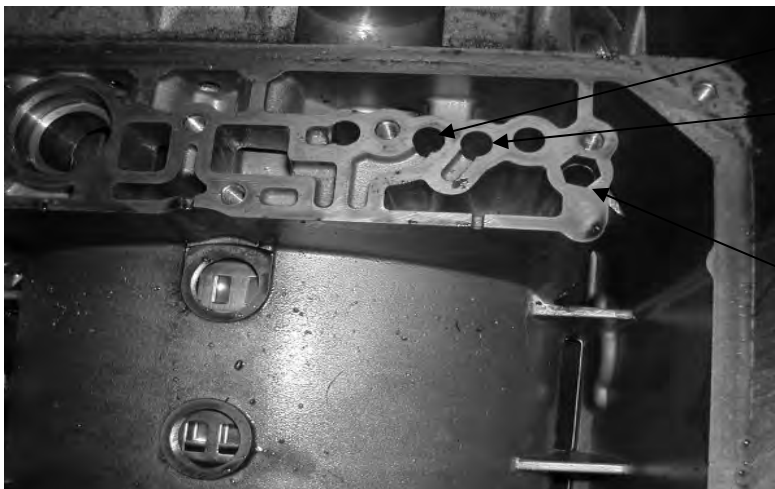
If the valve body is removed, the three converter circuits can be isolated. Any leakage from converter charge or converter out, is from cross leak at the pump or within the converter.

TCC Piston

Converter out

Converter charge

Note: Teflon type of sealing rings require fluid to lift. If air testing with a dry circuit, they will cross leak. Turbine shaft sealing rings should be the OE overlap design. Valve body must be flat and the pump stator or converter cross leaks should be eliminated. Internal transmission bushings insure the turbine shaft runs true, a requirement for the rings to seal.

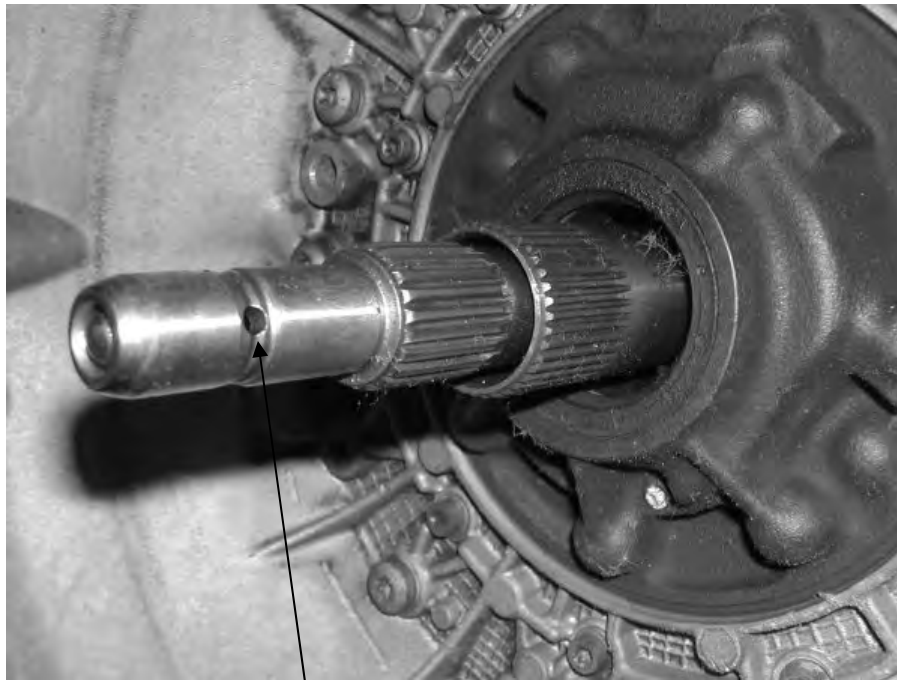
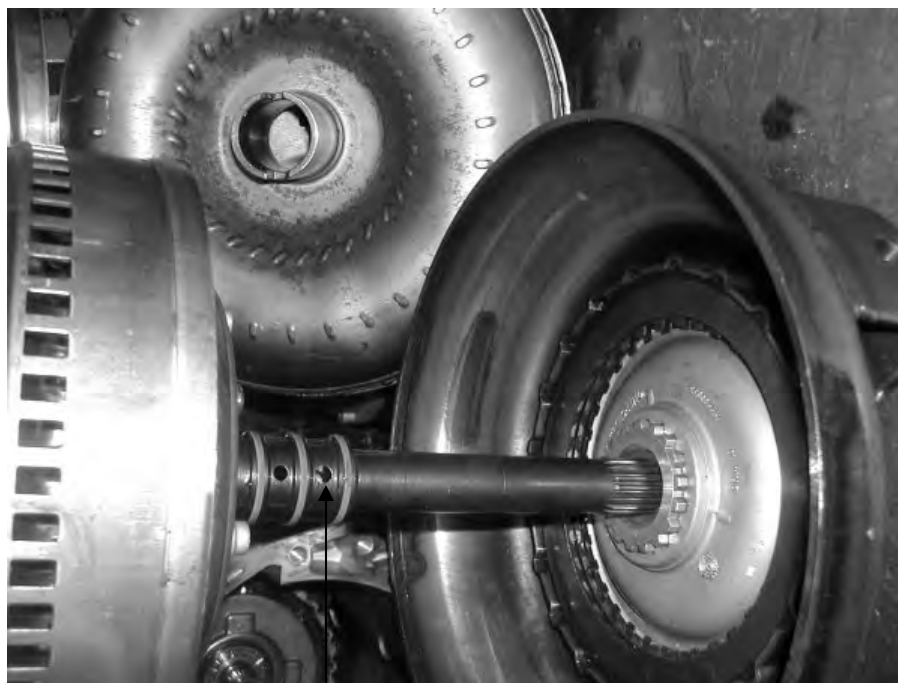
TCC Piston Apply

The turbine shaft can also be installed into the converter and the clutch tested as well.

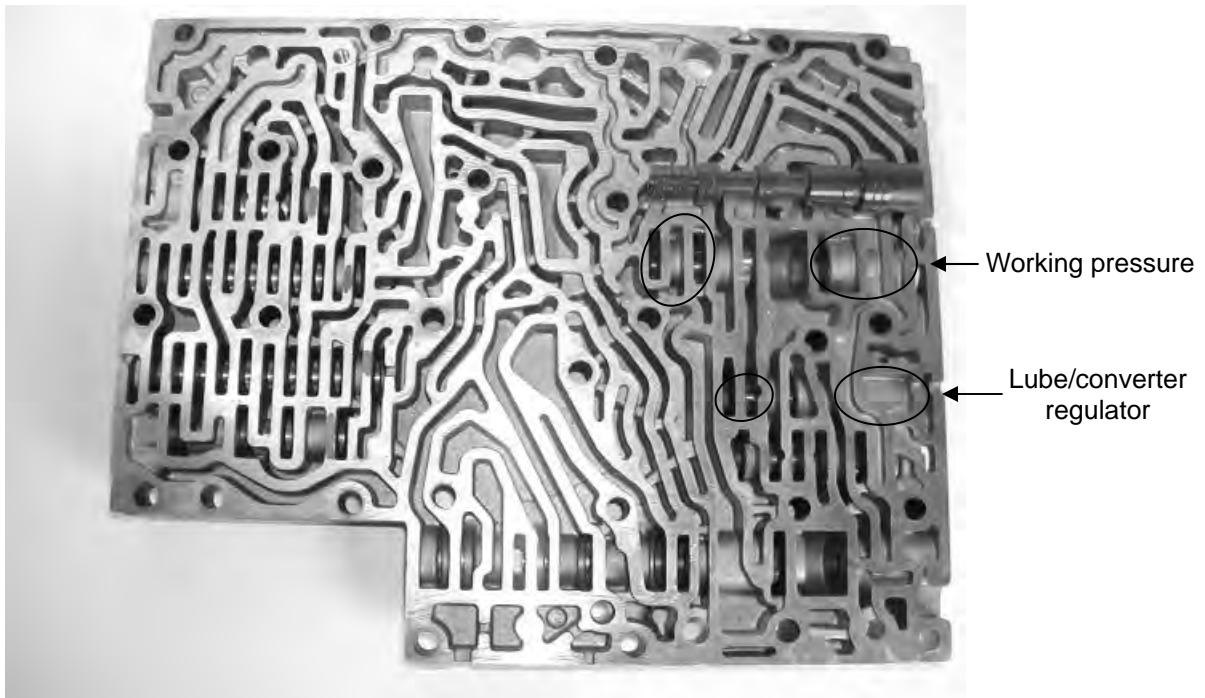
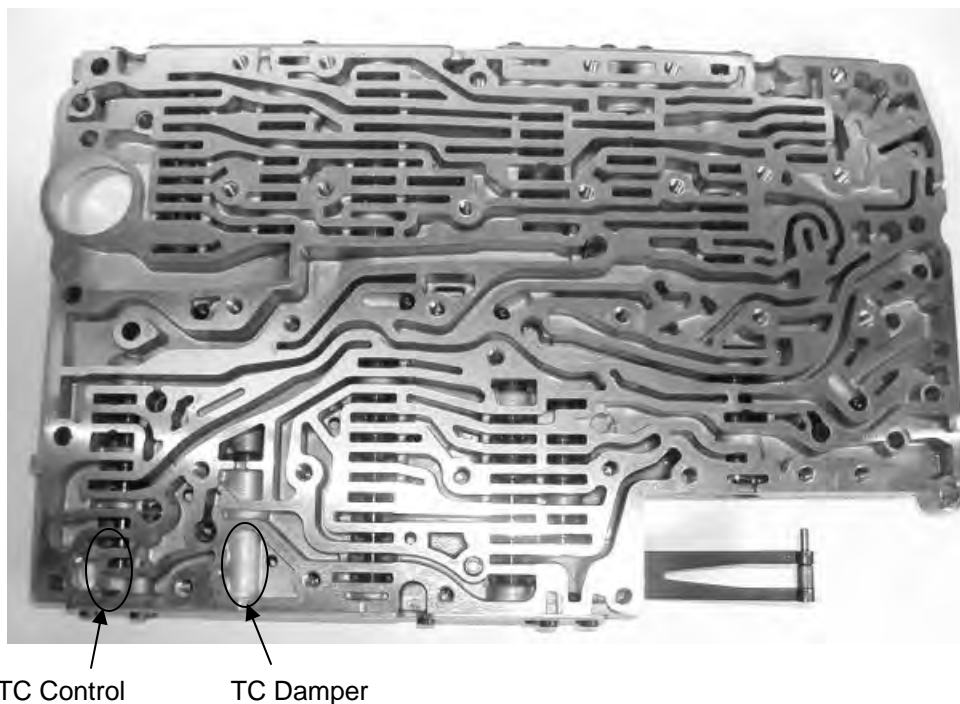
2: Low converter apply pressure extends from the main/working pressure regulator bore and the Lube/converter limit valve. Wear at either area affects TCC and converter charge psi. Critical wear points within circles. The TC control valve must stroke for full apply. Bore wear at either, reduces the TCC solenoid affect to stroke the valves.

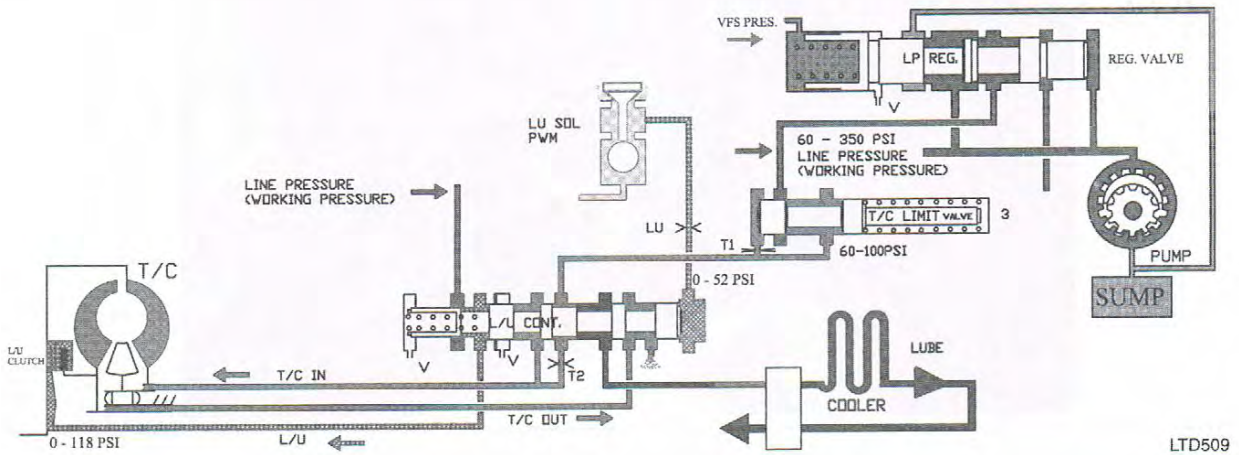
3: The normally closed, Y3/ 6y6, TCC solenoid strokes the torque converter lockup valve. If the Y3 solenoid leaks into the control valve circuit, the valve may rest in a partial apply position.

3: Test, replace Y3 lockup solenoid.

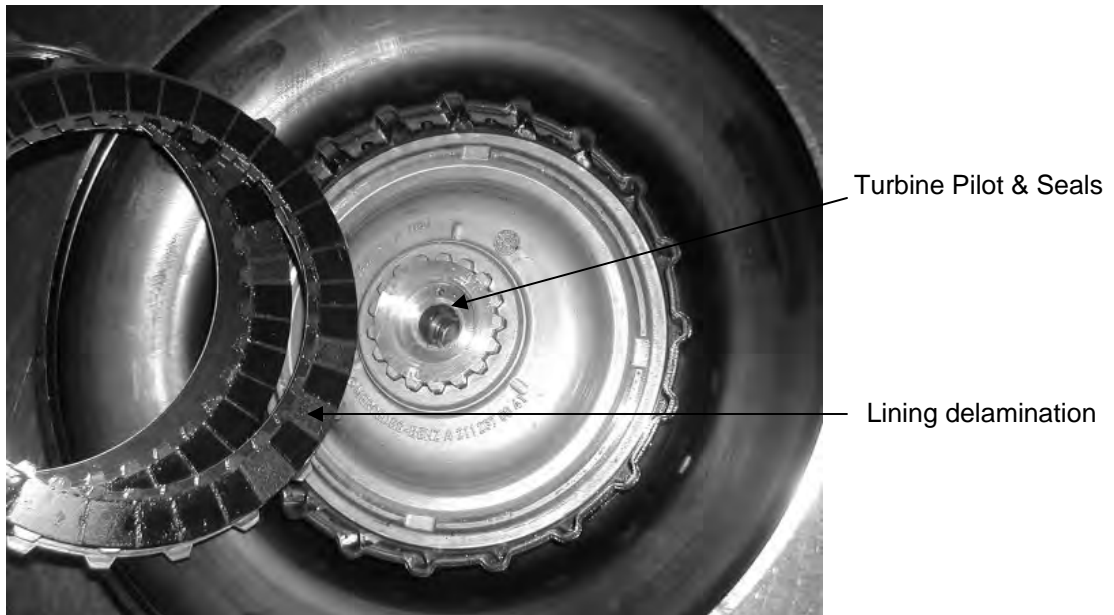
4: Test for water or antifreeze in ATF. In some applications, one drop is sufficient to degrade clutch linings.

Mercedes kit # 000-989-009 and 000-989-0014
 ESP Chemicals Inc. Ph; 520-622-4087 #HI 3859 @ \$75.00
 Chrysler cannot cross reference this number.
 An alternative is to use a hot plate and check for a sizzle noise as the water burns off.

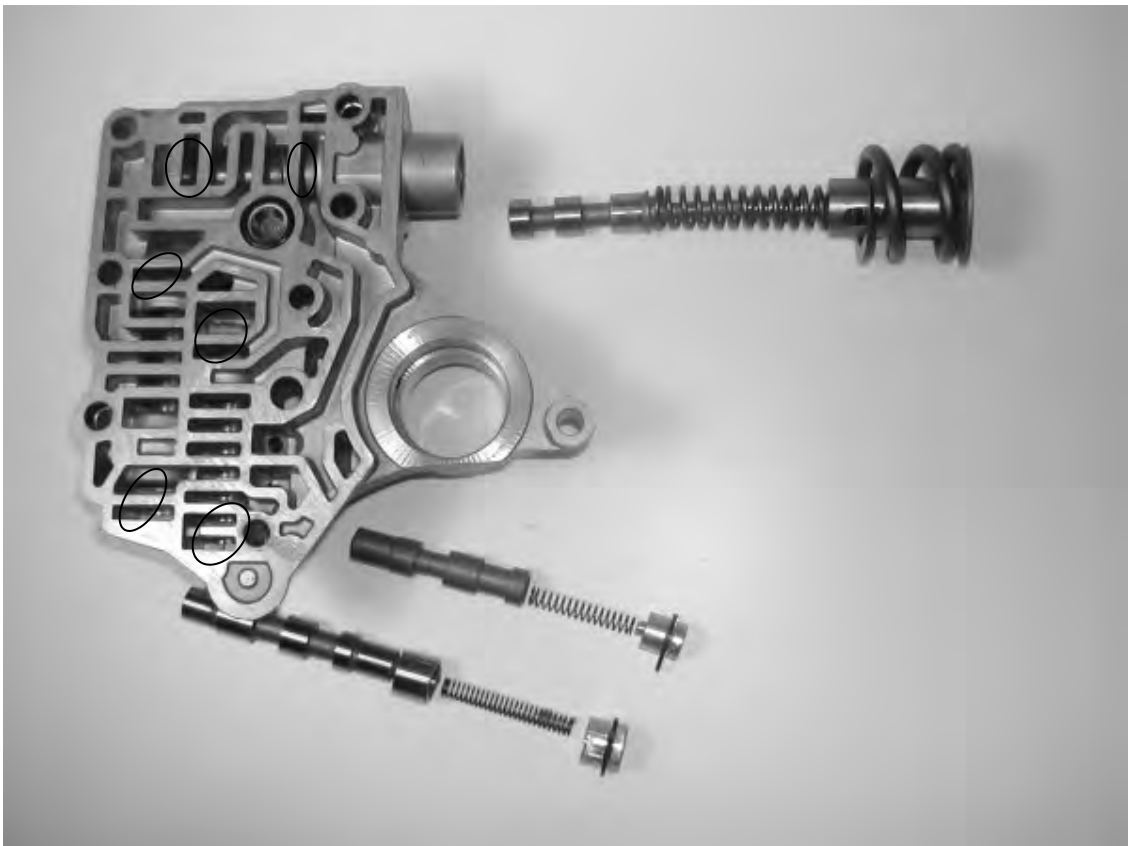
1: Main control body bore wear. Critical points at circles

Control valve body worn at the converter relief bore.

To isolate prior to removal, compare scanner data to the cooler flow. You should see the TCC command and amperage change in parallel to a cooler flow change on a SonnaFlow.

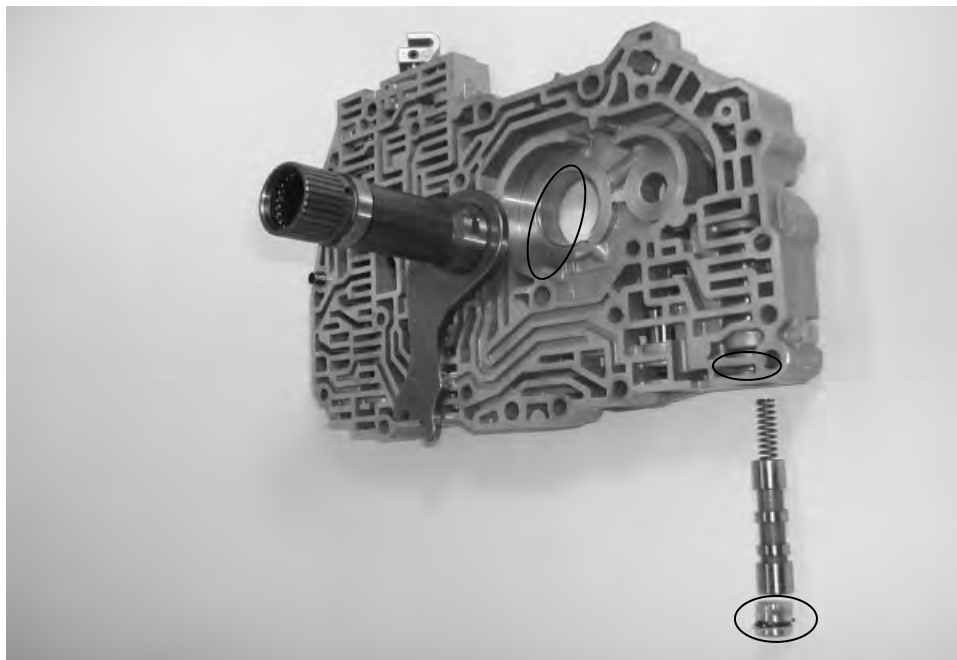
Loss of TCC or TCC slip: Created by end plug loose at the TCC control valve. A cross leak of converter charge oil into TCC control negatively affects TCC control. Inspect the stator for cross leakage at the finished area, where it passes through the casting.

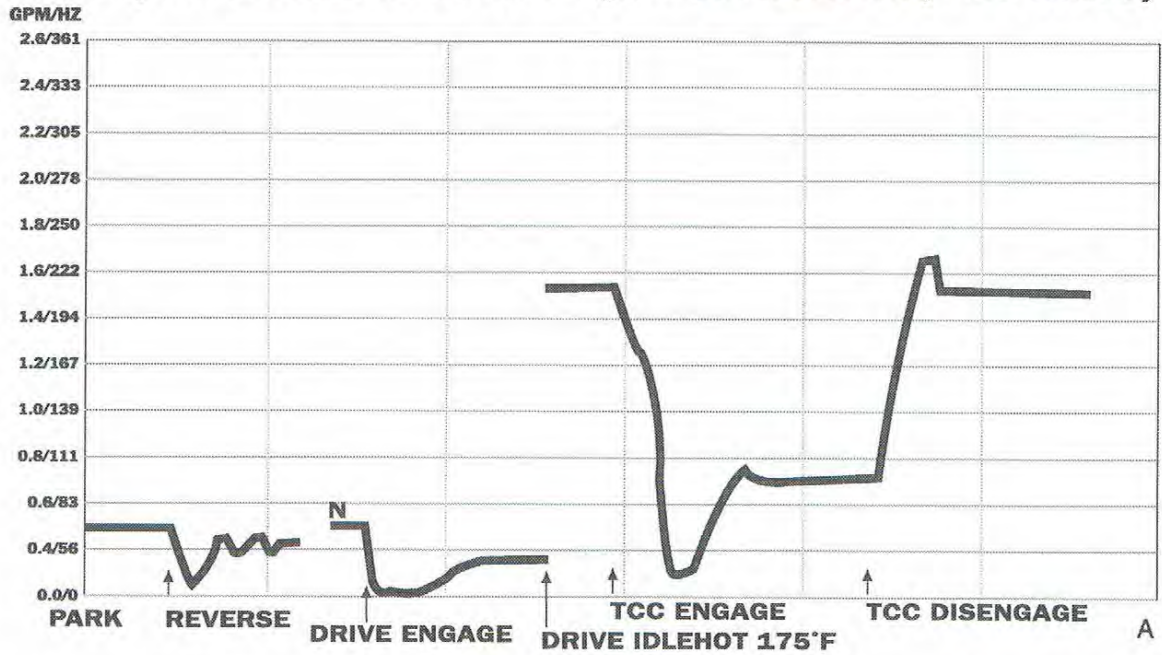
BAXA ('98 Honda Accord 4 cyl. USA built 83,750 miles)

Notes: Drive idle flow would drop to .3-.2-.1 at times, while brake torque would go up to 2.0. Park to reverse would be a smaller dip than neutral to reverse. Reverse to drive could see first dip for list clutch and second dip for no release.

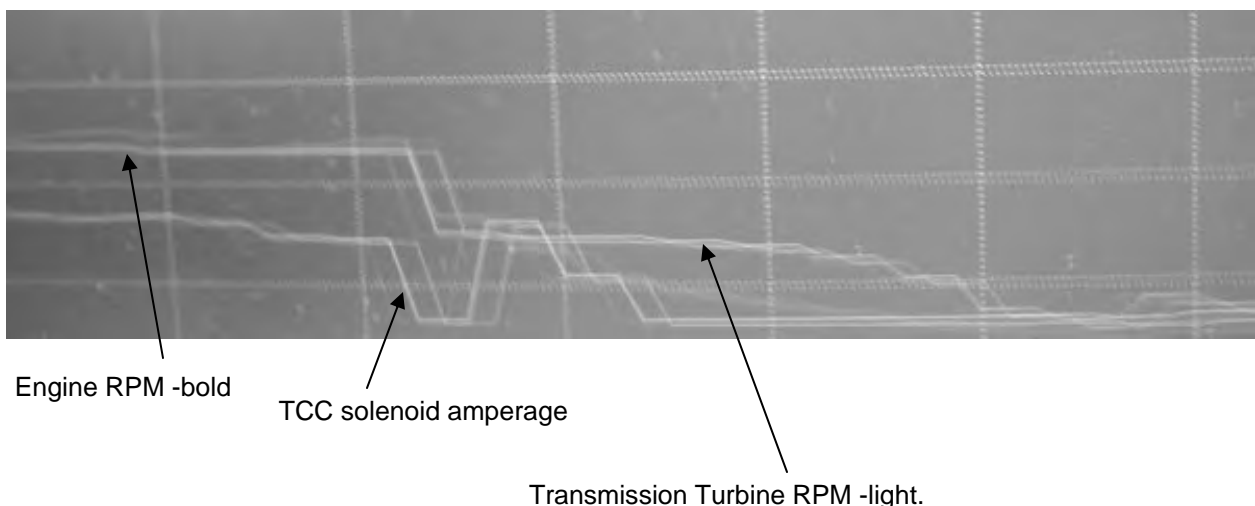
With a scanner; monitor the TCC solenoid. You should see amperage change as it's modulated briefly to open the converter.

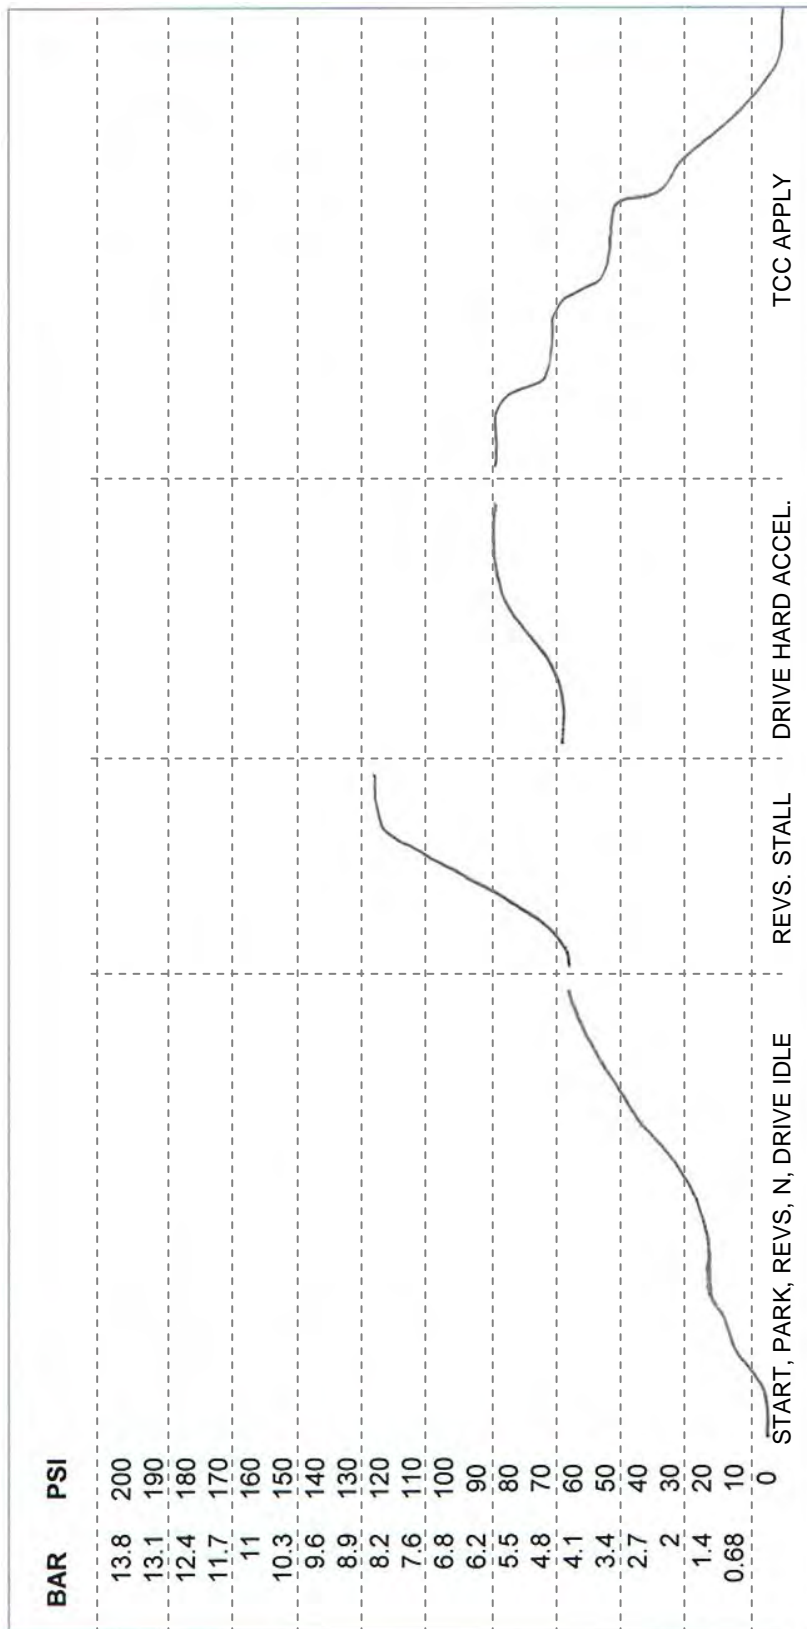
AW6 CONVERTER RELEASE PRESSURE (Typical)

Note: Tapping release pressure is a good method to verify operation of #4-N 91 solenoid.
 TCC modulates off-on during 4-5-6 gear shifts. This tap is a method to verify TCC is affecting shift quality.
 TCC modulates on after 1-2 shift.
 TCC cut off during Tip-Tronic up & down shifts
 TCC remains on during coast down.
 If cooler release pressure is low, check fluid level!

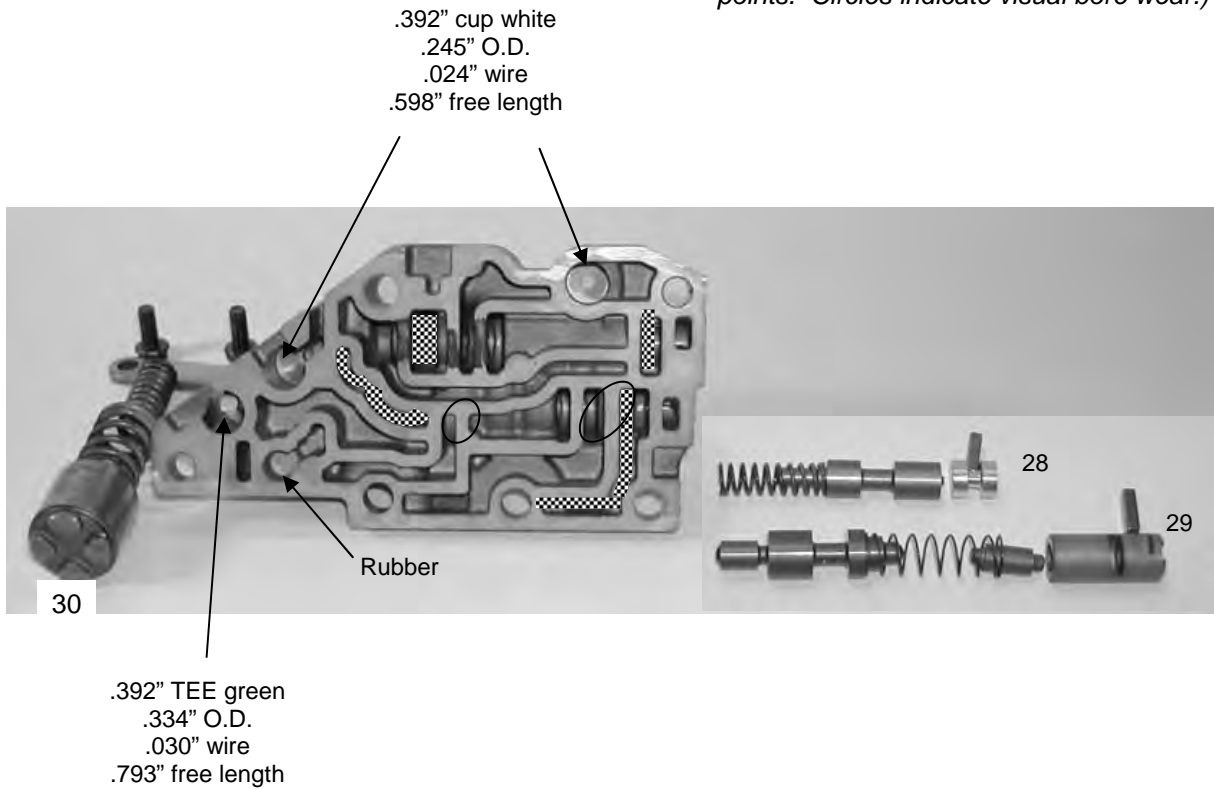
TF 80- AF 40/AM6

(The dotted areas indicate vacuum test points. Circles indicate visual bore wear.)

1: Visual inspection, WAT or vacuum test the TCC control bore at the inboard end and the outboard sleeve. If worn ream or replace the valve body. Aftermarket valve body rebuilders generally have these in stock.

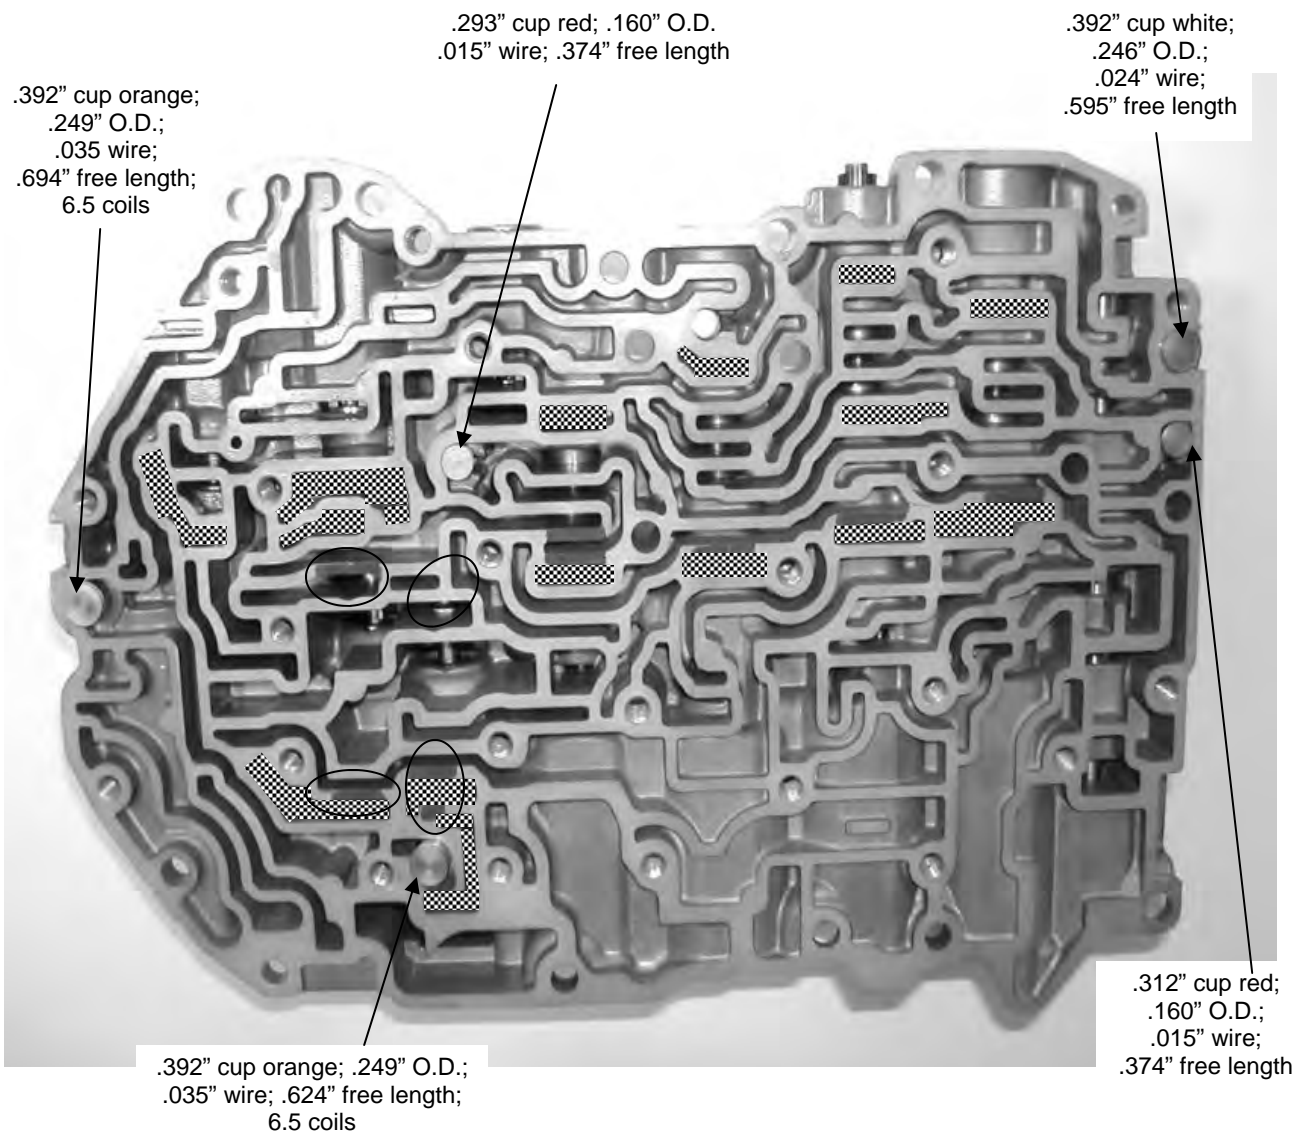
Relief is not in all TF60 units.
No hole in plate=no relief.
