PRECISION INTERNATIONAL

Torque Converter Issues Related To Transmission Overhaul Before and After Rebuild

**TCRA Seminar
Louisville, Kentucky
April 25-26, 2014
Sponsored by W.I.T.**

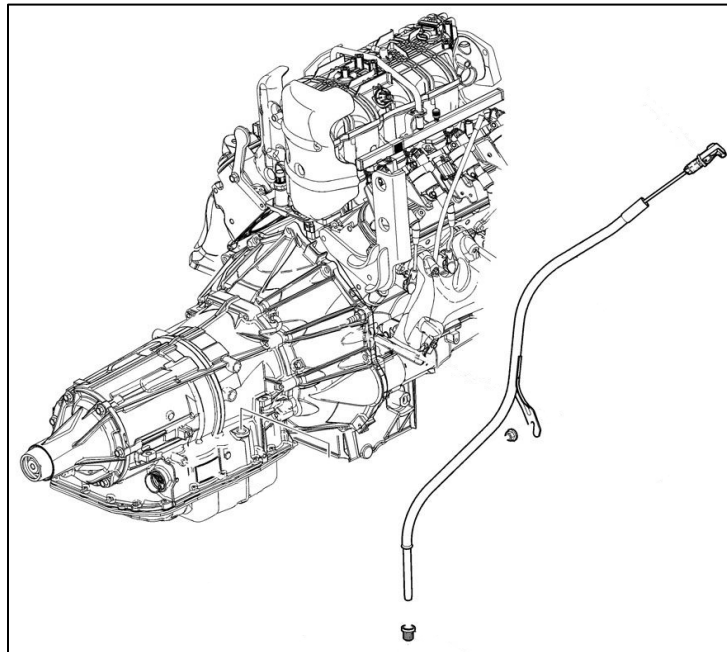
The fill-tube on this transmission will be up to 60 inches long (depending on model). It has been known to vibrate and crack. When this takes place, water will enter the transmission. **This happens with such frequency GM released a service package 24262134.** It contains a foam sleeve and “zip-ties” to stabilize the fill tube. When receiving a request for an exchange 6L80/90 torque converter, advise your customer to *closely* inspect the fill tube as any water intrusion into the transmission fluid will cause the torque converter to shudder on apply and cause a very short service life.

This transmission has not been plagued with anti freeze or glycol intrusion. It is strictly rain water or A/C system run off causing this concern globally. The 6L80/90 transmission will come into repair shops for transmission service. Upon pan removal, filter inspection will reveal filter body damage. Either the seams appear to have “popped” open or the neck of the filter is cracked. This is due to transmission pump failure causing a high pressure fluid spike going down the filter neck resulting in filter body failure. If a repair shop is not aware of this, the vehicle will return shortly for major transmission service involving the pump and torque converter. This applies to Escalade, Avalanche, Camaro, Caprice, Savana, Sierra and Yukon models 2010-2014. This has also been seen in early release models going back to 2006.
