Torque Converter Rebuilders Association

2014 Seminar

***What Else Can It Be
But The Converter***

Mike Souza

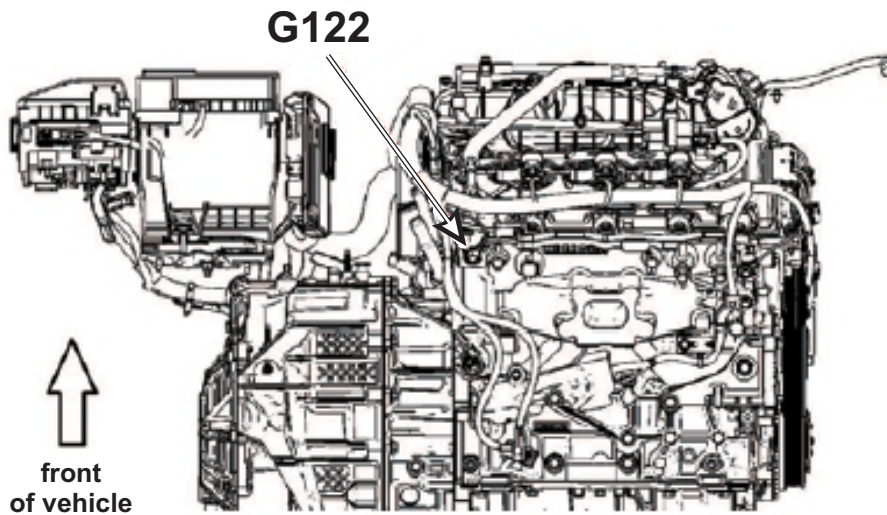
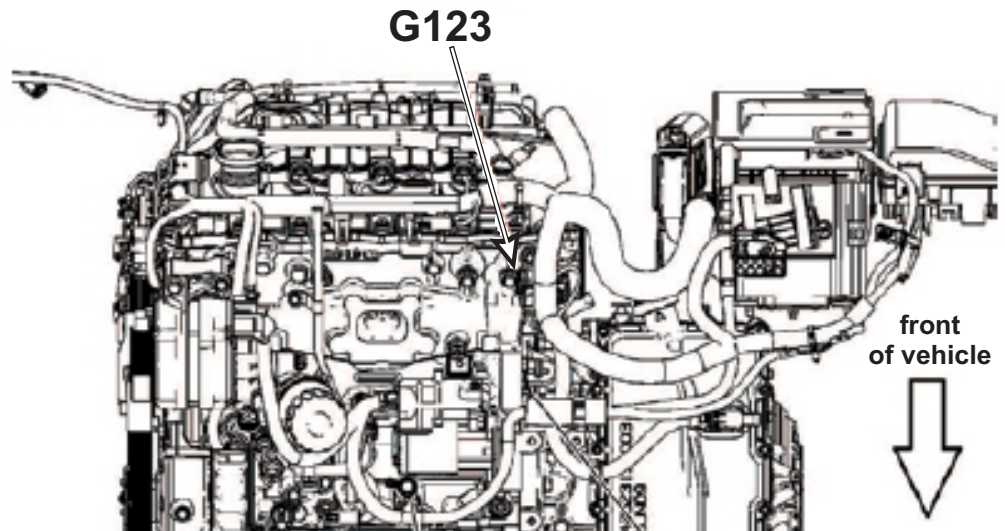
Inspect the ignition coil grounds for a poor connection. The G122 location supplies the ground for ignition coils 1,3,5 while G123 location supplies the ground for ignition coils 2, 4, 6. The G122 is located on the left rear corner of the inboard head. G123 is located on the right front corner of the outboard head near the high pressure fuel pump.

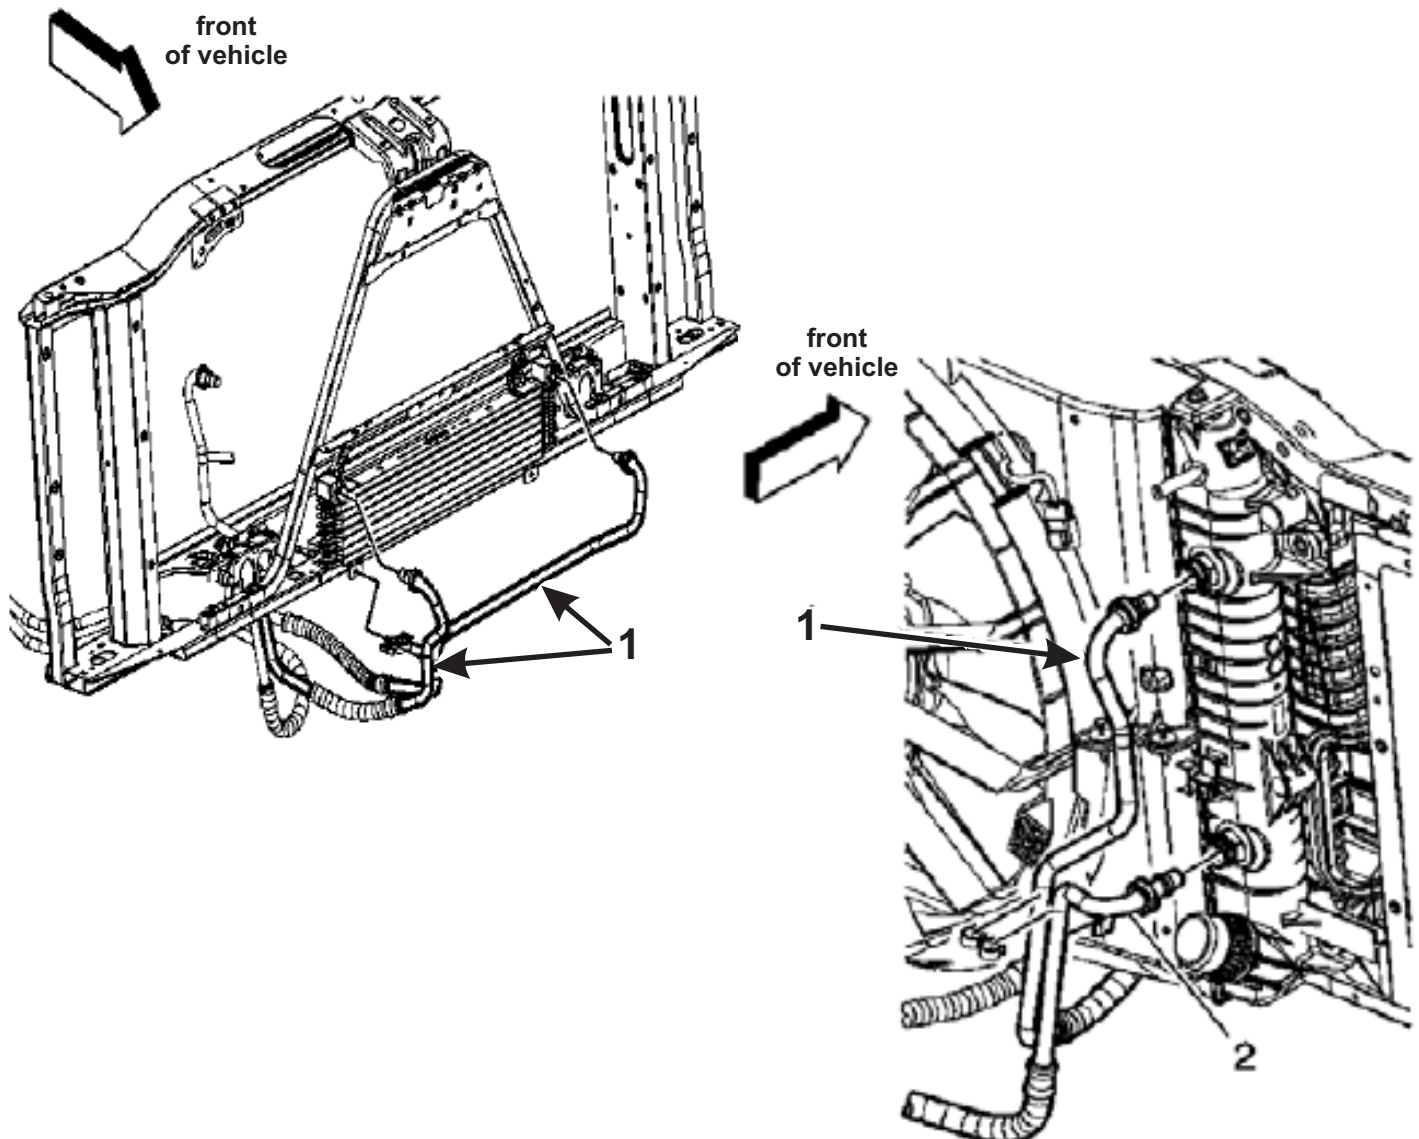
This unit came in to the shop with a spun pump bushing. The coolers were flushed during the repair. But when the vehicle was driven and reached normal operating temperature the cooler line would rattle. As a test, we bypassed the coolers one at a time to isolate the specific cooler. The noise was still there when each one was bypassed.

Anytime you have a major repair on a transmission that requires the transmission to be removed, always flush the cooler in the radiator and **“replace”** the auxiliary cooler. Auxiliary coolers are very difficult to flush even with the best flushing machine. Installing a new radiator fixed the vehicle. In this particular case both needed to be replaced.

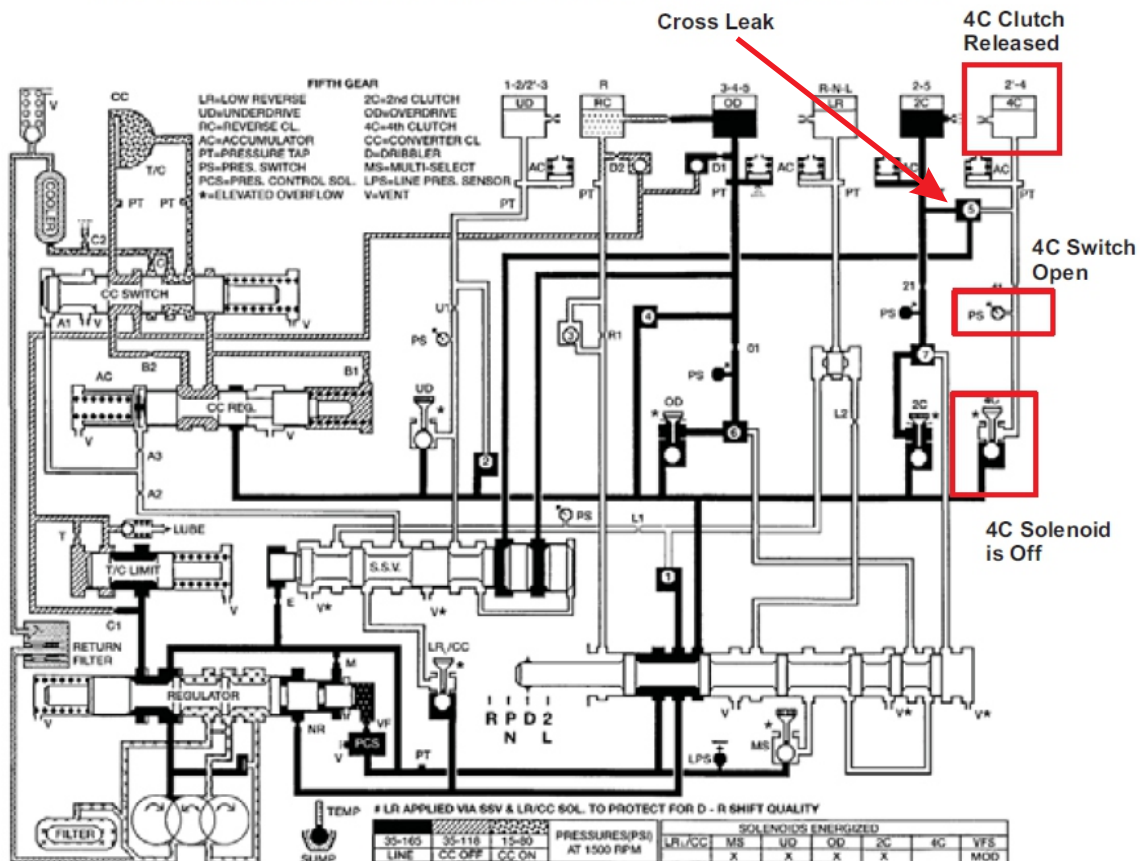
A bind up between 55-57 mph can be caused by the pressure switches or the switch valve. This can sometimes be intermittent. While driving, the transmission may bind up momentarily for a split second, then work normally.

Looking at the hydraulics the only two locations of failure are the #5 check ball or the 4C solenoid sticking.

The 4C Solenoid would have to be stuck open momentarily

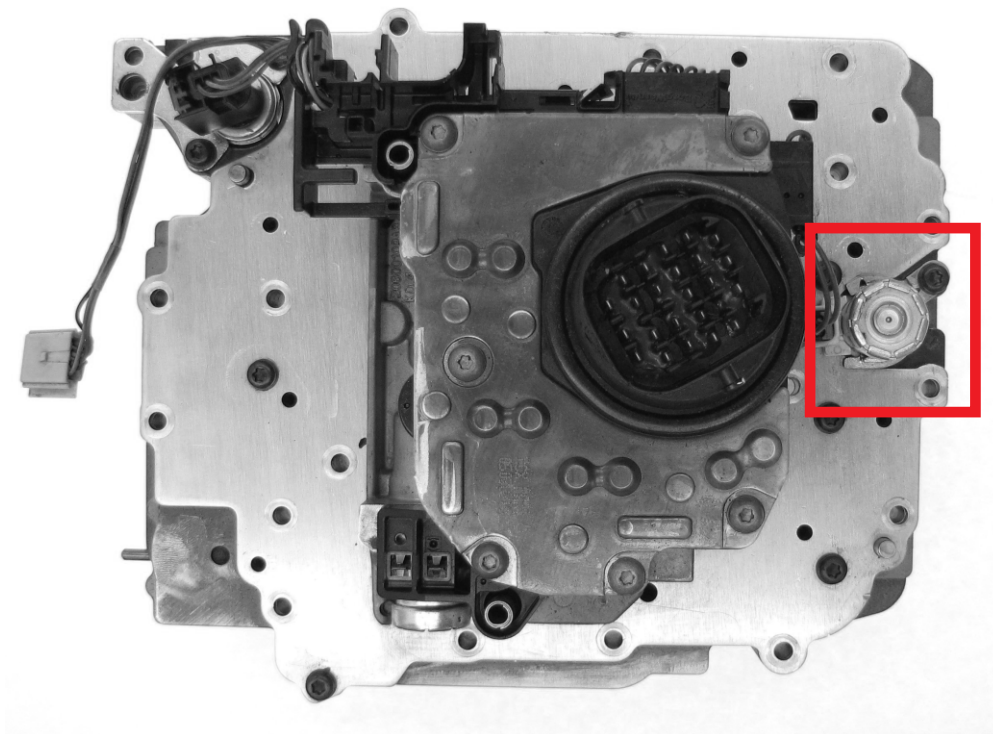
This vehicle was towed in and the customer stated that he was on a long trip and when he got off highway and stopped at gas station, his engine died. After getting gas he started the vehicle and every time he put it in Drive the engine died but not in Reverse.

The EMCC VFS Solenoid is used to control the duty cycle of the Torque Converter Clutch (TCC). The PCM monitors the voltage on the EMCC VFS Solenoid Control circuit. If the PCM detects a failure for 2 consecutive trips, a P2764 DTC is set.

Replace the TCC
solenoid
part#5169313AA.

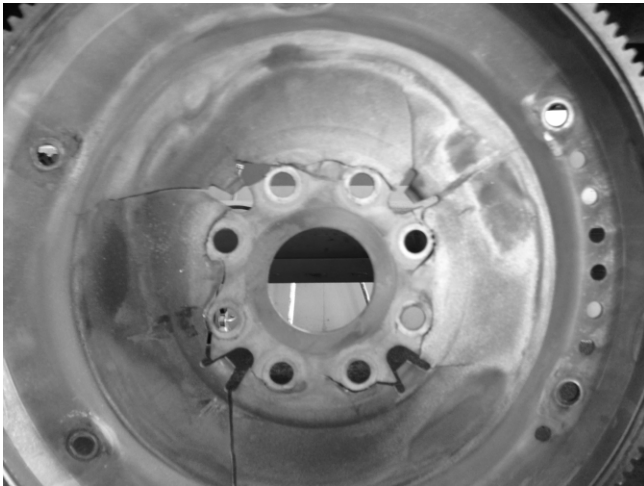
Flywheel

The vehicle returns to your shop with a scraping noise coming from the bell housing. Upon inspection metal particles found in this area. With the unit removed you find the converter bolts have come loose and has caused damage to the flywheel, starter drive, converter pilot and intermediate adapter plate.

This vehicle had a billet converter installed along with a billet flywheel. The billet converter has much deeper threaded holes than a stock converter. It is recommended that a longer thread be used on this application. The billet flywheel is approximately .080" thicker than stock and would require a longer bolt thread.

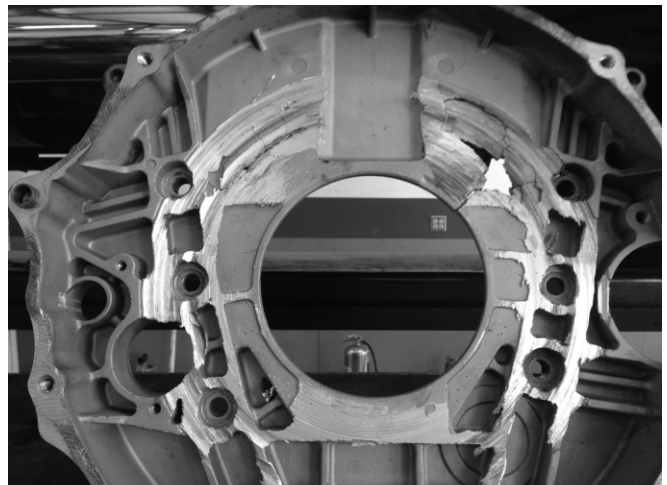
**Intermediate Adapter Housing
(comes w/o an oring, if installed
without it will cause engine oil leak)**

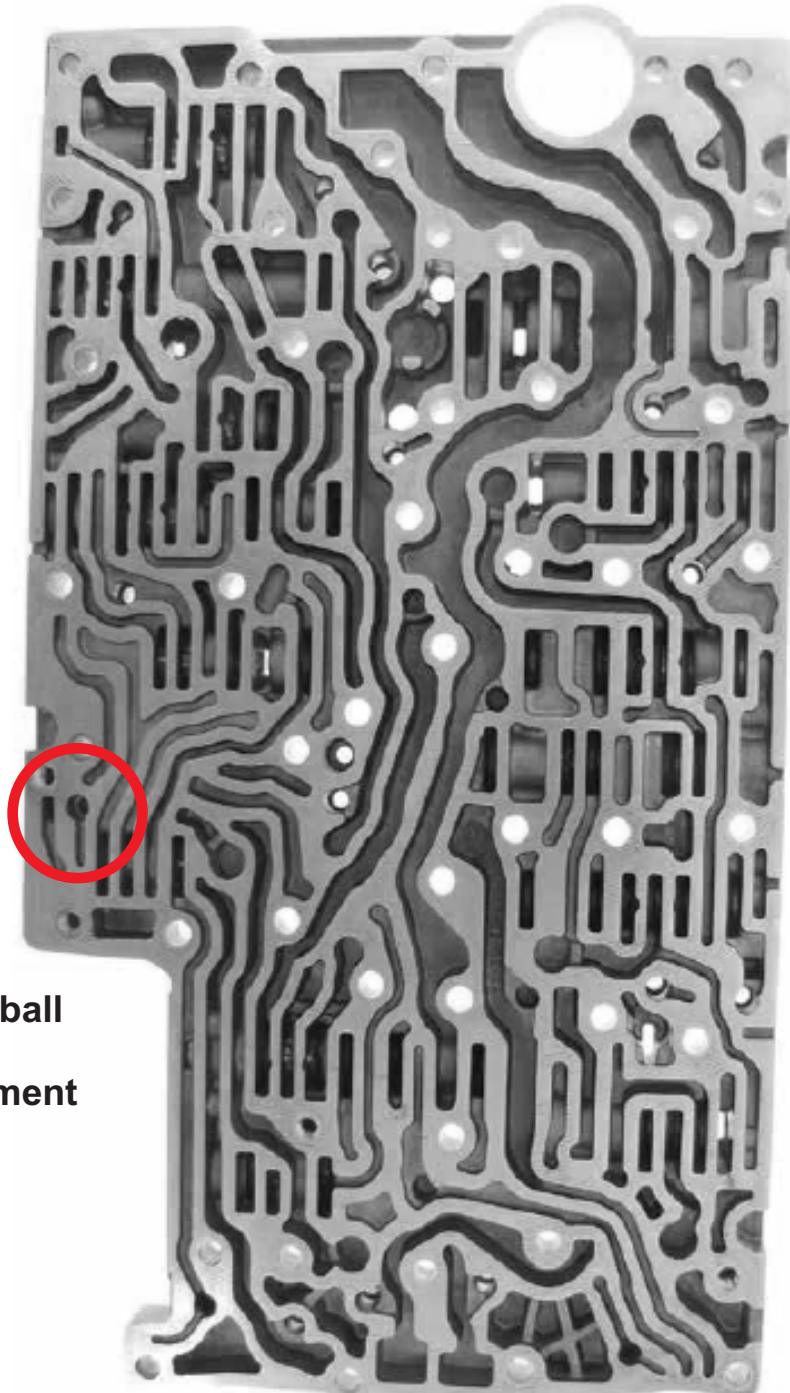
After rebuild you have a no move condition. One possible problem is a missing check ball.

**Missing check ball
here will
cause no movement**

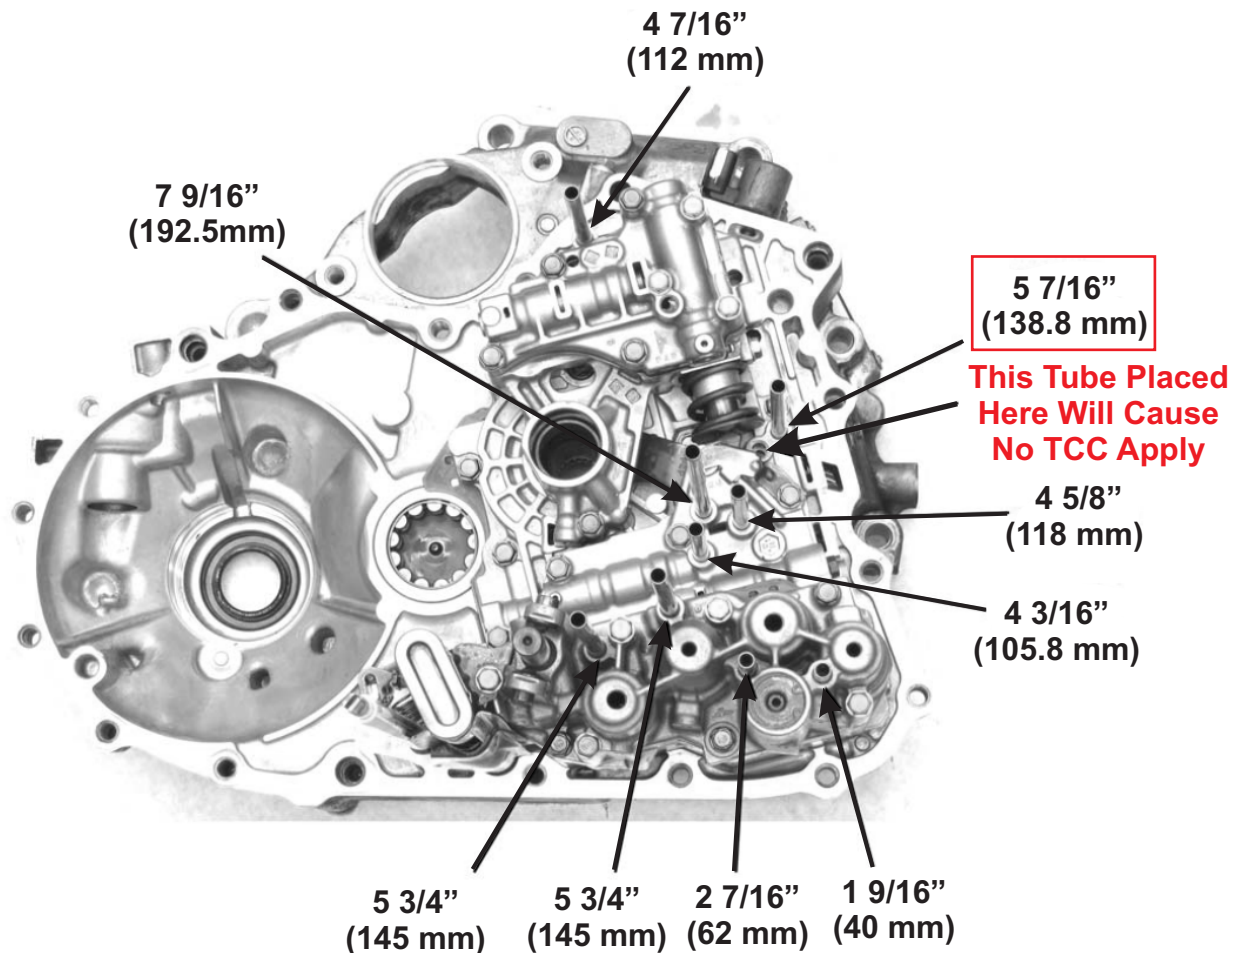
The tube shown in the illustration below was misplaced.

This can also cause a 2-3 shift flare complaint.

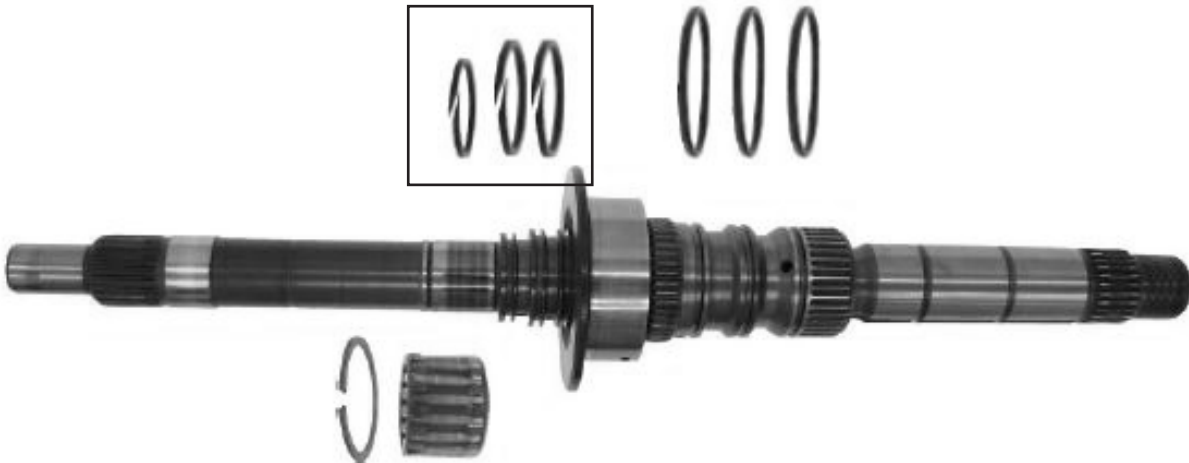
This complaint can be caused by a damaged or missing sealing ring on the input shaft.

**check for damaged
or missing sealing
ring and bore wear.**

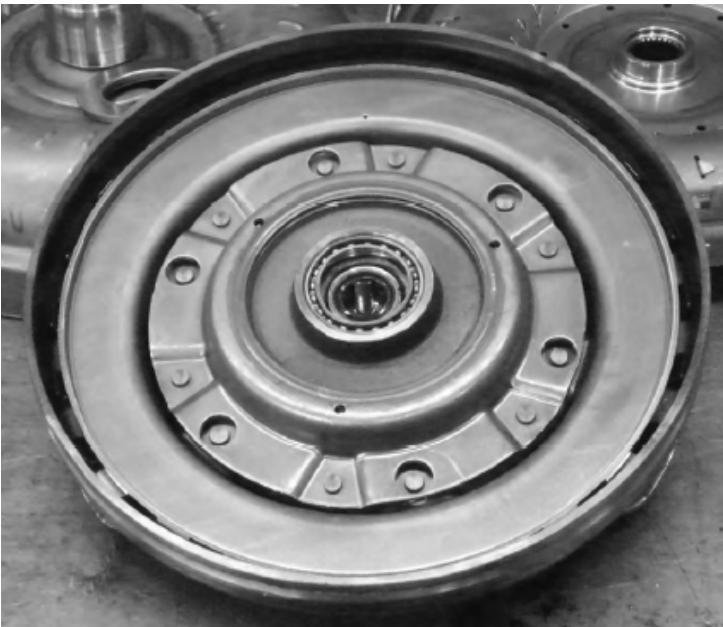
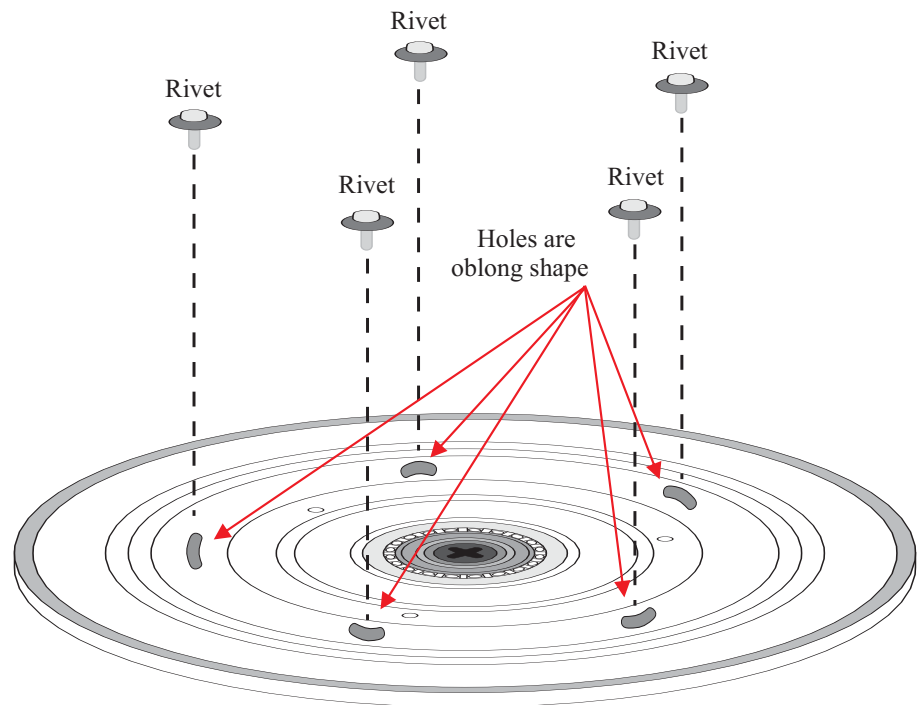
With this transmission, the problem was the rivets in the torque converter drive plate had come loose and the rivet holes worn. This allowed the drive plate to vibrate back and forth until the transmission actually engaged and put a load on the rivets, stopping the rattle.
