Welcome To The 2016

Seminar

Those %#@&! Torque Converters

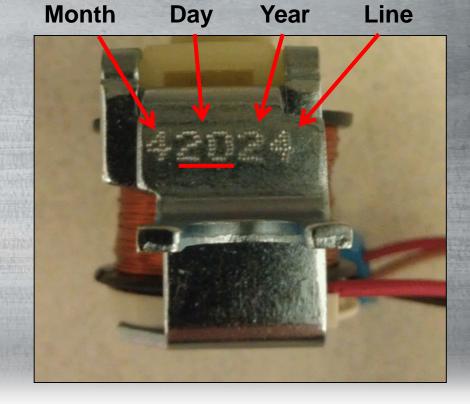
Check the TCC enable solenoid's five digit date code found on the solenoid body to see if it requires replacement.

- 1st digit (month of build) should be a 4 or higher or an alpha character.
- 2nd and 3rd digits are the day of the month.
- 4th digit should be a 2 or 3 (calendar year 2012, 2013).
- 5th digit (line of build) should be a numeric character typically a 3 or 4

Example: 42024 shown in the picture was produced April 20, 2012 on line 4. Any solenoid produced on or after April 17, 2012, date code of 4172# or greater, does not need to be replaced.

Some models manufactured between 10/01/2011 and 11/13 2012 may require the internal transmission wiring harness and TCC enable solenoid to be replaced anytime the transmission is in for a repair with DTC's P0741 TCC Stuck Off present.

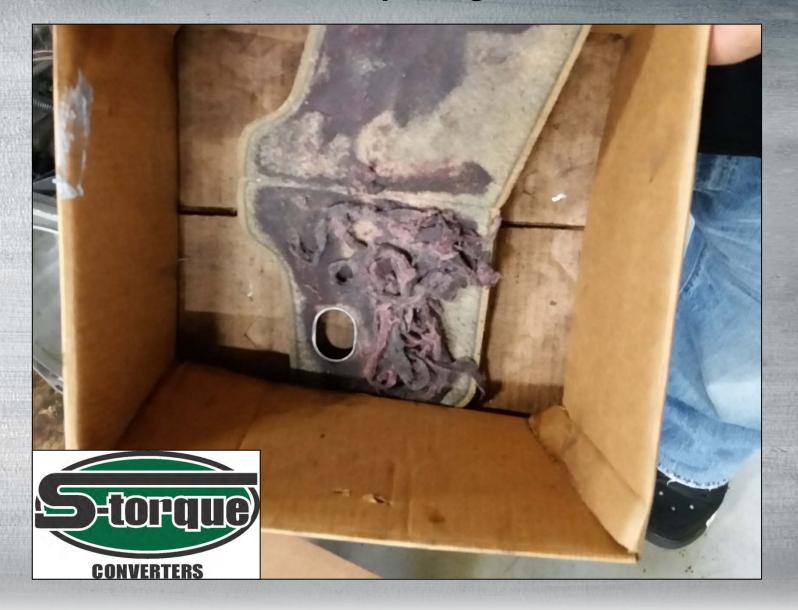
GM 4L60E the converter tore up a rag and restricted the filter.

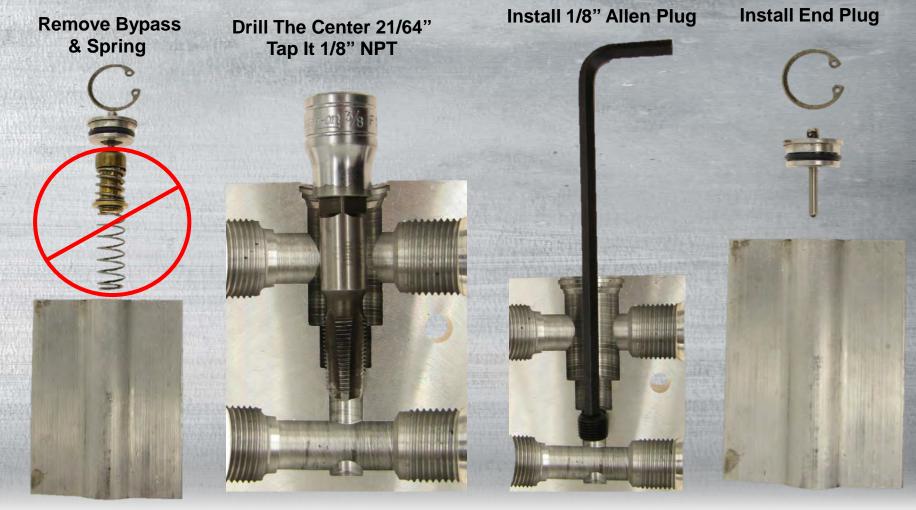
Transmission over temp can be caused by a malfunctioning cooler bypass.

An easy fix for this is to remove the cooler bypass from the vehicle and do the modifications listed below

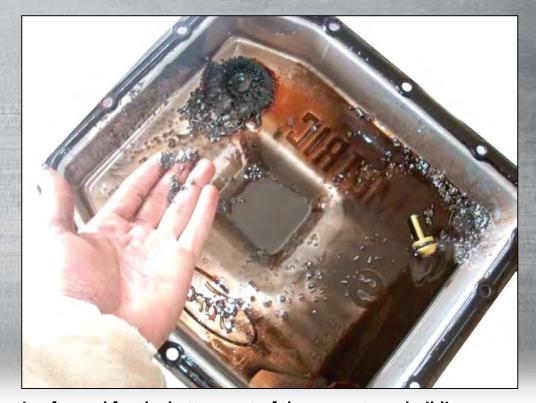
There is a Ford TSB- 14-01-53 (which supersedes TSB 13-4-23) that states some Ford 2008-2010 models have a service kit available for repairing premature gear train failure caused by the forward sun gear needle bearing coming apart damaging the planet assembly.

There may be torque converter related codes P0741, P1741, P1742 and/or P1743 present. Inspect the transmission fluid pan and magnet for large metallic debris.

Carefully inspect the bearing down inside the planet. If there is any roughness felt the bearing and or the planet must be replaced.

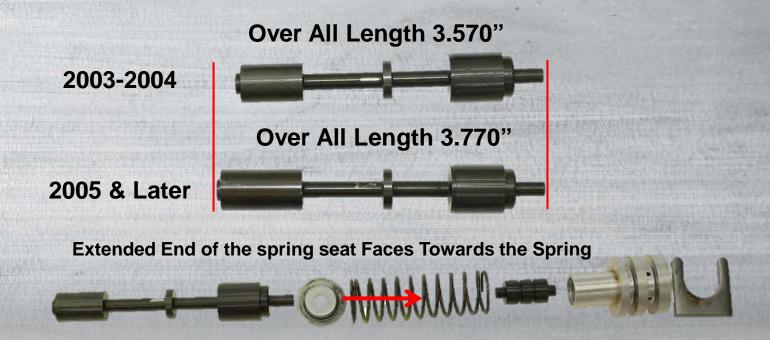
This could be caused by the wrong TCC control valve being installed into pump stator.

There are two different lengths for the TCC control valve, the early 2003-04 and the
2005 and later.

With the early 2003-04 valve (shorter) installed into a 2005 and later pump stator, there will be no spring tension on TCC control valve spring. There will be approximately 1/4" of travel on the valve.

The overall difference in length between the two valves is 0.200" almost a 1/4".

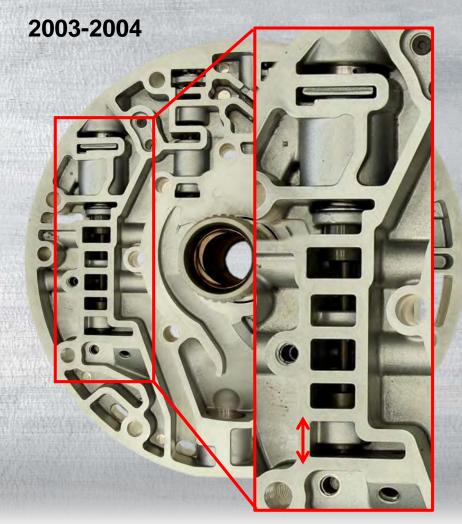
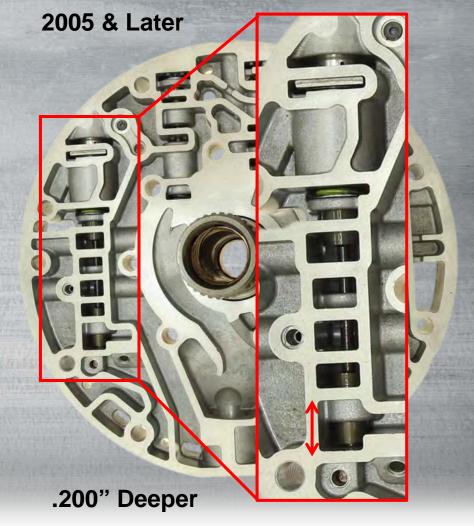
If the valves are different then there must be something different in the stator support also.

The TCC control valve bore is .200" deeper on the 2005 and later stator support.

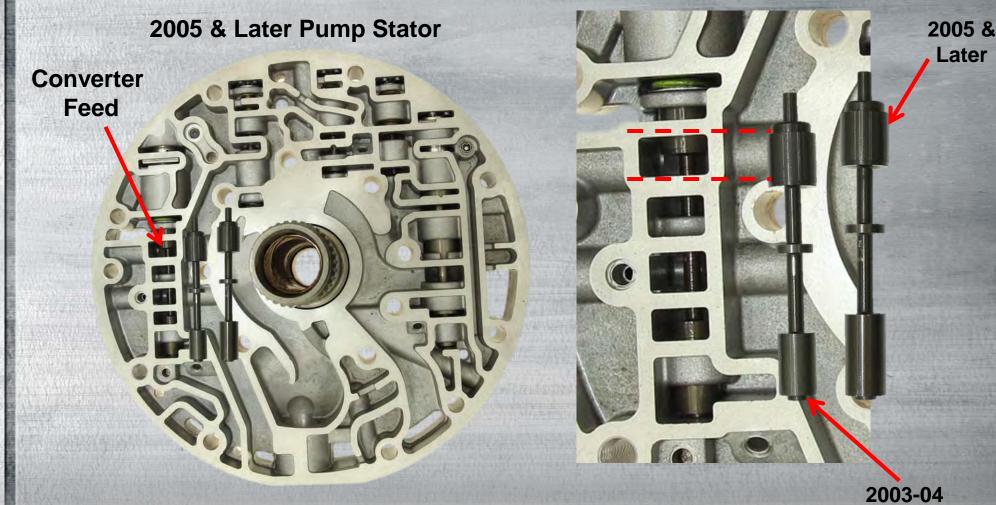
This will allow the shorter valve to intermittently move into a position that will block converter feed oil.

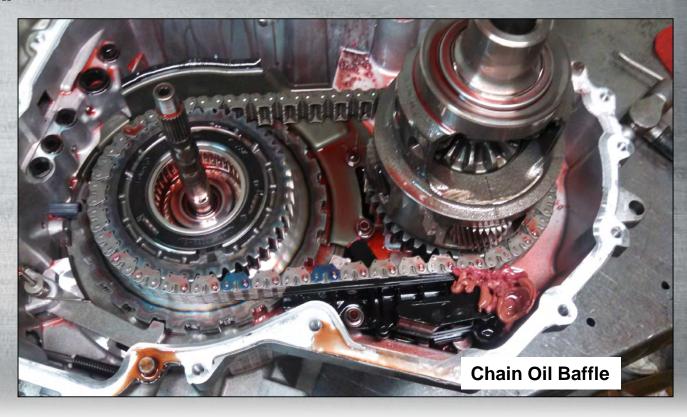
DTC P0218 Transmission Fluid Temperature Over-Temperature Condition is a common concern.

This happens very often within a day or two after the transmission has been serviced at a quick lube facility.

When the fluid level is checked you may see the transmission fluid level may only be a 1/4" above the full mark.

This can be as much as 3 quarts overfilled internally.

The chain oil baffle may become liquefied.

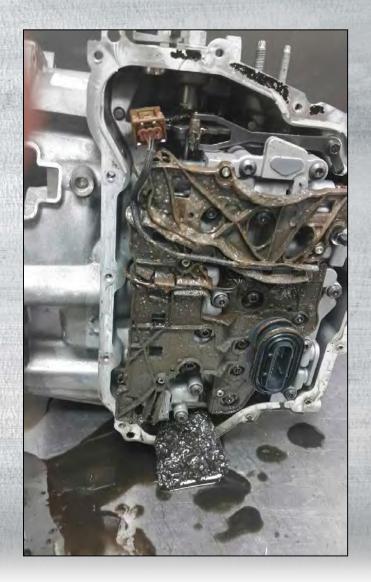
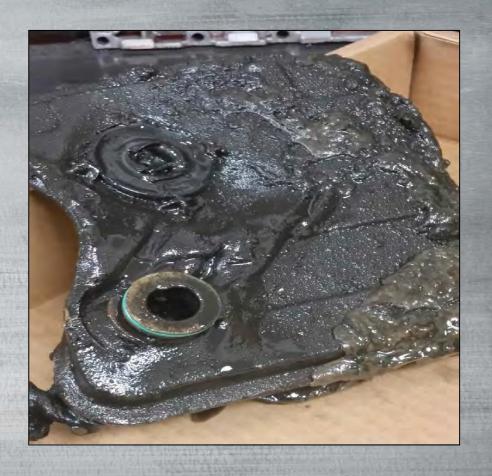
The solenoid block and filter can become distorted.

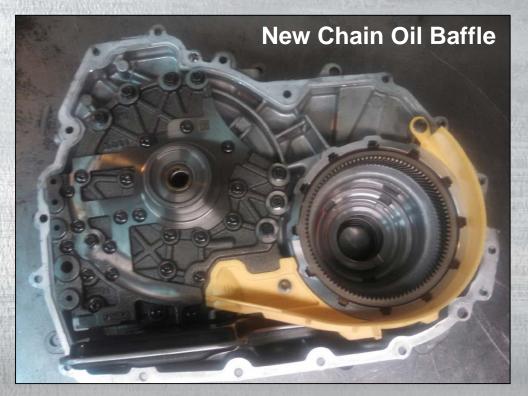
This will cause the transmission fluid to aerate and become extremely hot.

So hot melted plastic will be found in the valve body molded around the valve springs and inside thrust bearings.

There is an updated dipstick and filler tube Part Number AL8Z-7A020-A for the 2009 Escape/Mariner built on or before 10/29/2008.

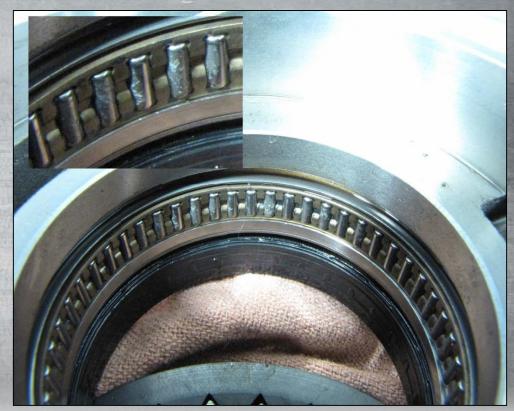
Ford now uses a bearing like some of the Mercedes transmissions. This bearing is also failing with low miles.

Inspect the bearing for pitting and wear marks. At this point in time the bearing is only sold as part of the complete pump.

Note: As a precaution always add a ground strap from the bellhousing to the frame or battery ground.

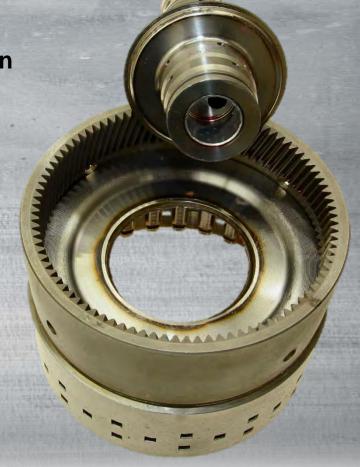
A no movement before or after overhaul may be caused by the forward/overdrive clutch drum assembly being damaged.

You may not detect the crack between the shaft and the drum until the drum is disassembled.

The drum may be marginal during overhaul and then break after installation.

The break is extremely smooth and can easily be overlooked.

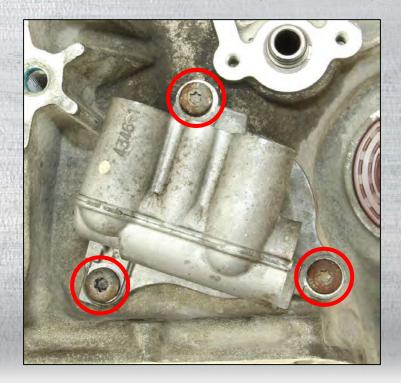
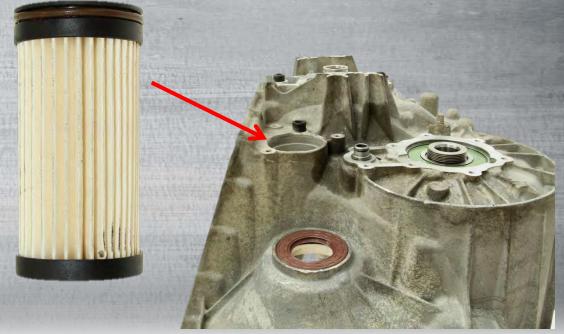
TCM detected TFT sensor out of range 55°-175°C (67°-347°F). This may be followed by a no move condition with codes P0868 Transmission Fluid Pressure Low P0701 Transcontrol.

Check for a blocked or missing high pressure filter (when a used transmission has been installed). The filter is located behind the wheel well on the driver's side under the cover/cooler line adapter.

Note: Pressure codes may be set by bad aftermarket filters.

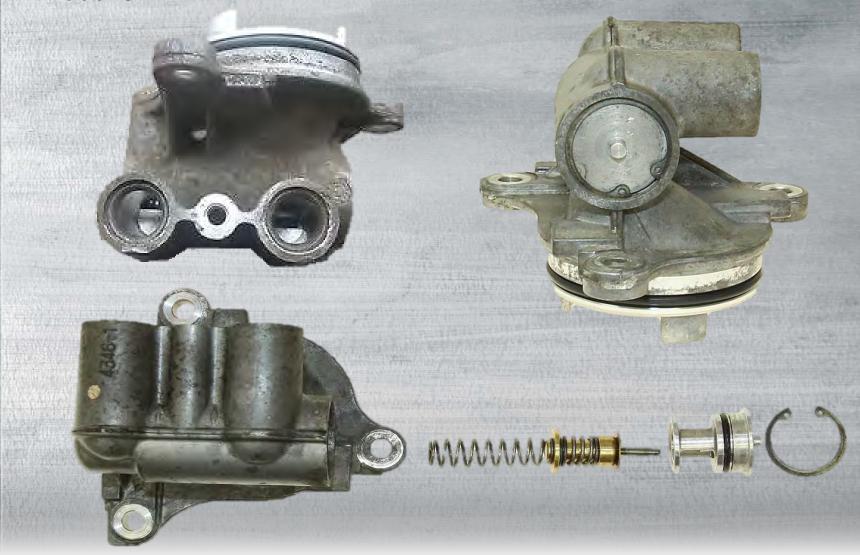
Always check to make sure the thermal element is working properly and not sticking with debris.

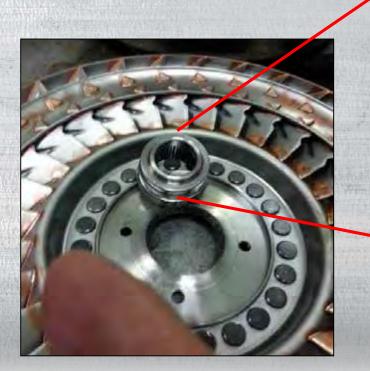
Breaking Off

The tip of the input shaft has no sealing ring or O-ring to seal the converter clutch apply circuit. The seal should be inside the converter.

There are no bushings or seals for the converter clutch apply circuit. The smooth area just past the spline in the converter is where the tip of the input shaft contacts to seal the converter clutch circuit.

If there is any wear in this area it could cause a TCC slip code. The problem is not so much that the smooth area is wearing out, instead they're breaking off causing a no move condition.
