TCRA 2008

A.W. 55 50 SN/GM AF23/33

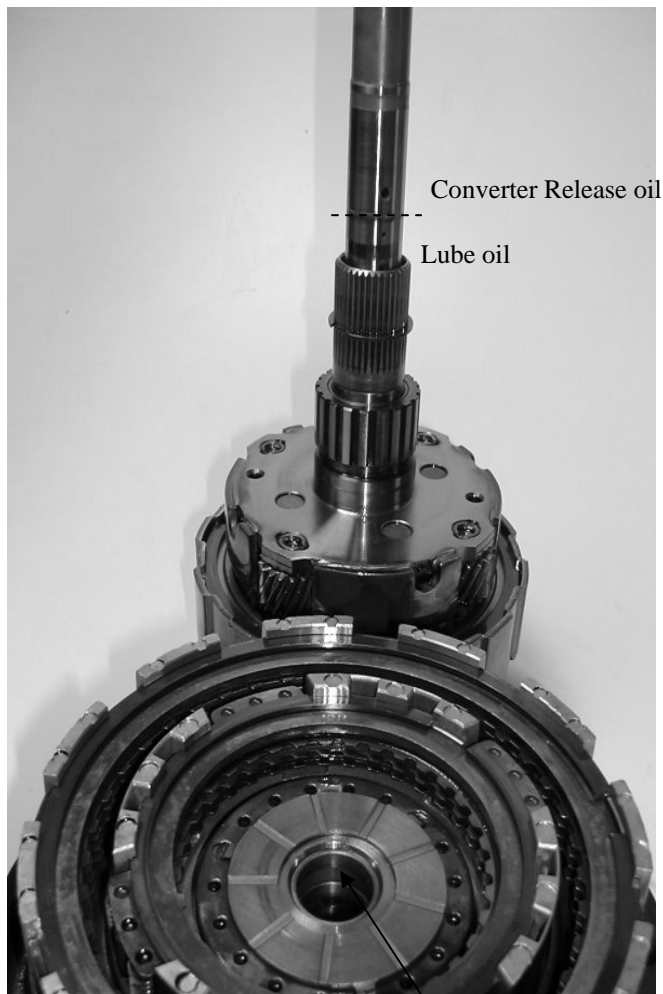
Critical pump stator

- Excess heat build up due to loss of valve body control.
- Improper adjustment of SLU solenoid.
- Worn valve body (see illustrations)
- Metal contamination on turbine speed sensor
- Incorrect fluid type or level. This unit will work better with synthetic fluid.
- Rear pump bushing wear (illus. #1)

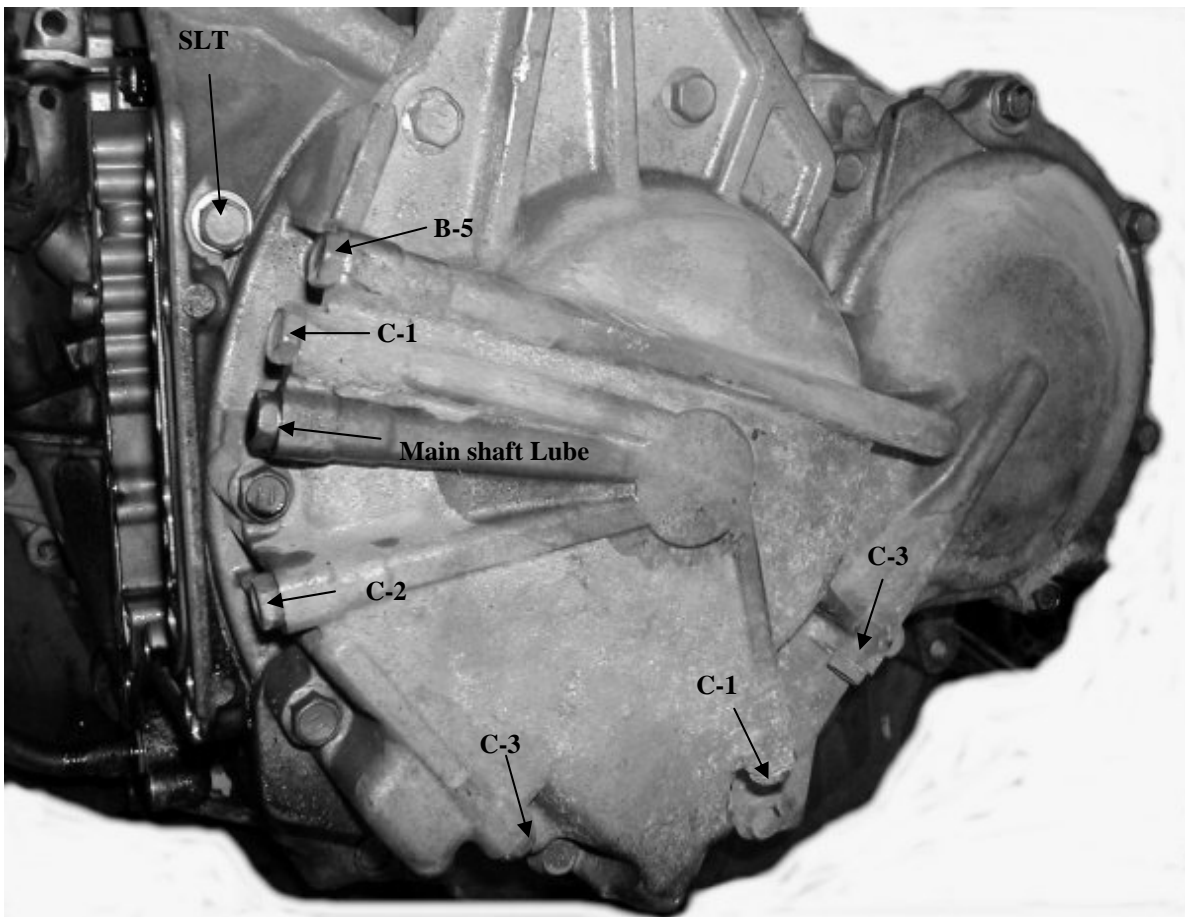
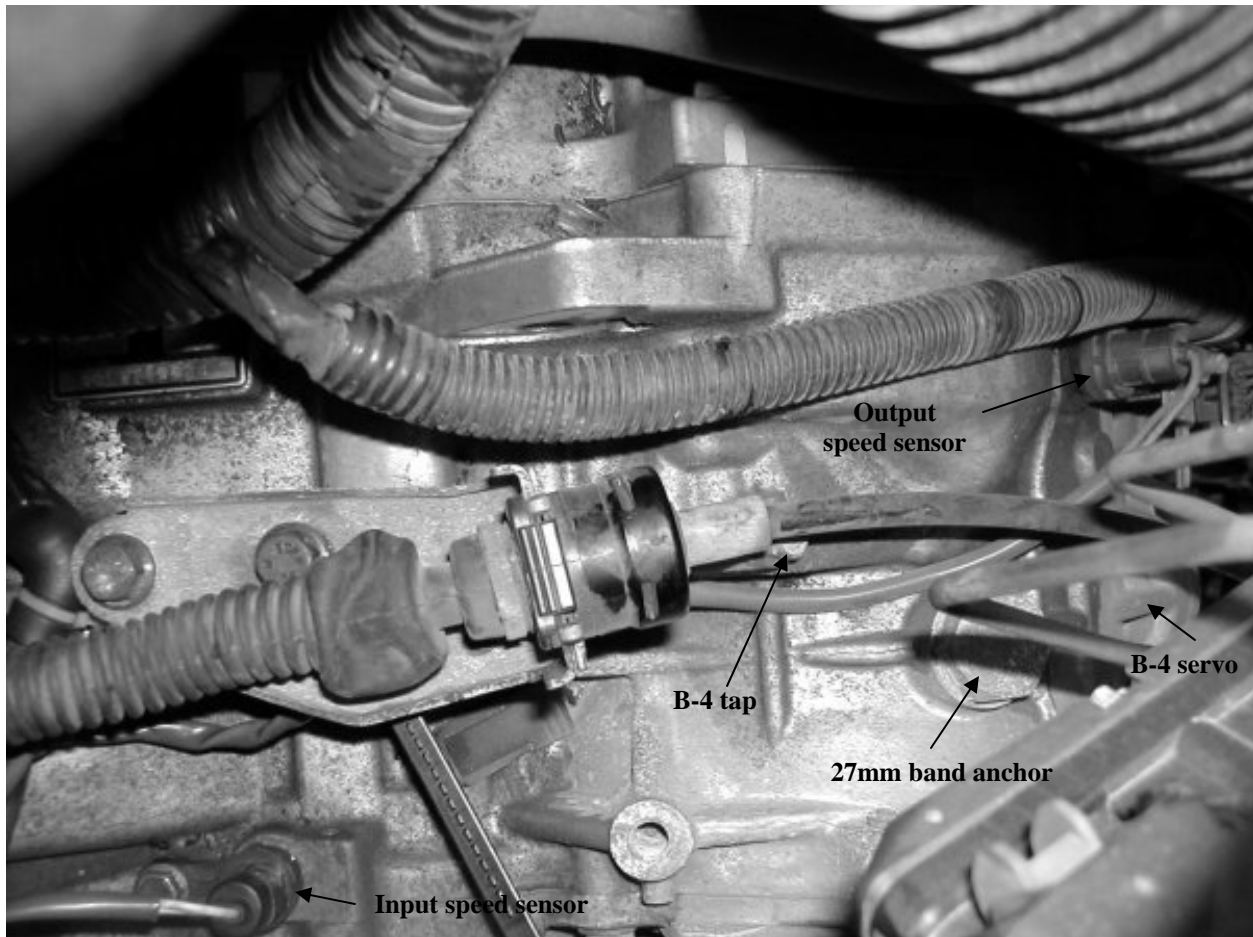
All the pressure plugs have a 12mm head. Do not mistake the 27mm band anchor (see Figures 1 and 2) for a fill plug or pressure tap. If that anchor is removed, the band will have to be recaptured. Positioning the band requires removal of the servo, at best and possibly the complete transmission.

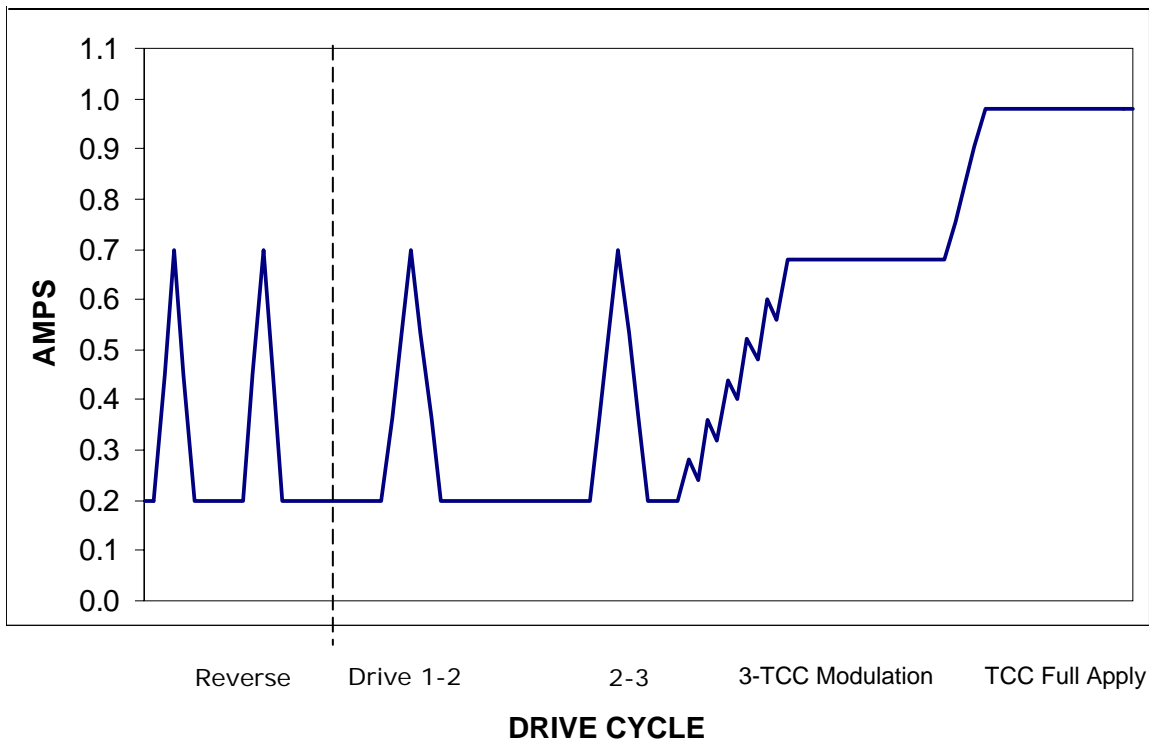
SLU Solenoid

SLU- Has been know to create 1-2 slip, 2-1 harsh downshift if not adjusted or defective. It also can over heat fluid and affect TCC apply.

- If your TCC control, 1-2 and 2-1 are good, cooler flow drops properly as noted above, leave the adjustment as is. If not, adjust accordingly.
- Slight bump on 2-1 down-shift... and/or TCC rpm fluctuates at 30-40 MPH during modulated apply....and/or excess TCC slip at full lockup...and/or Sonnaflow sensor indicates TCC control valve is continually toggling on-off. If so... turn adjuster screw in/clockwise 1.0 turn.

- Harsh 2-1 downshift....and/or heavy TCC RPM fluctuation at 30-40 mph...and/or late and firm full TCC apply. If so...turn adjuster in/clockwise 1.5 to 2.0 turns.

- TCC will apply not modulate slip RPM at 30-40 mph. Beyond 40 mph, TCC apply is short and harsh.... and/or a harsh TCC release on coast and/or 1-2 shift is too harsh. The adjuster is too far inward, back it out/ counter clockwise as required 1.5 to 2.5 turns.

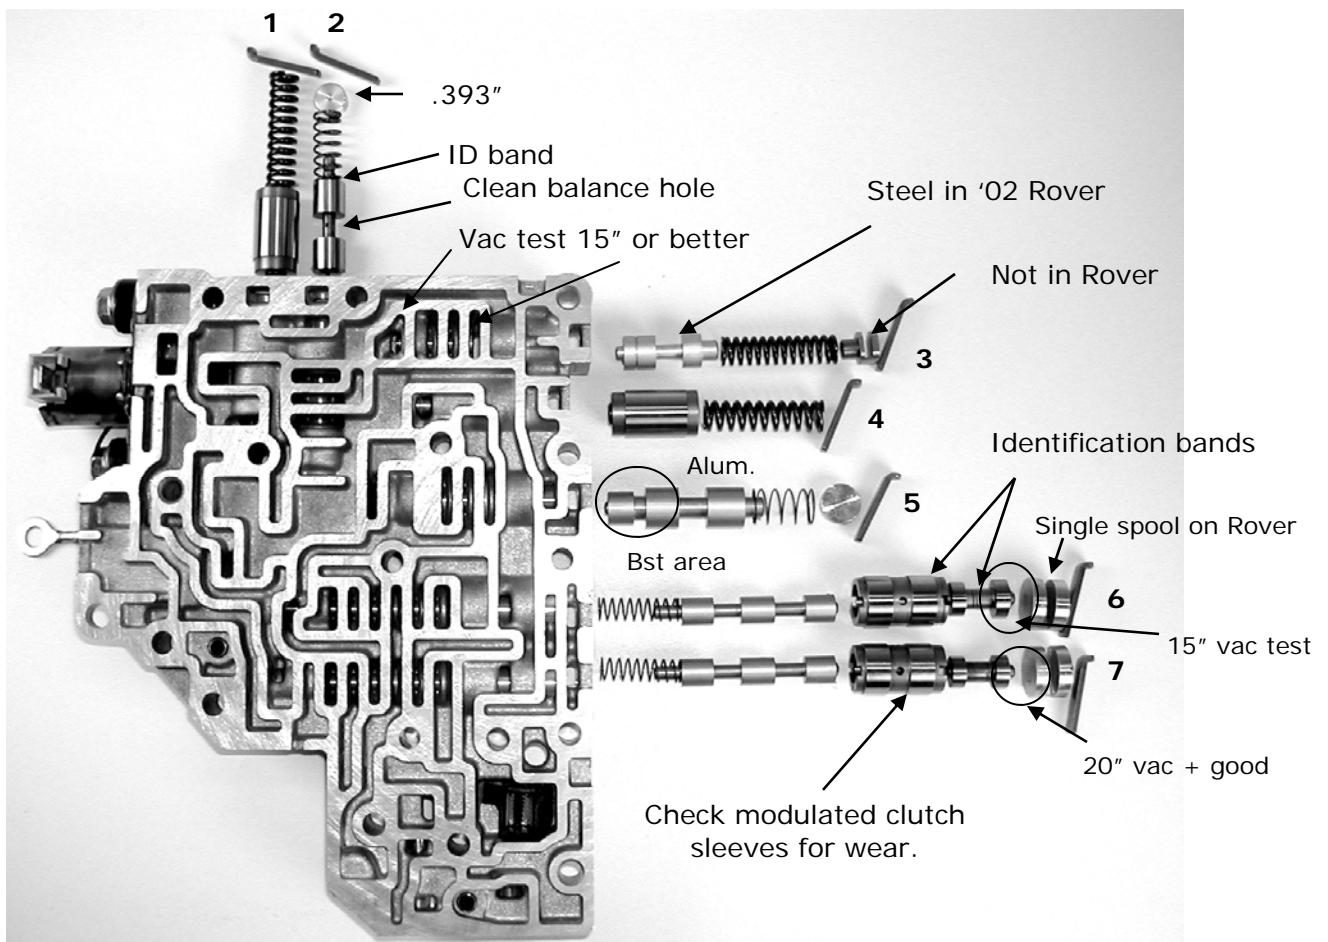
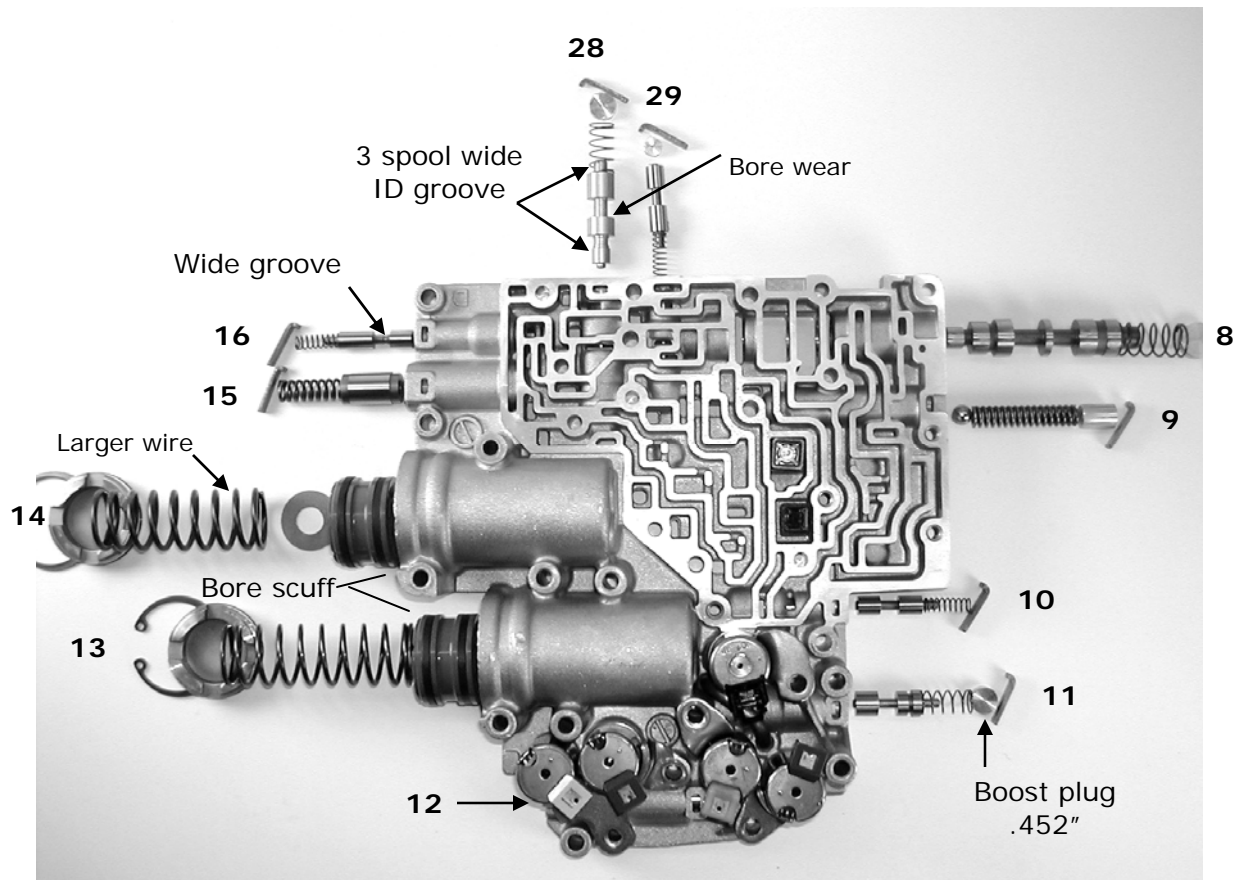
- Cooler restriction
- Valve body wear

- By-pass and/or replace cooler
- Inspect valve body as indicated

- Also check case bore & accumulator.
- Suggest .017 wire expanders under accumulator (tag wire) seals (outer/spring side)

Suggestion: 2 rounds, not overlapping but parallel each other.

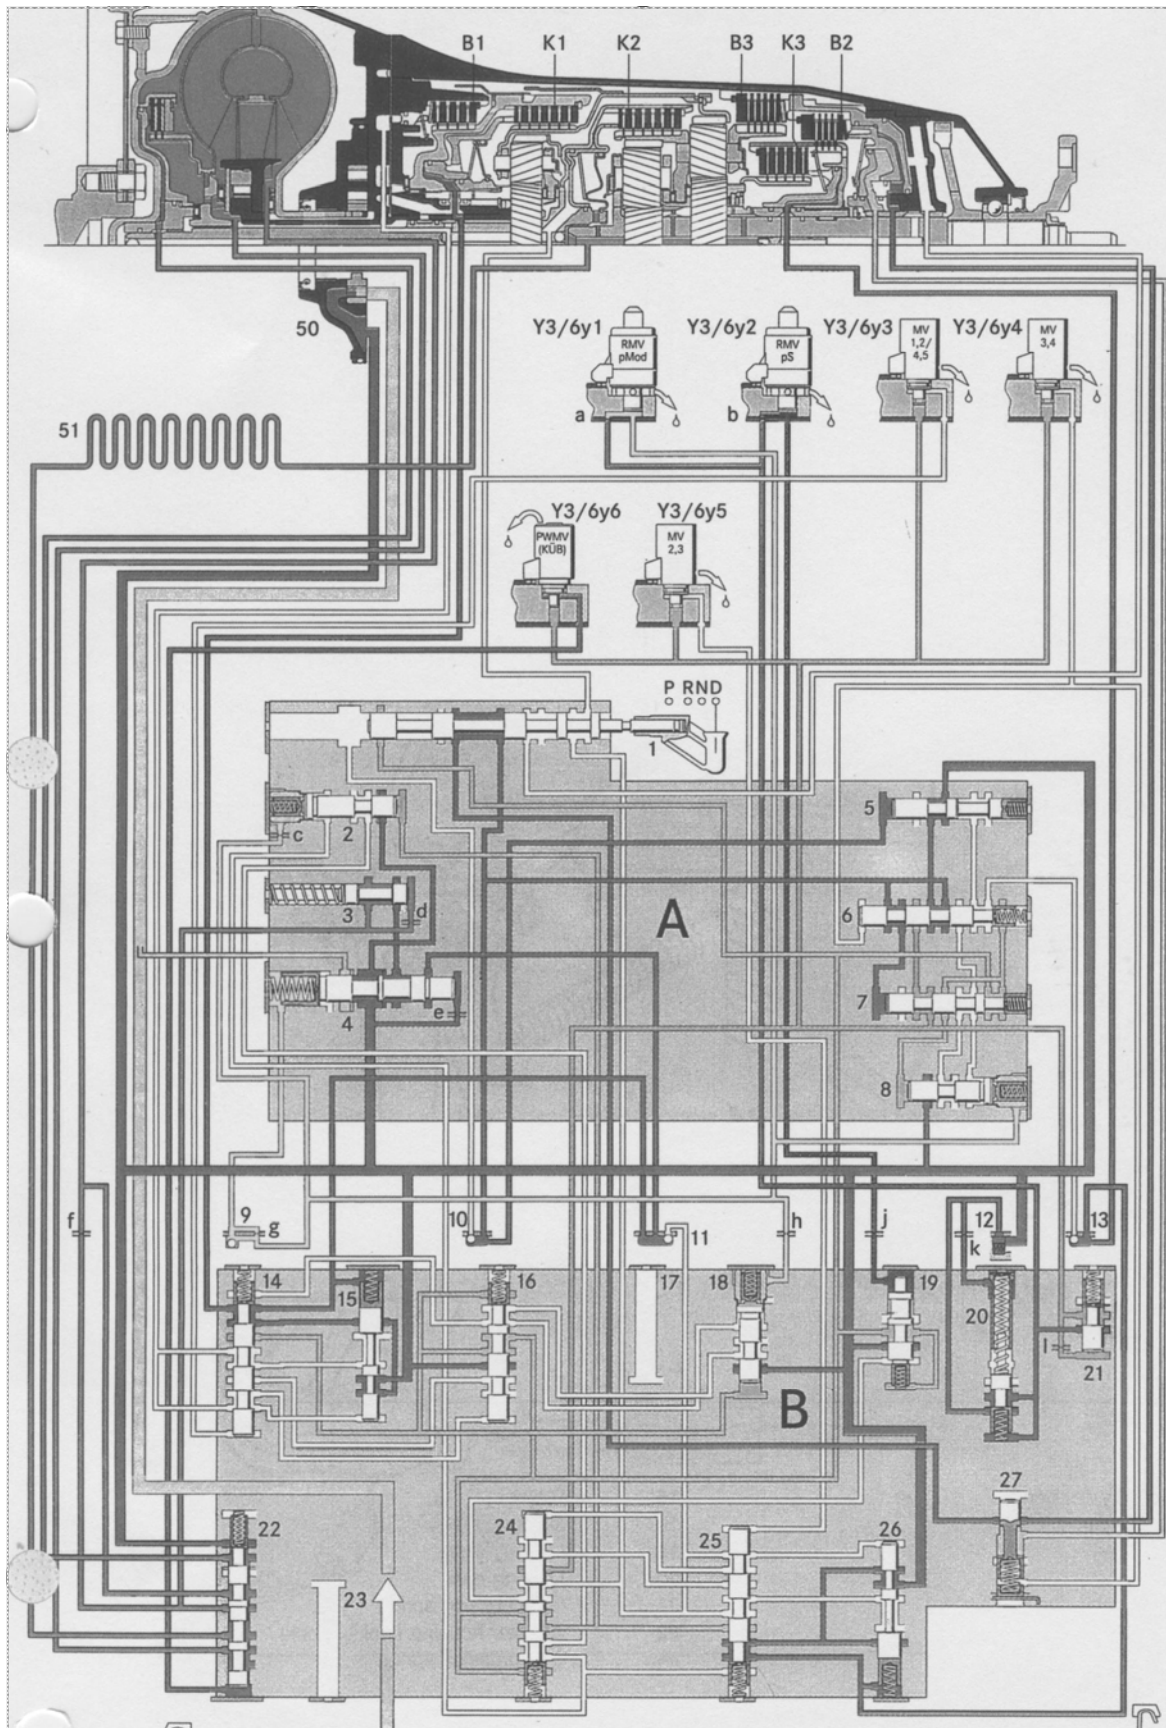
- Friction material of converter clutch is not compatible to fluid. May have coolant mixed into ATF.
- Converter control valve bore worn
- Main working pressure regulator valve bore wear

- Test fluid: Mercedes had a test kit or us a "Perk Test"
- Replace friction material
- Inspect converter cover bushing & seal
- Inspect valve body at bore numbers 3,4 & 22

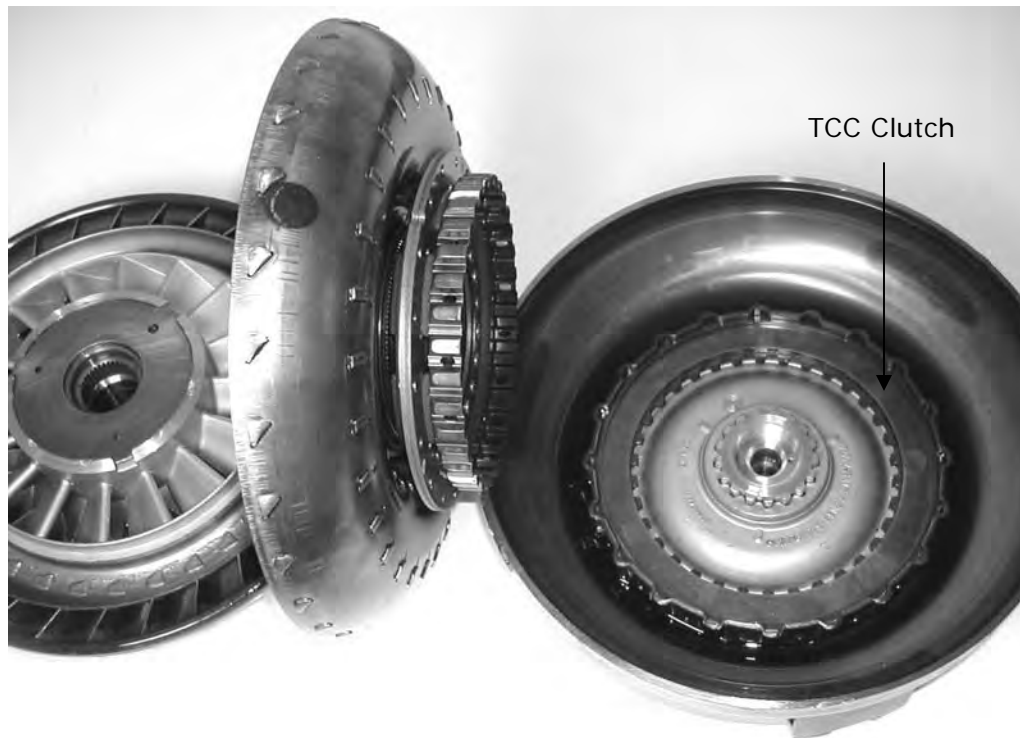
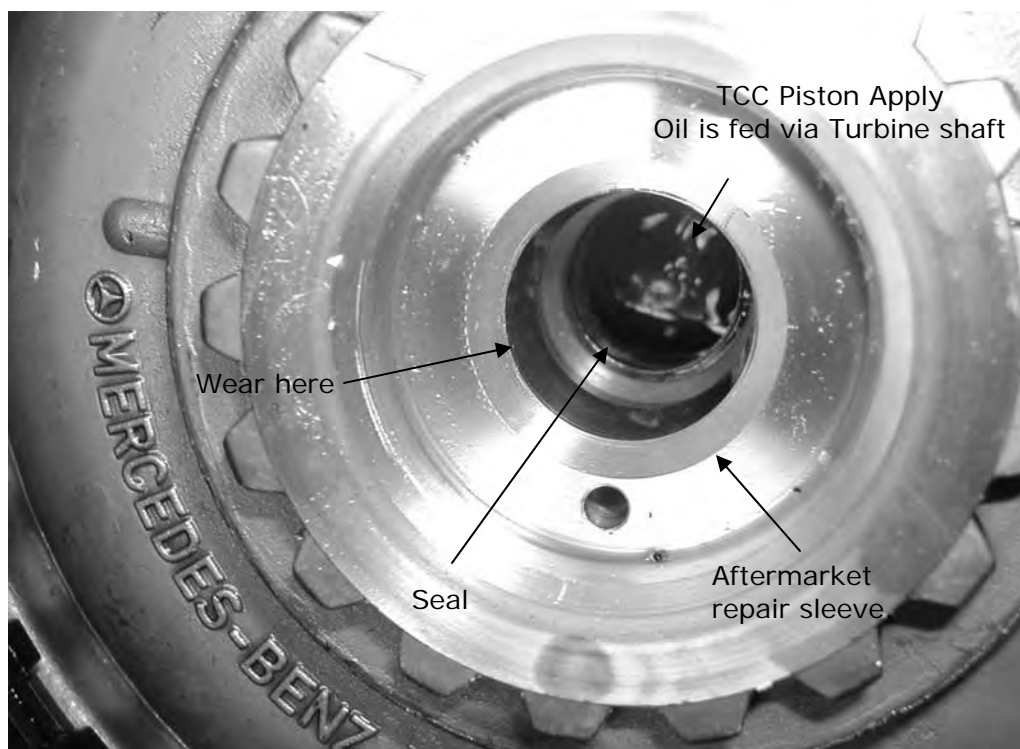
722.6 Converter Design

722.6 Turbine shaft seal & pilot wear causes engine stall. TCC shudder.

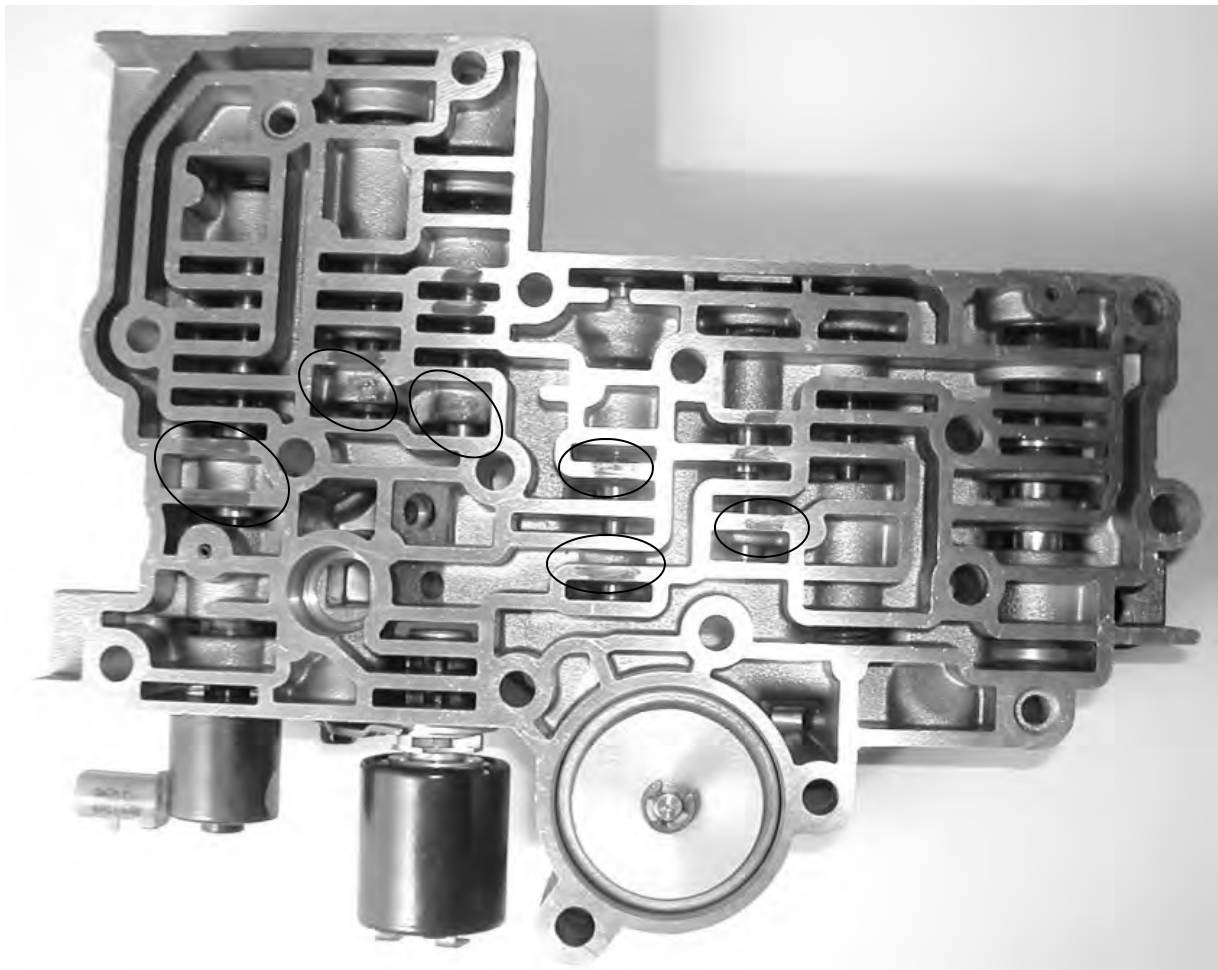
- Wear at the TCC control valves (ills.#1)

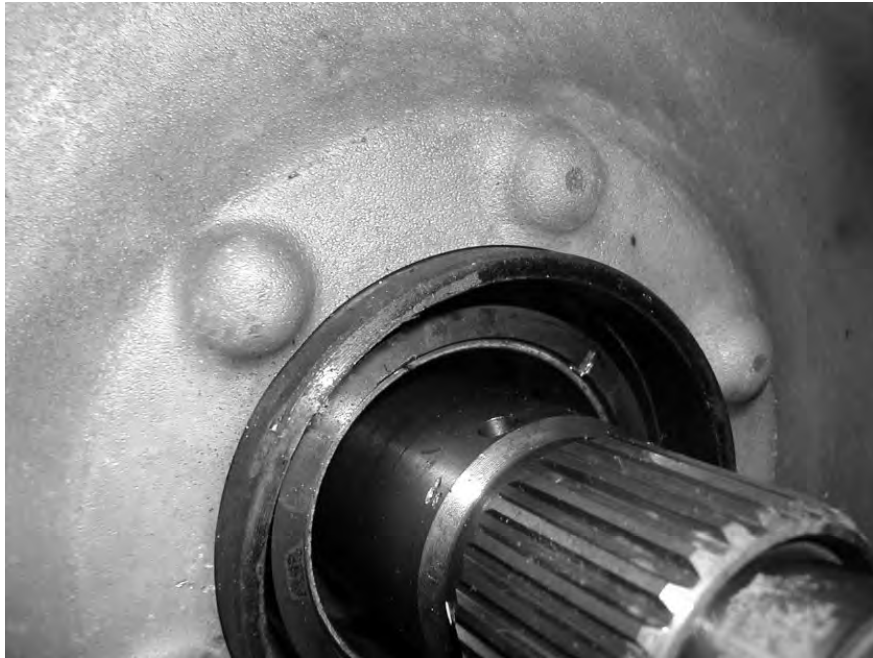
- Stator support bushing to converter Impeller hub wear. (Ills. #2)

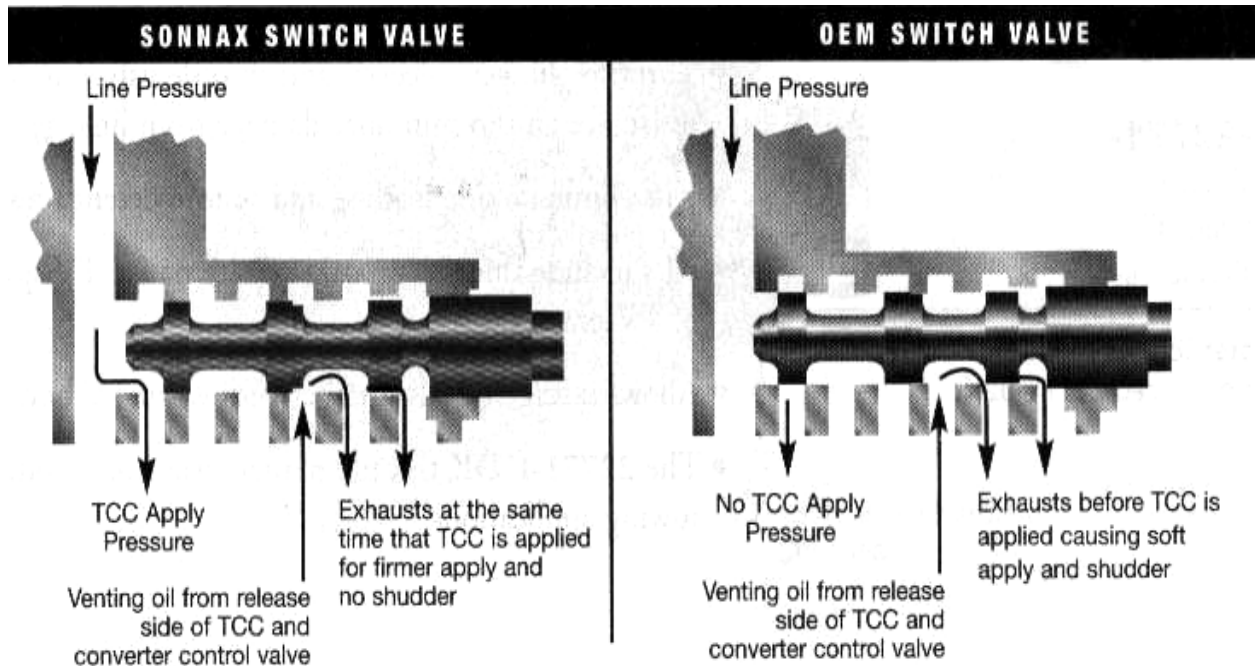
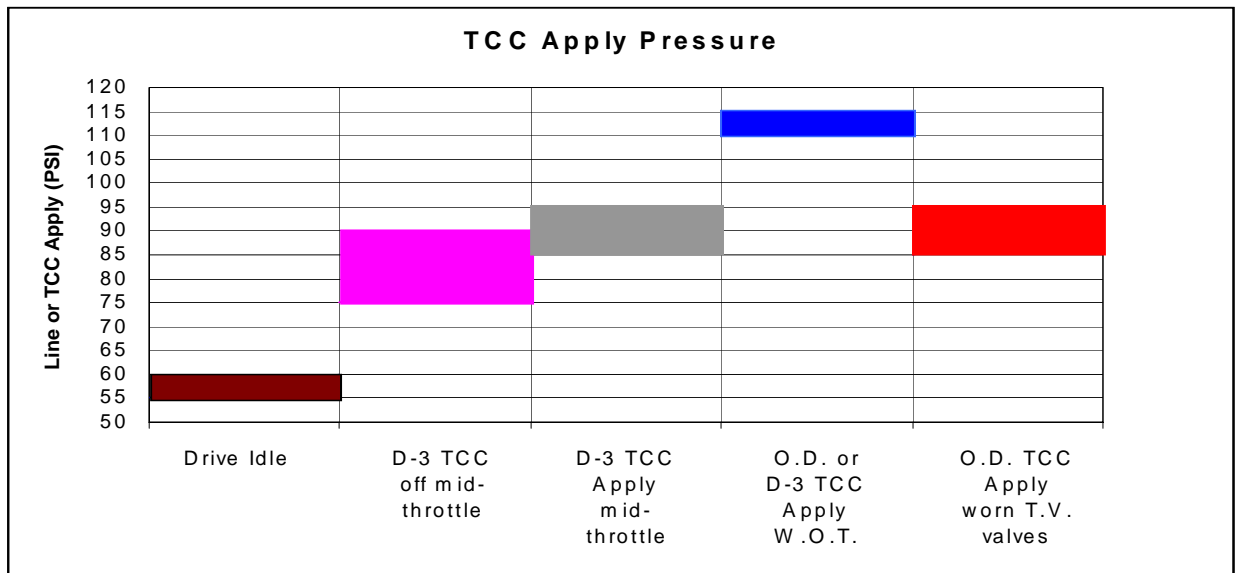
- Numerous! See previous Sonnax materials in '05 TCRA on how to diagnose.
- Recent trend has been in area of witch valve bore. Wear at the inboard end is loss of apply oil pressure. Wear at the outer spring end affects timing of release and reduces the sharp application.

Correction: Repair valve bore with oversized valve.

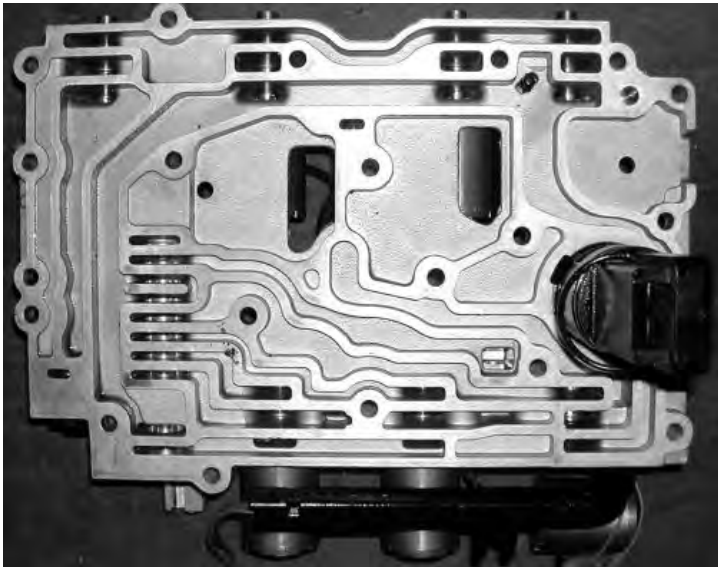
Fig 1

- Contamination at TCC solenoid or its feed orifice in the valve body.

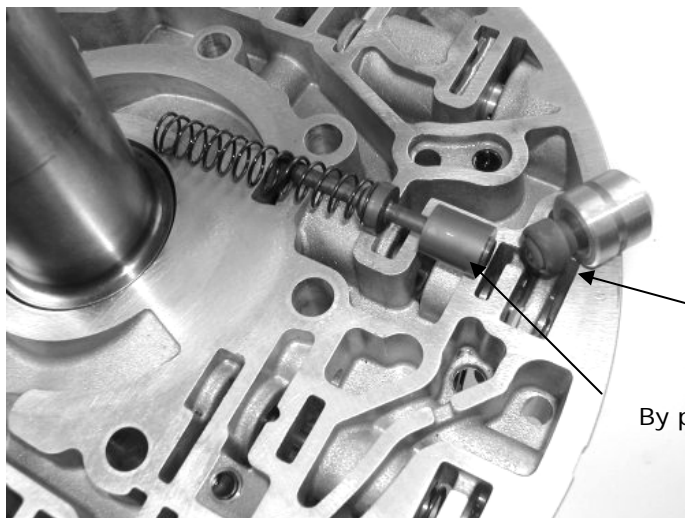
Fig 2

- The thermal valve in pump may be stuck or not fully open. It should be fully open after 125 degrees f.

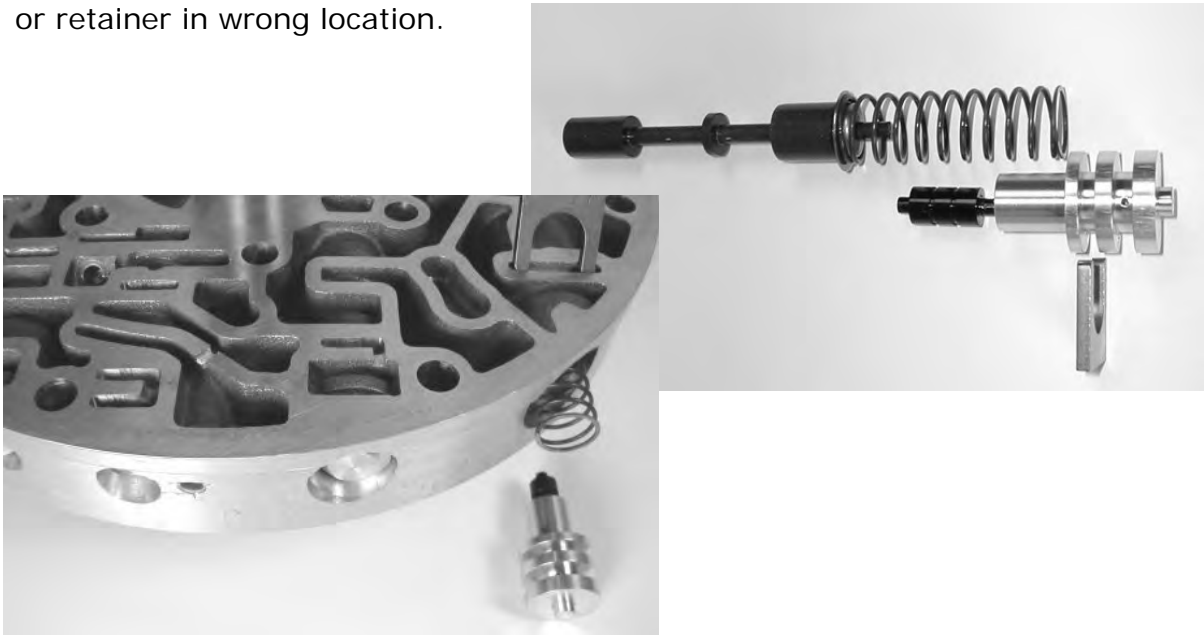
- Worn TCC modulator sleeve or retainer in wrong location.

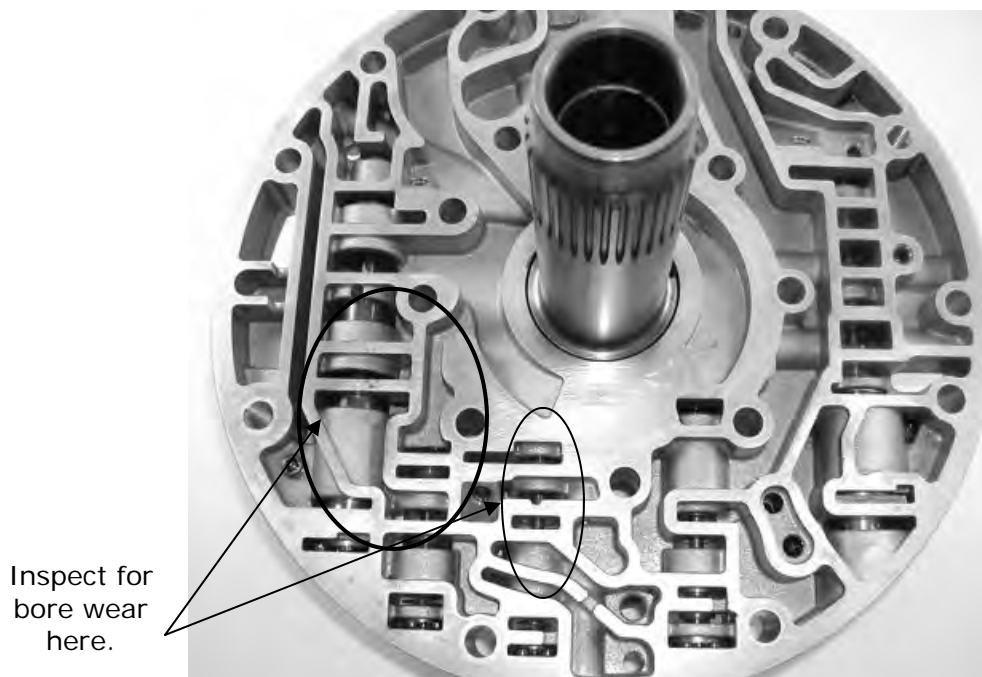
- Pictured is an early 03-04 pump casting. It is suggested all pumps be updated to the '05. Circuitry has been changed and does not look like this picture. The '05 will have improved pressure, flow and TCC apply.

Inspect for
bore wear
here.

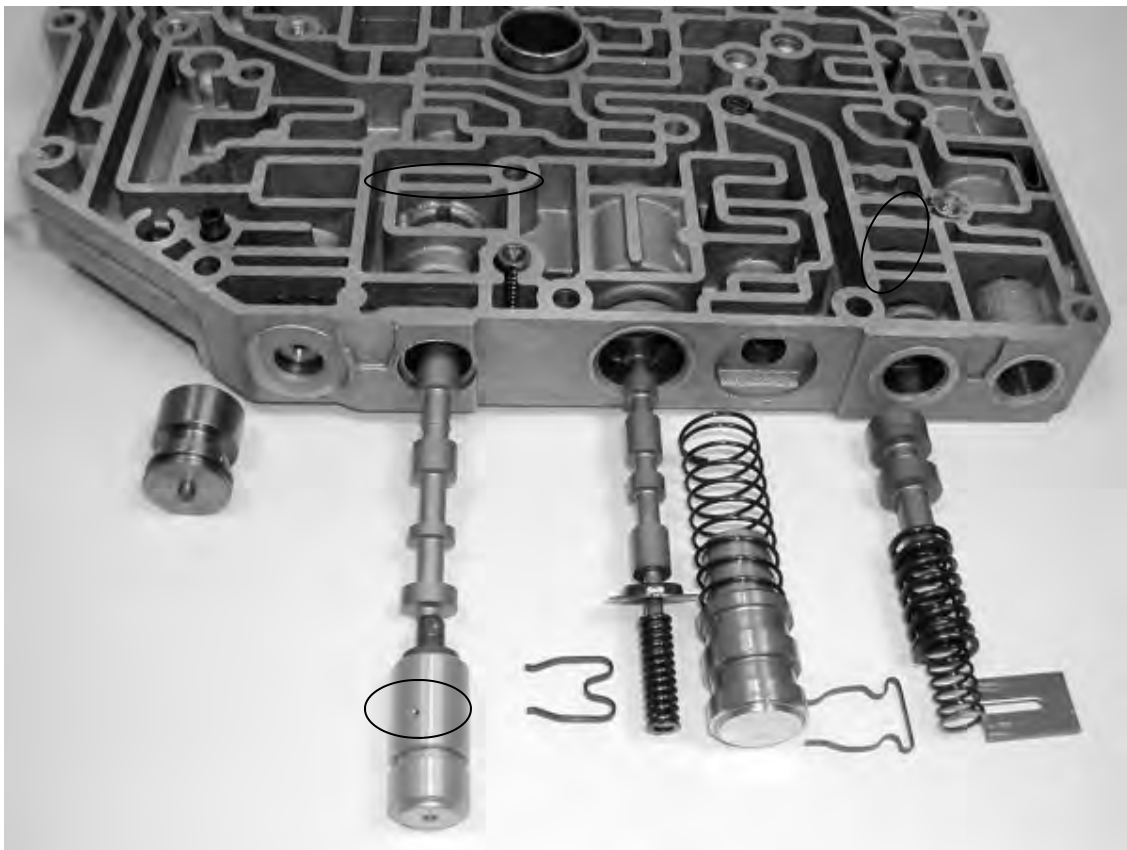
- Applications after '98 have a different design converter regulator valve. It will be a two spool valve with heavy spring(s). This design wears the valve body casting.

- This circuit can be vacuum tested easily to verify wear. Upon dis-assembly, if the valve is loose, discolored or sticks upon removal, the bore is worn.
