"2007" SEMINAR

Chrysler RWD
TCC Hunting
&
5R55W/S
Converter Noises
By
Mike Souza

DODGE & JEEP RWD VEHICLES

TCC CYCLING

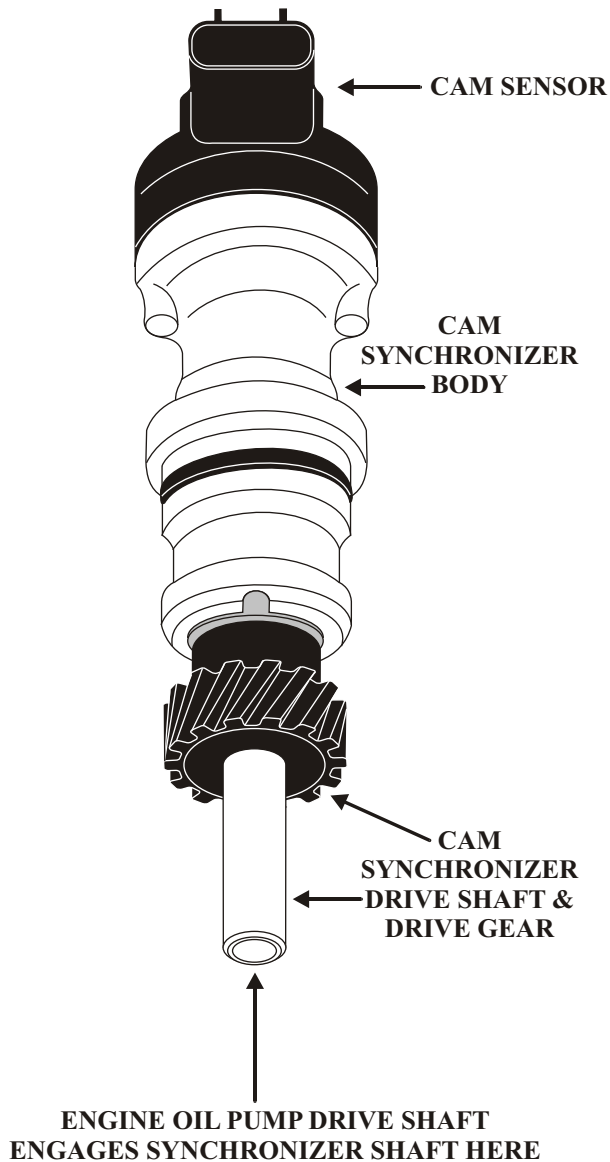
Figure 2

CAUSE: Camshaft Position Sensor/Synchronizer assembly bearing failure due to lack of lubrication. The synchronizer assembly lube hole becomes clogged cutting off oil to the area between the synchronizer body and shaft causing it to run dry.

CAM SENSOR & SYNCHRONIZER ASSEMBLY EXPLODED VIEW

WEAR & SCORING BETWEEN THE SYNCHRONIZER BODY & SHAFT CAUSE NOISE

CORRECTION: Replace with an OE assembly from Ford Motor Co. The Camshaft Position sensor is located on top of the Camshaft Synchronizer in the back of the engine block centered just in front the of the transmission bell housing held in by two bolts (See Figure 1). The PCM uses this sensor to control Fuel Injector timing. When this sensor begins to fail it can cause a loud whining or buzzing noise. Because of its location you may think the converter is the problem on an Explorer or Mountaineer. This one has tricked several technicians into spending countless man-hours changing torque converters, EPC solenoids and pumps trying to correct the source of the noise. Line pressure should be checked before changing the EPC solenoid or pump. A steady pressure gauge needle with a reading of 60 to 75 psi will very that the solenoid and pump is working correctly. If the gauge is reading low and the needle is very erratic verify that the filter is not restricted (such as the pan hitting the filter inlet), or sucking air around a damaged filter seal. You may or may not notice any engine performance problems or find any codes stored. *A good test is to place your finger on top of the sensor with the engine running to feel if the vibration or buzz is coming from a bad sensor.* Remove the sensor/synchronizer assembly and dis-assemble it. Check for signs of rust and scoring, (Refer to Figures 2 and 3). Replacing this sensor/synchronizer assembly on an Explorer or Mountaineer is much easier with the transmission removed because of the tight area in which the sensor is located.

The Cam Synchronizer must be installed in the correct position as it is timed to the engine much like a distributor, failure to do so will result in a poorly performing engine. Installation tools are available from Ford Motor Company or mark its position with paint.
