TCRA 2008

A.W. 55 50 SN/GM AF23/33

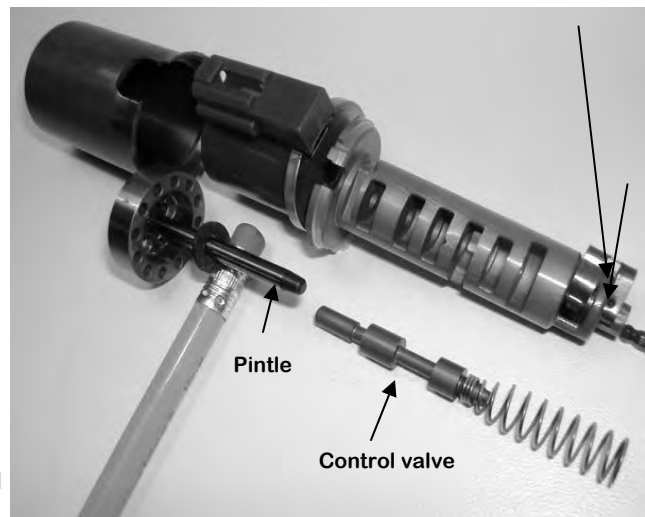
Linear Lock-up Solenoid (SLU)

Turning screw inward, reduces SLU
6 clicks = 1/2 turn.

- Adjustment clicks are created by the increments on exterior of threaded allen, 3mm
- With control valve removed, shaking the coil should result in a free pintle movement.

- 1-2 up-shift. i.e.; too firm or bumpy
 - 2-1 downshift. i.e.; harsh, bump
 - Light throttle TCC modulation. i.e.; cycling rpm or cooler flow
 - Full TCC lockup. i.e.; late, bump on coast down release
 - TCC release on coast; too early, loss of engine braking
- Refer to the pressure chart for examples of operation.

- Pre-measure the adjuster, remove the threaded adjuster, then the valve from the solenoid.
- Verify the pintle (shaft passing through coil), is free floating by performing a shake test.
- Re-assemble and turn the adjuster to the original position.

- The solenoid can be adjusted if a pass-through hole has been located in the cover during bench rebuild. The SLU access will be at the top, left corner. A 3 mm Allen wrench, will pass approximately 1.60" or 40.9 mm. through the cover, when it's inserted into the adjuster. You should be able to feel the Allen engagement. As you turn the Allen wrench you will feel the retainer click over the index. Always count your rotations, in clockwise (CW) or counterclockwise (CCW), so you know where you start /stop.
CW/ In : Reduces SLU output.
Resulting in: hard 1-2, 2-1 shifts and firmer/late TCC
CCW/ Out: Increases SLU output. Resulting in softer shifts and earlier TCC

- If your TCC control, 1-2 and 2-1 are good, cooler flow drops properly as noted above, leave the adjustment as is. If not, adjust accordingly.
- Slight bump on 2-1 down-shift... and/or TCC rpm fluctuates at 30-40 MPH during modulated apply....and/or excess TCC slip at full lockup...and/or Sonnaflow sensor indicates TCC control valve is continually toggling on-off. If so... turn adjuster screw in/clockwise 1.0 turn.

- Harsh 2-1 downshift....and/or heavy TCC RPM fluctuation at 30-40 mph...and/or late and firm full TCC apply. If so...turn adjuster in/clockwise 1.5 to 2.0 turns.

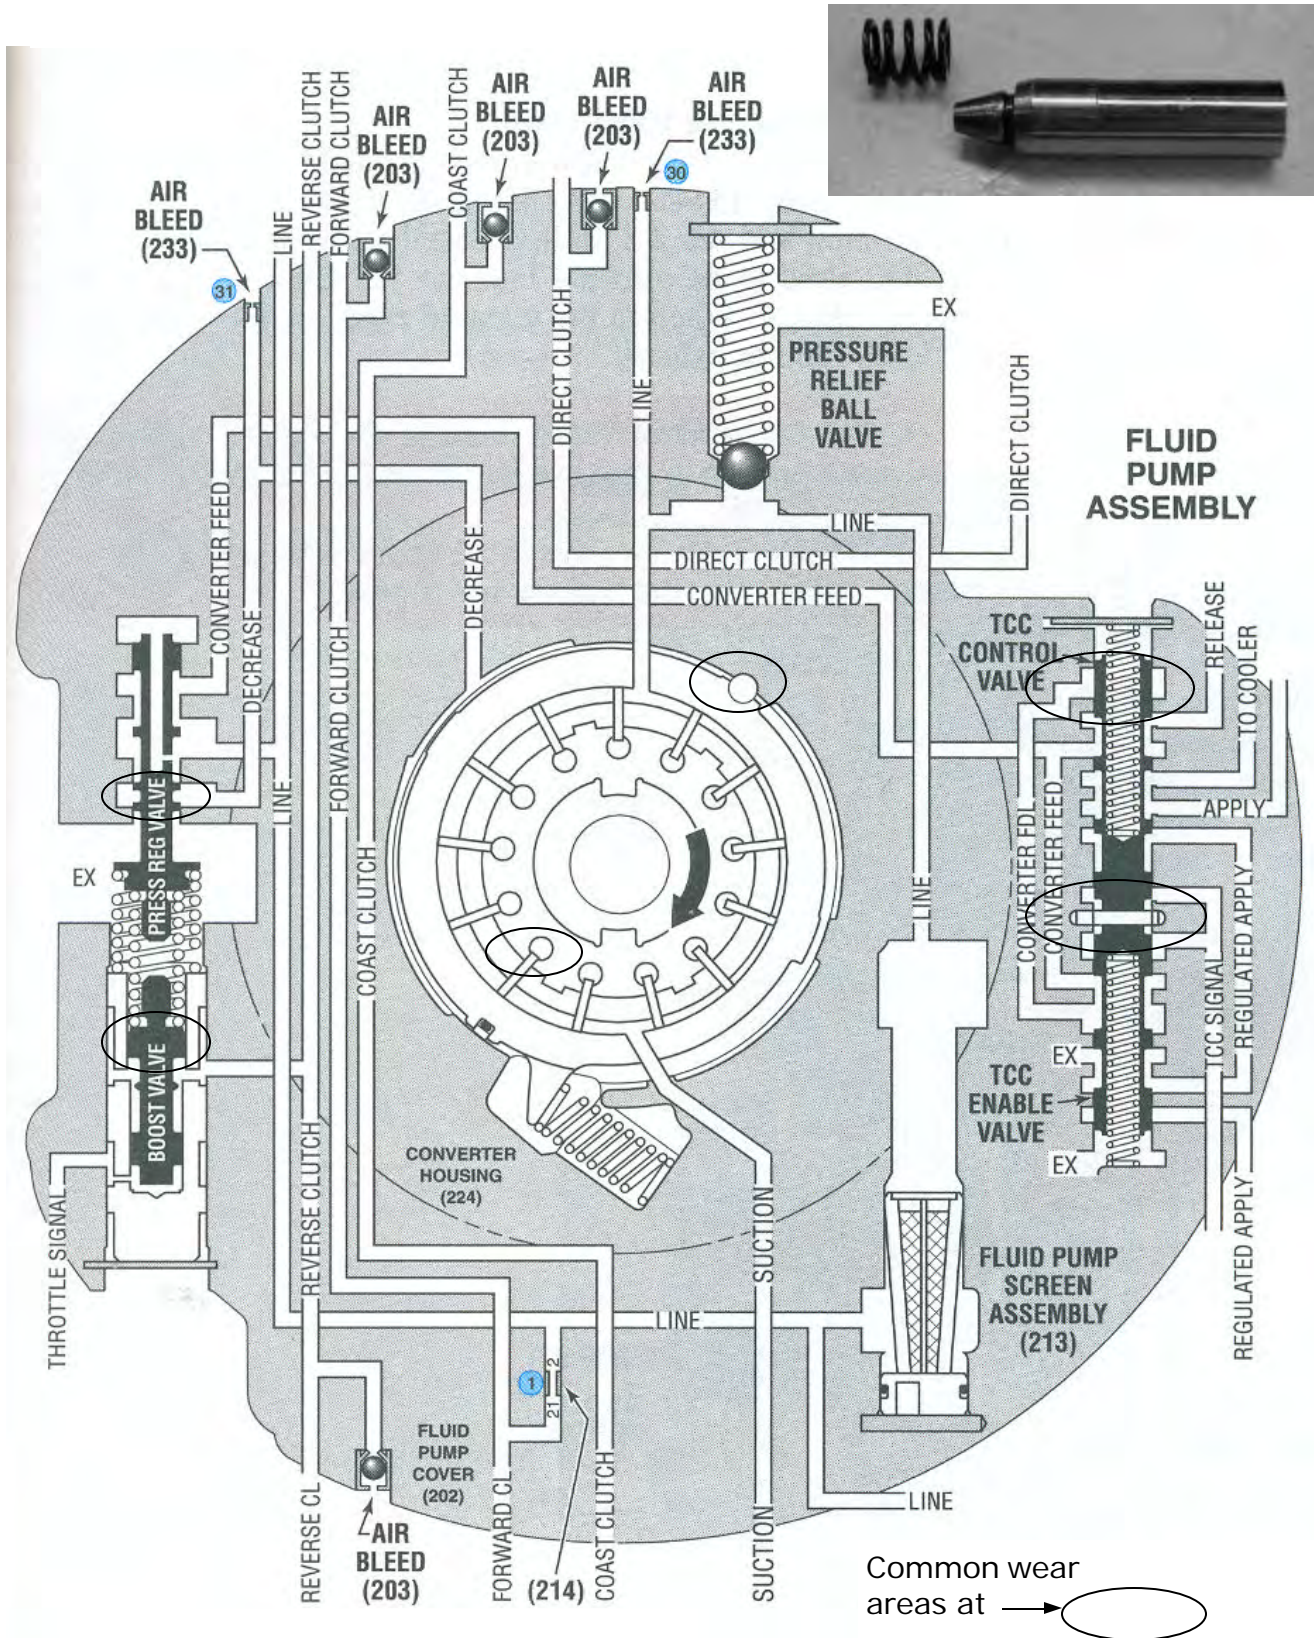
5L40E Pump

- TCC solenoid not holding internal pressure and bleeding into TCC apply oil
- TCC enable valves partially stroked
- Valve body cross leaks at reverse lock-out valve or TCC regulator.
- Pump cross leaks.

- Resurface pump halves and valve body.
- Install quality OE BMW TCC solenoid, or Borg Warner (III#1)
- Rebuild TCC valve bore and AFL bore or replace valve body

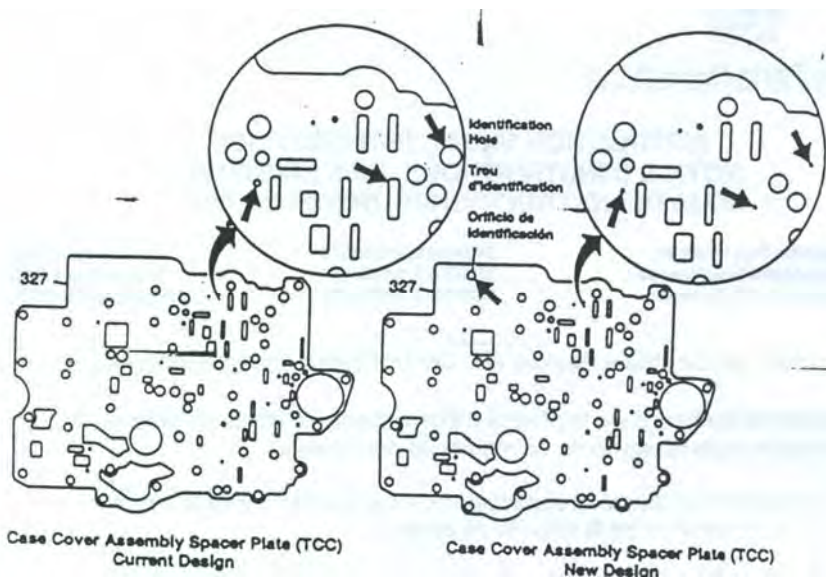
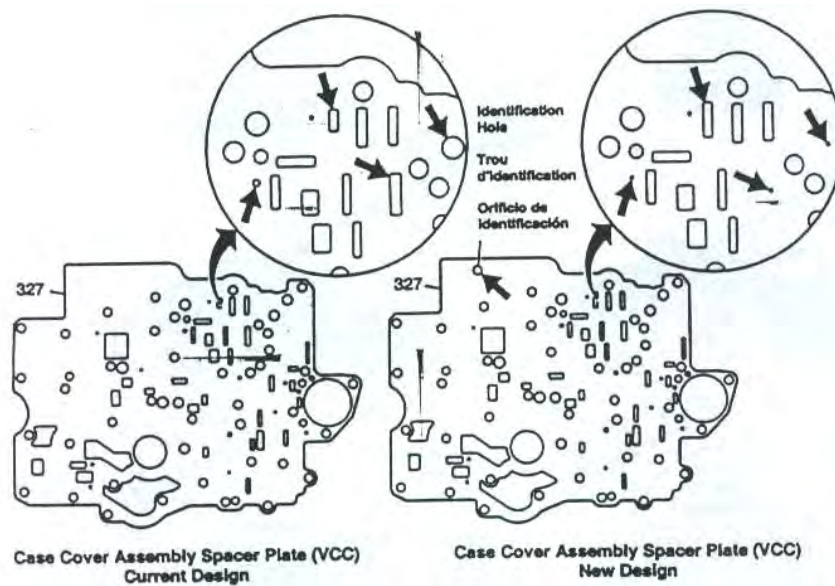
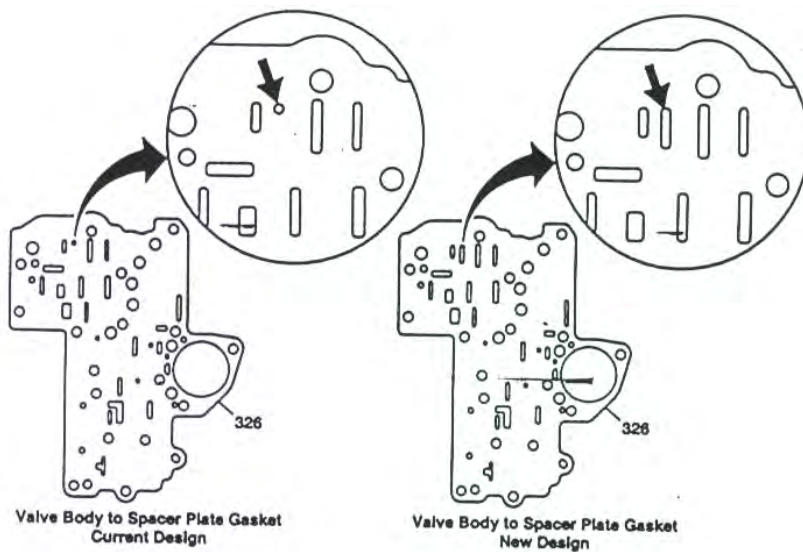
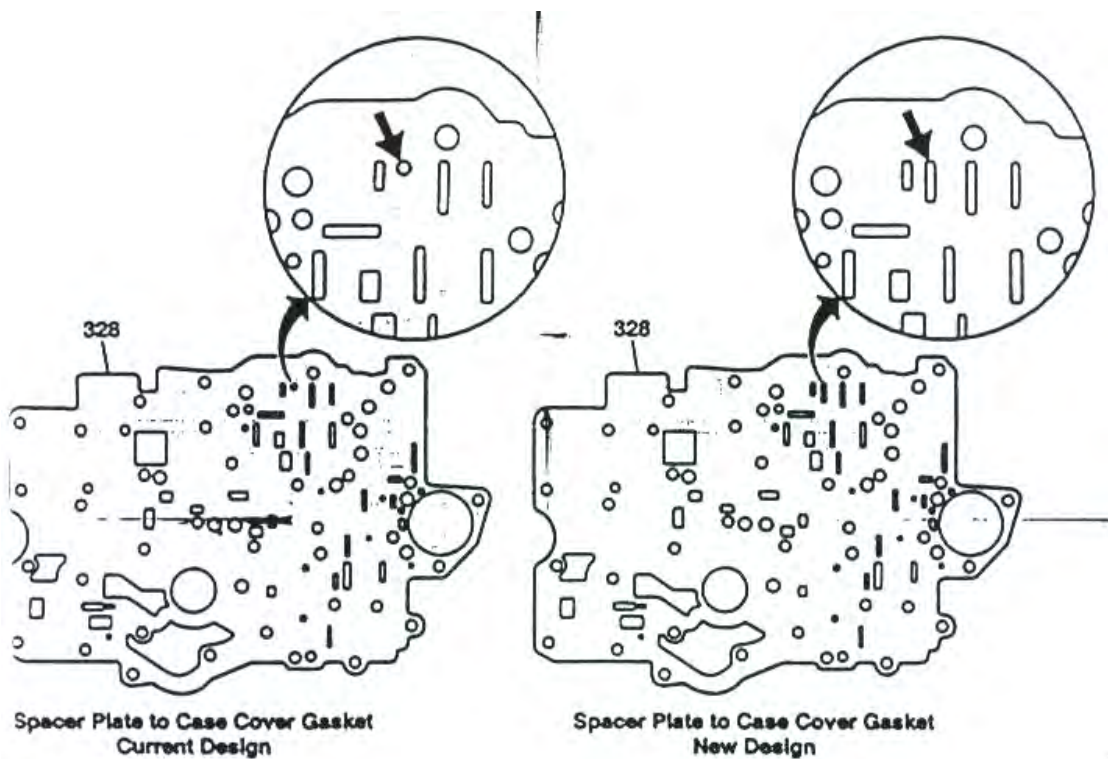
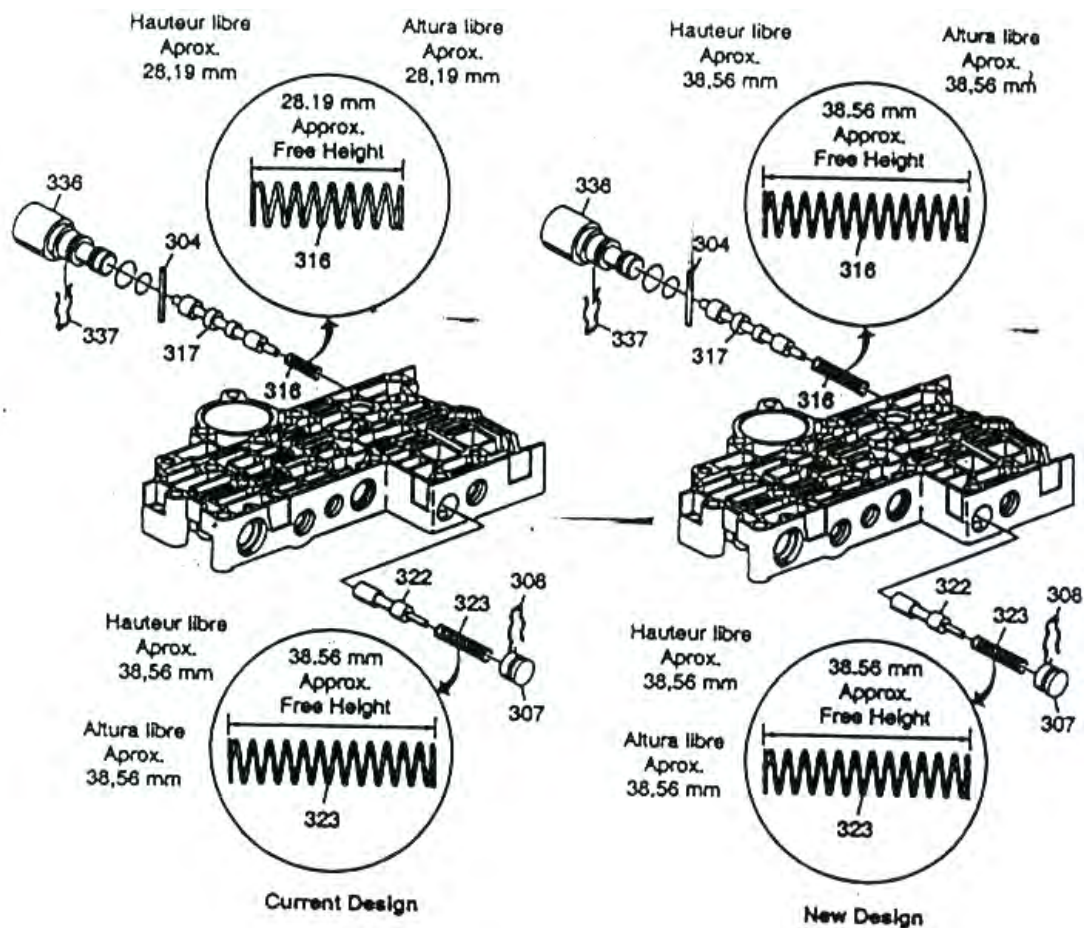
WARNING: When servicing a non-ECCC 4T80E Transaxle, reassemble it with an ECCC auxiliary control valve body spacer plate, ECCC auxiliary control valve body gasket (lower), ECCC control valve body gasket (upper), and ECCC control valve springs as a set. Do not reassemble non-ECCC 4T80E transaxles with any combination of ECCC and non-ECCC components (auxiliary control valve body spacer plate, auxiliary control valve body gasket (lower), control valve body gasket (upper), and control valve springs).

The transaxle will not function properly with wrong combinations of ECCC and Non-ECCC components installed. Please review the included graphics for ECCC and Non-ECCC component identification features and correct usage.
