Torque Converter Rebuilders Association

2014 Seminar

***What Else Can It Be
But The Converter***

Mike Souza

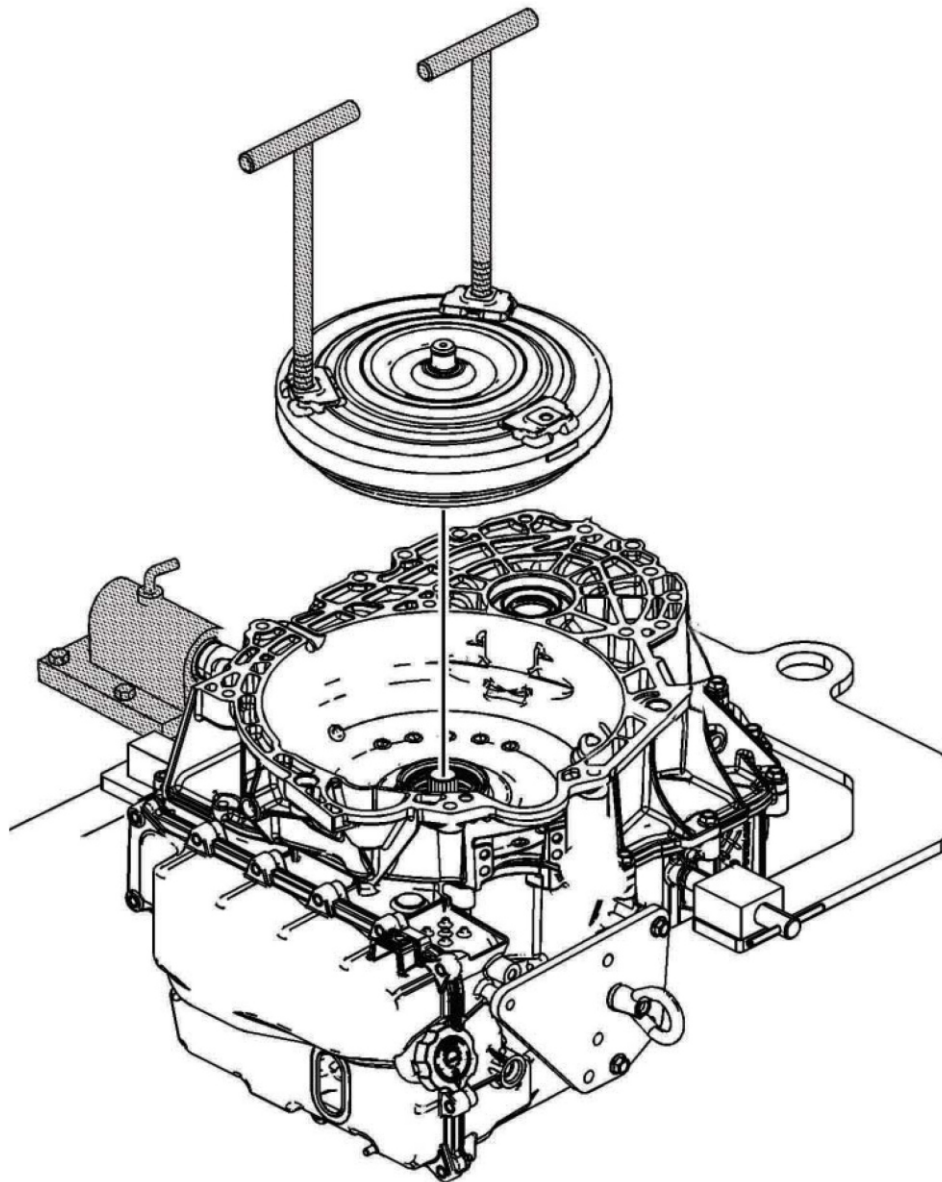
Only install these handles until they stop. Do not tighten. Over tightening these handles can cause damage to the torque converter.

Failure to raise the torque converter straight up could damage the torque converter clutch lip seal inside the torque converter clutch assembly.

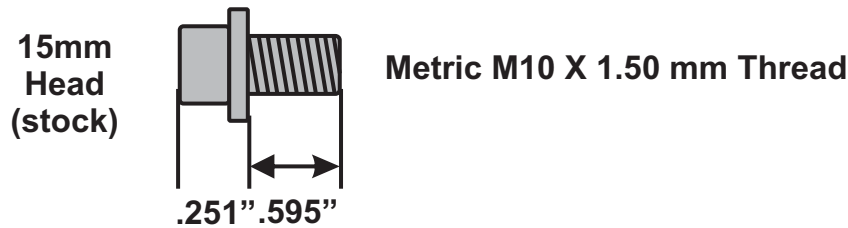
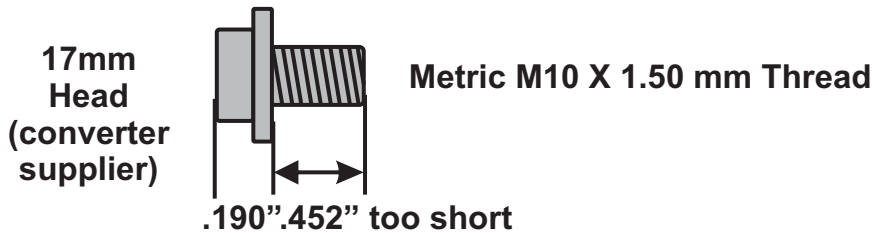
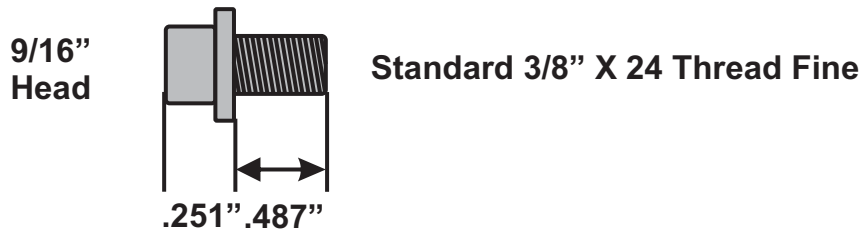
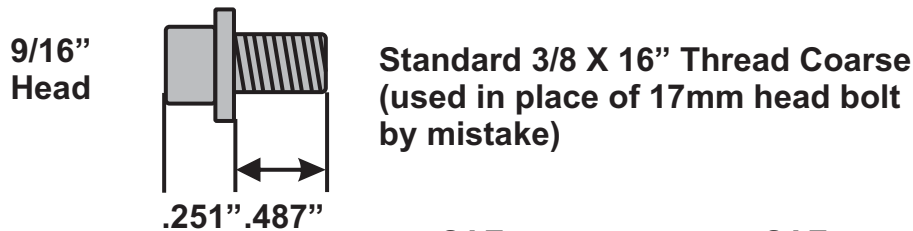
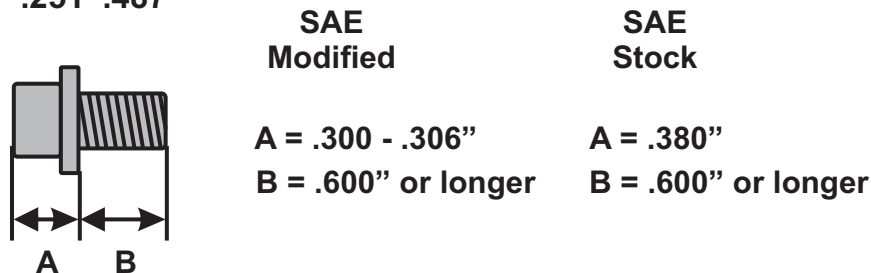
Billet Converter Bolt Damage

The vehicle returns to your shop with a scraping noise coming from the bell housing. Upon inspection metal particles found in this area. With the unit removed you find the converter bolts have come loose and has caused damage to the flywheel, starter drive, converter pilot and intermediate adapter plate.

This vehicle had a billet converter installed along with a billet flywheel. The billet converter has much deeper threaded holes than a stock converter. It is recommended that a longer thread be used on this application. The billet flywheel is approximately .080" thicker than stock and would require a longer bolt thread.

The bolts shown in the diagrams identify what is available and what should or should not be used.

6.7L Diesel flywheel is .083" thick.

6.7L Diesel Billet flywheel is .165" thick (use a longer bolt thread recommended w/Billet Torque Converter) The supplier may send shorter bolt head but the thread length is too short. Billet converter can come with all 3 threads.

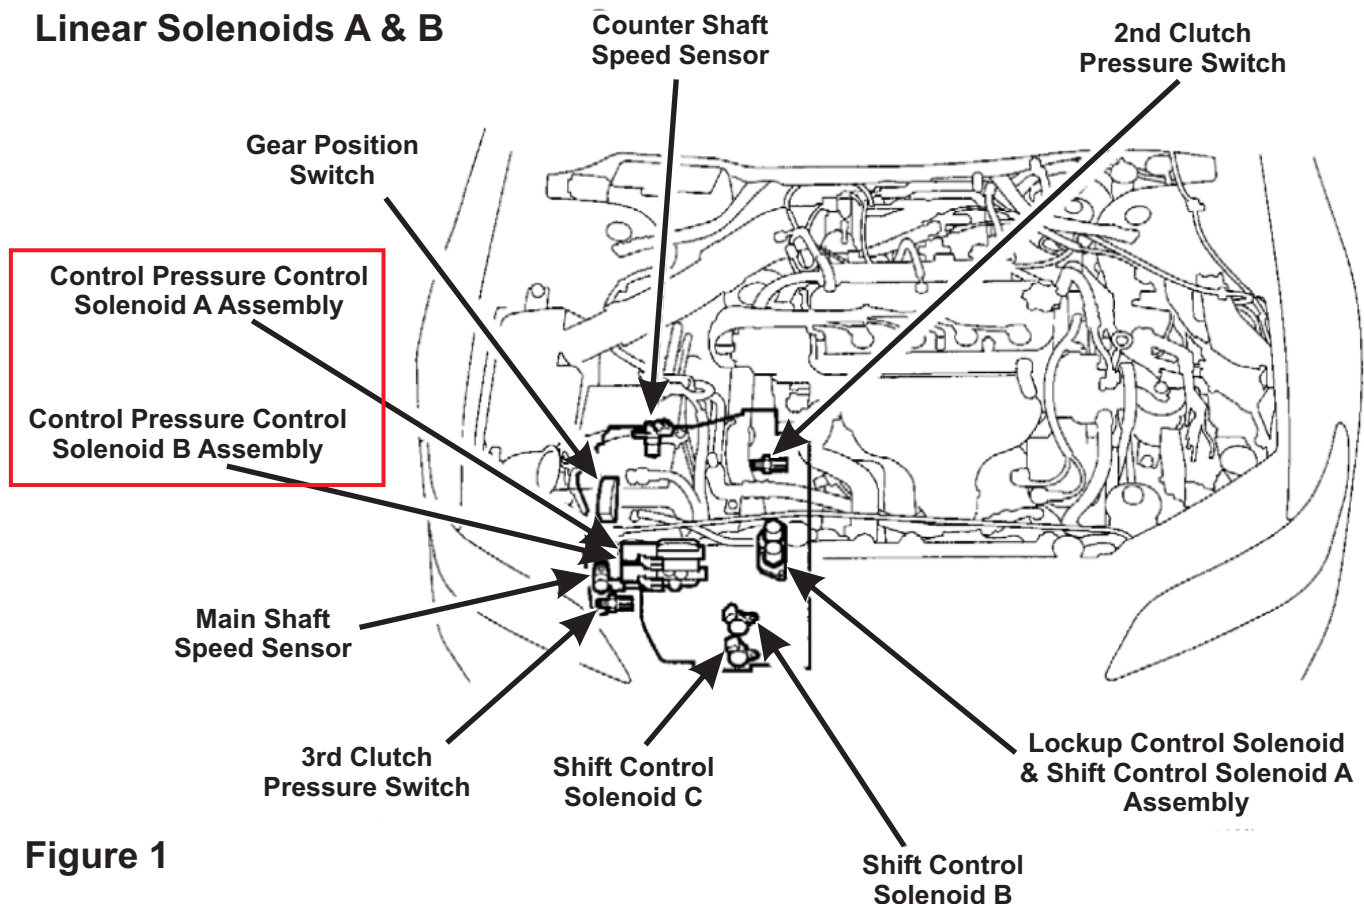
Figure 1

On most Honda 4 and 5 speed transaxles there are two linear solenoids attached onto one block to control shift overlap and converter clutch. These Solenoids are designated as Clutch Pressure Control Solenoids A & B (figures 1 & 2).

4 Speed Models With Only 2 Clutch Pressure Control Linear Solenoids A & B

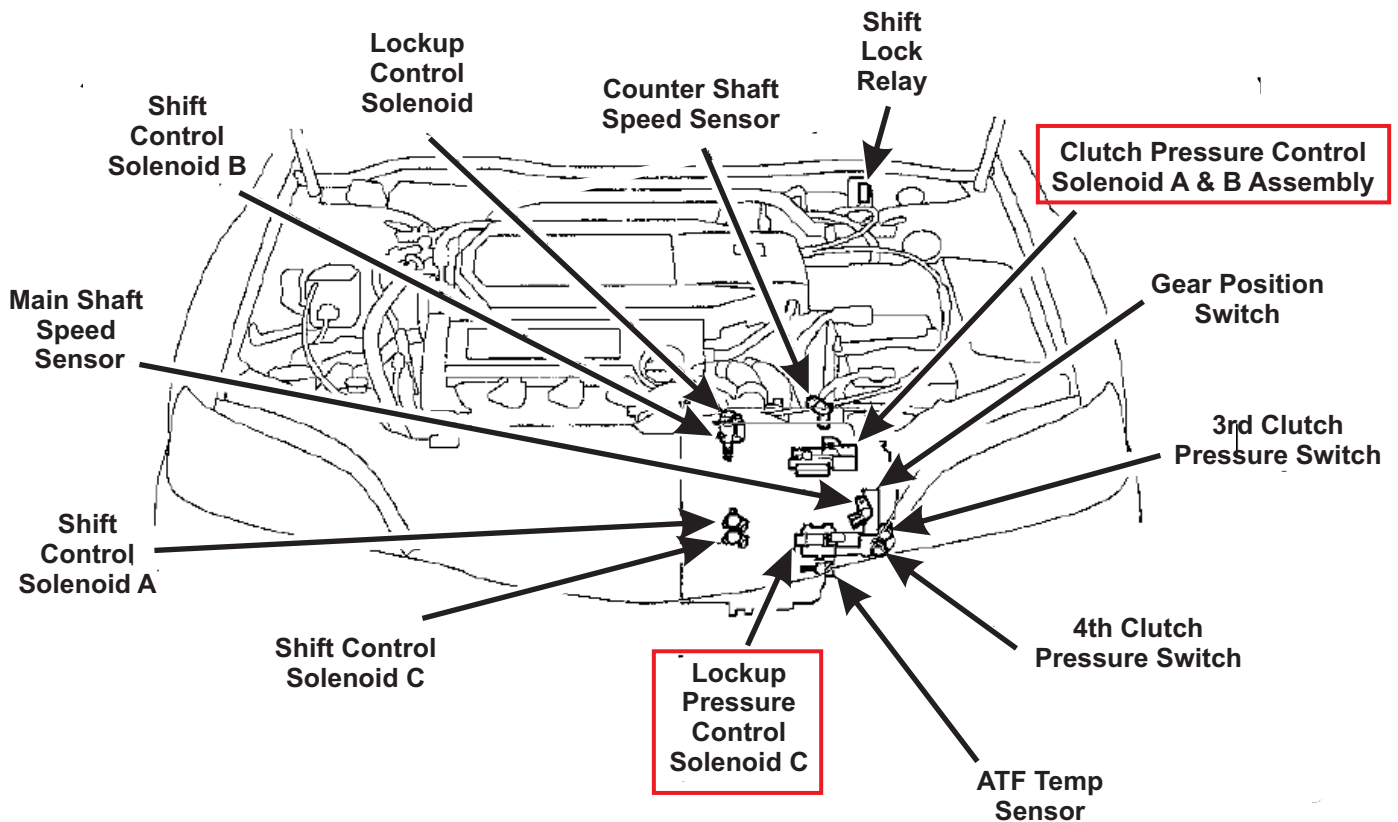
Figure 2

5 Speed Models With 2 Clutch Pressure Control Linear Solenoids A & B and 1 Single Clutch Pressure Control Linear Solenoid C For Lockup

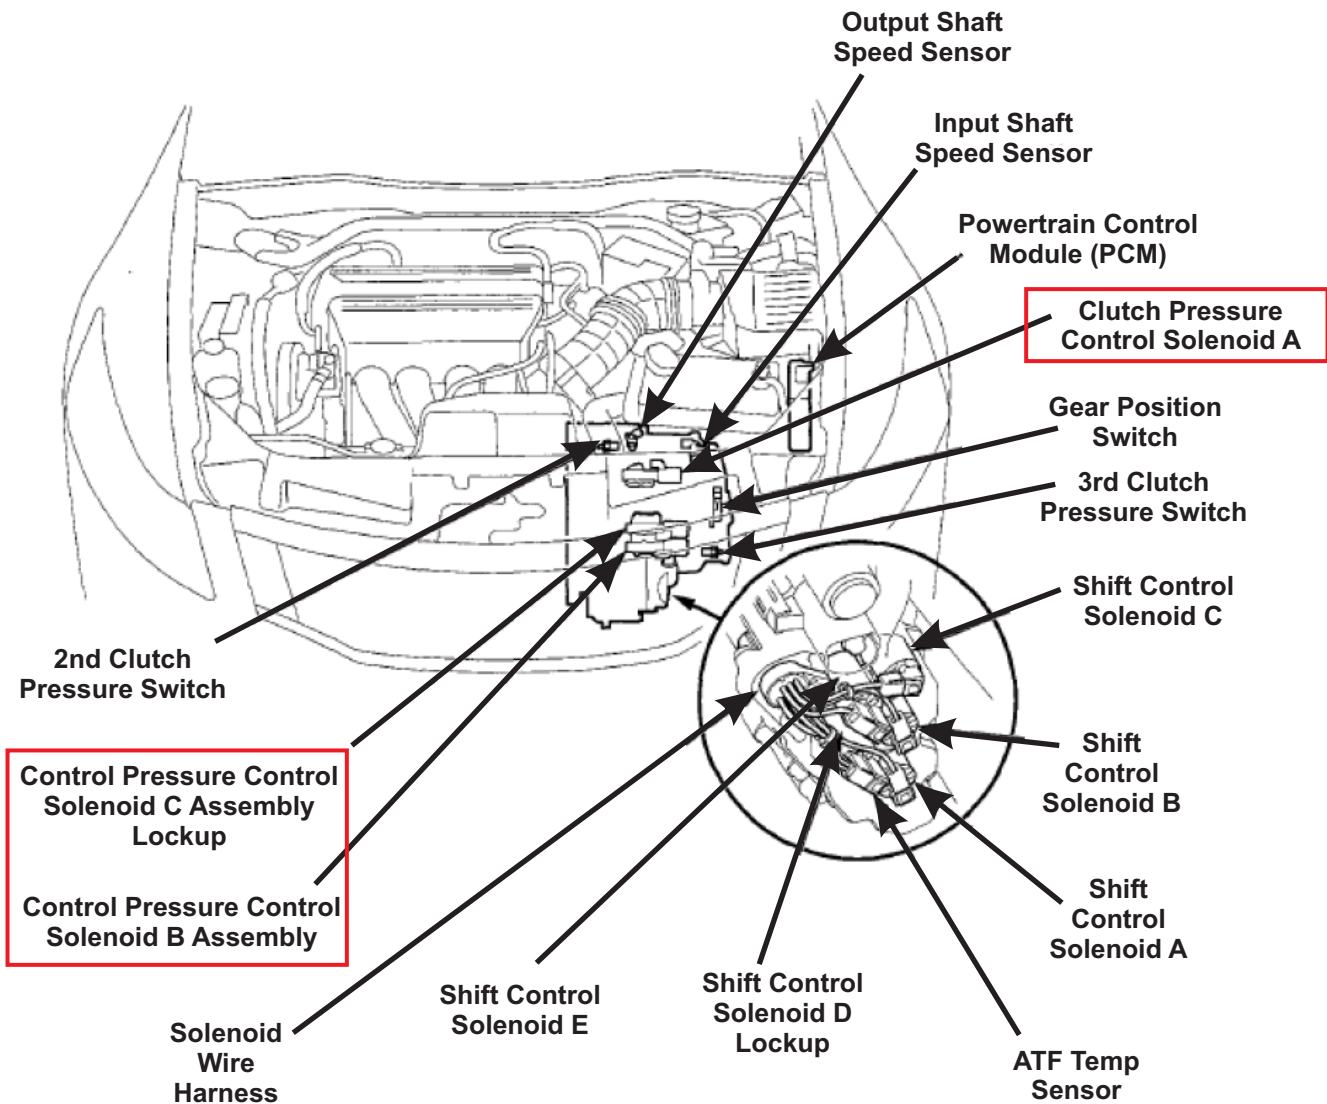
Figure 3

This is where the confusion begins. On some later model 5 speed transaxles such as the B90A and M91A found in the 2008 and later Accords models. The single linear solenoid is now designated Clutch Pressure Control Solenoid A for shift overlap and the dual Clutch Pressure Control Solenoid C is found on the same block with Clutch Pressure Control Solenoid B (figure 3).

The Clutch Pressure Control Solenoid C still controls lockup feel. During diagnosing a lockup problem on one of these models Clutch Pressure Solenoid A may be replaced by mistake to fix a lockup concern.

2008 & Later 5 Speed Models With 2 Clutch Pressure Control Linear Solenoids B & C (lockup) and 1 Single Clutch Pressure Control Linear Solenoid A
