Welcome To The 2016

Seminar

Those %#@&! Torque Converters

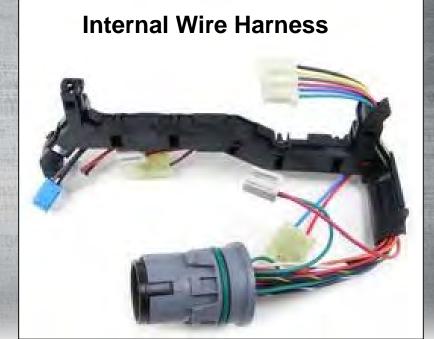
GM 4L60E DTC P0741 Set and Harsh 1-2 Shift

On some 2012 model year vehicles and engine sizes listed on page 3 with RPO codes LU3, LLV, LLR or M30. With trouble code (DTC) P0741 TCC Stuck Off.

If DTC P0741 is found, dealers are to replace the internal wire harness at no charge to the customer.

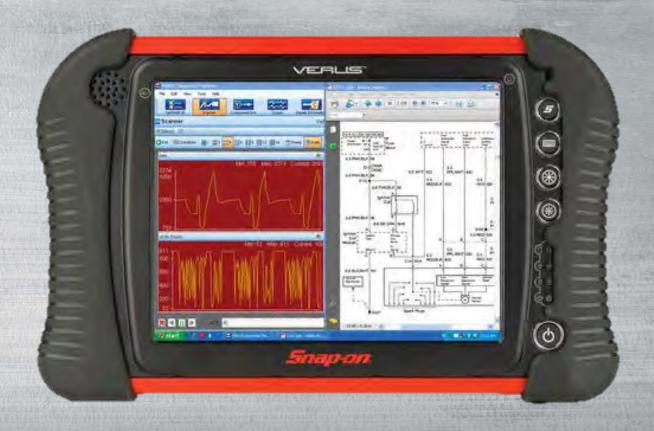
GM 6T40/70 No Movement After Reflash

When reflashing some GM vehicles with an aftermarket scan tool the transmission will not engage. It may remain in neutral until the scan tool is removed.

The actual reprogramming procedure for a GM vehicles shown in handout.

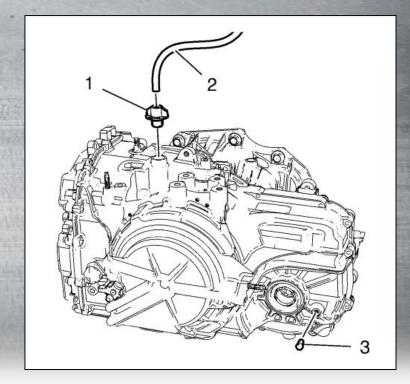
GM 6T40/70 Overheat When Overfilled, Setting Code P0218

The 6T40/45 utilize a thermal type element to control the oil level in the unit similar to other GM units. Known as a "Fluid Level Control Valve" the unit is basically a thermally controlled stand pipe.

As little as ½ qt. overfull can lead to fluid leaking from the vent.

It may be easier to fill to the correct level using the Fluid Capacity chart shown below.

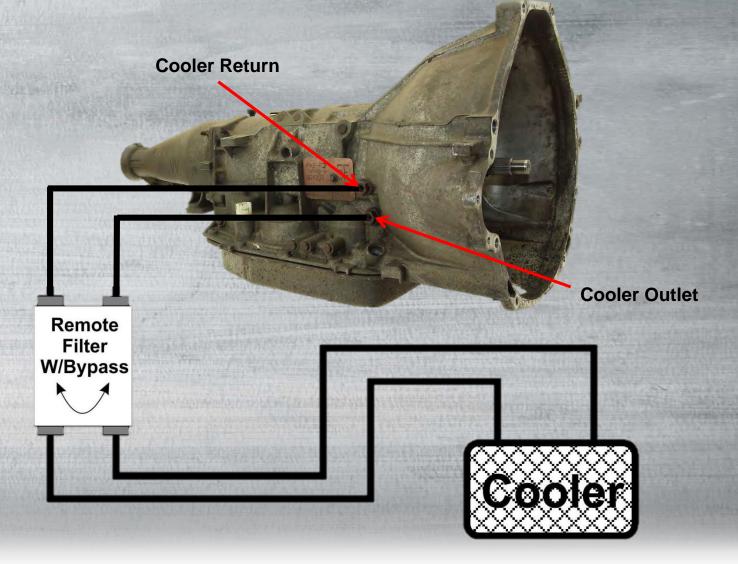
Ford 4R70W/75E Transmission Over Temp

Make sure to check cooler flow using a flow meter at operating temperatures when lockup is applied.

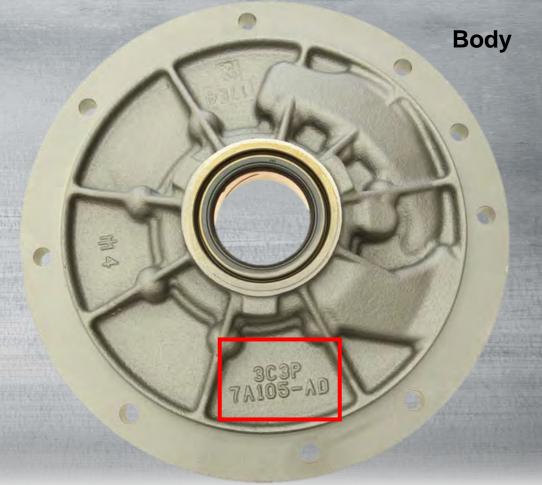
Stator Support

5R110W (Torqshift) No Movement After Rebuild

The problem is mismatched pump parts. The change occurs in 2005 and is not interchangeable with the earlier 2003-04 parts. The 2005 and later pump will retrofit back as a complete assembly. No interchange of parts between early and late are possible.

The early 2003-04 can be identified by the rough forged date found on the castings #3C3P on the pump and RF3C3P on the stator.

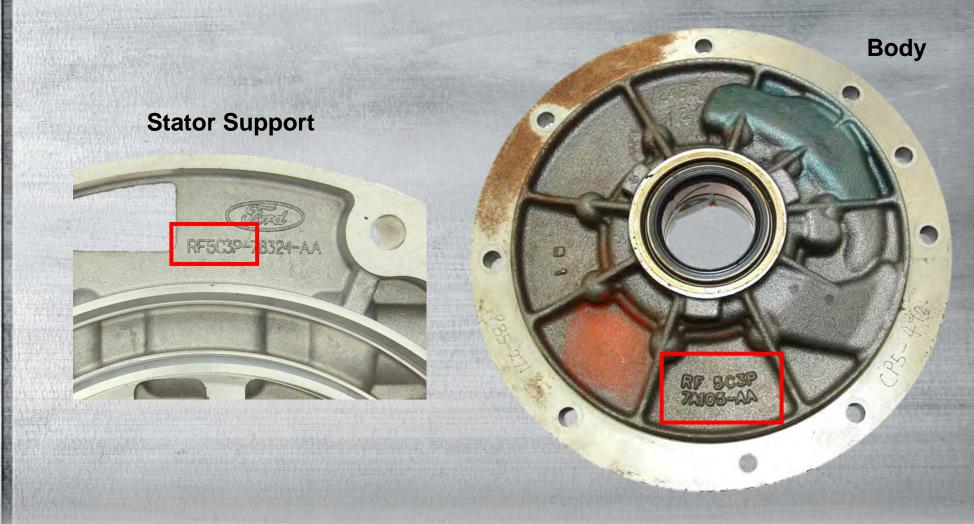
5R110W (Torqshift) No Movement After Rebuild

The 2005 & later pump assembly can be identified by the rough forged date found on the castings #RF5C3P.

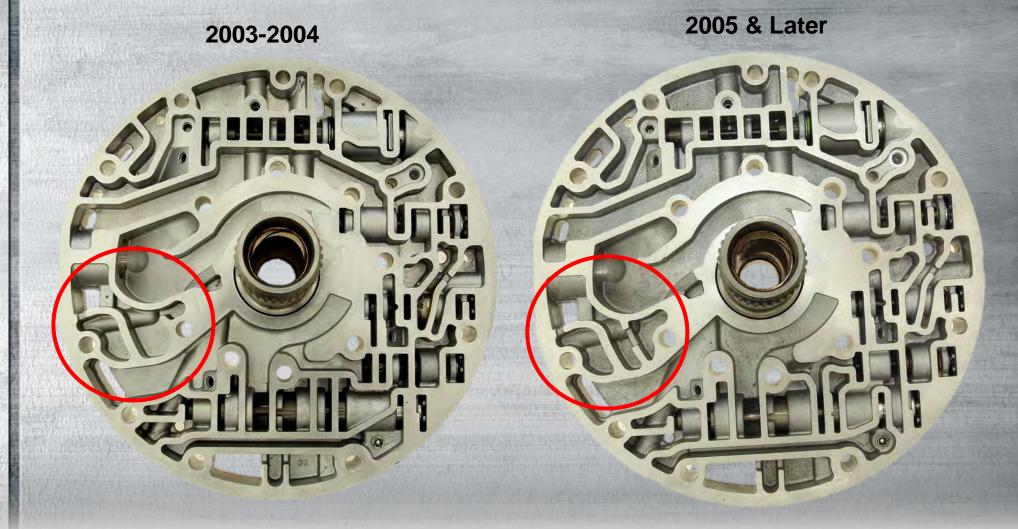
5R110W (Torqshift) No Movement After Rebuild

The difference between the oil circuit worm tracks found in the pump stator supports are shown here.

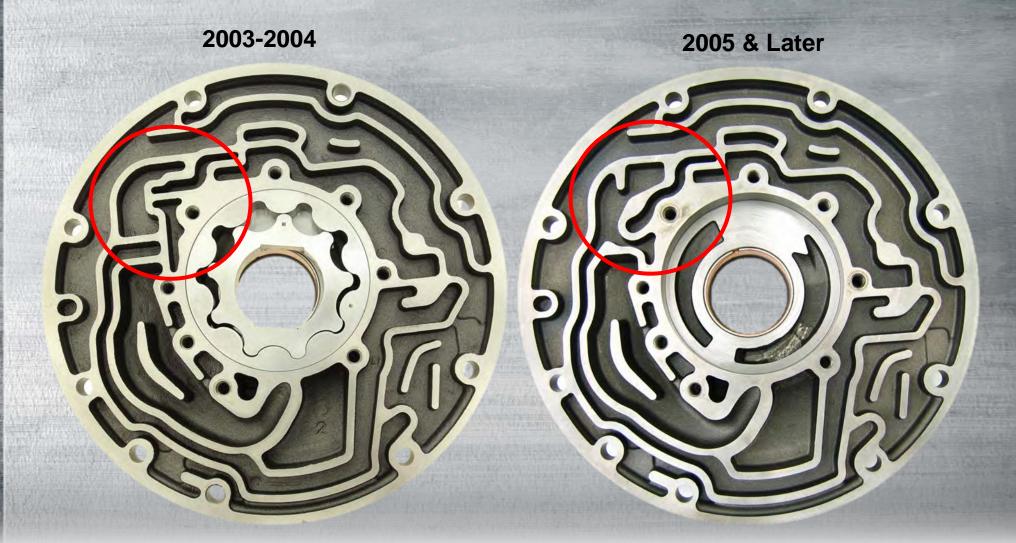
5R110W (Torqshift) No Movement After Rebuild

The difference between the oil circuit worm tracks found in the pump bodies are shown here.

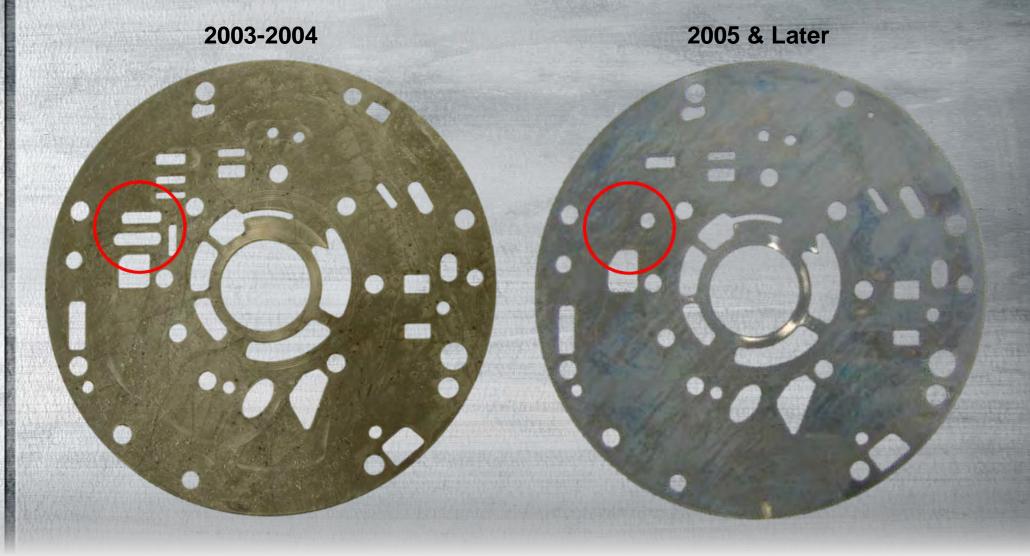
5R110W (Torqshift) No Movement After Rebuild

The difference between the oil circuits found in the pump wear plates are shown here.

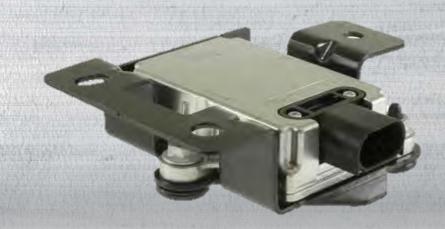
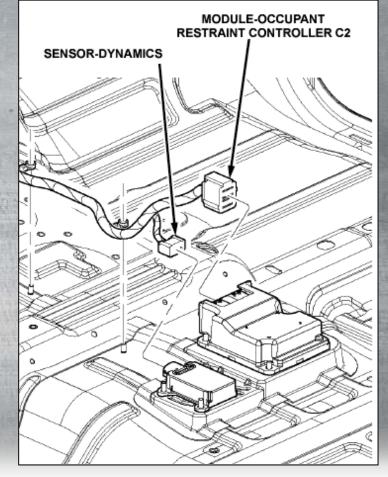
Some Dodge vehicles may experience what feels like a TCC shudder during turns. This may be caused by a bad Dynamic (G/Yaw) Sensor.

If the sensor signal to the ABS system was not working correctly during turns, the ABS module will partially apply the brakes and may trip a DTC. The shudder feeling from the brakes can be mistaken for a TCC shudder.

If any codes such as C1213 "G" Sensor Input Signal Stuck C1242 "G" Sensor Input Signal Performance or C1243 "G" Sensor Not Initialized, you must address these first.

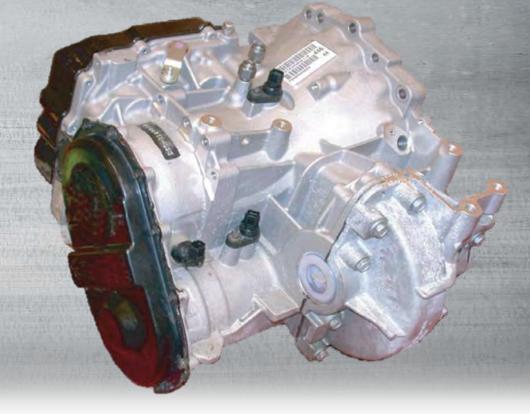
Chrysler/Dodge 62TE TCC and Shift Chatter After Rebuild

A complaint of a firm 2nd gear and a chatter going into 3rd gear after rebuild. The scan tool did not retrieve the codes. The computer would not quick learn or allow the converter break-in initialization.

This is a clear case of the scan tool not communicating properly with the vehicle computer.

When the scan tool function to clear all codes was performed it allowed the quick learn to be performed. The 1-2 shift became normal and the chatter was fixed after converter break in initialization was performed.

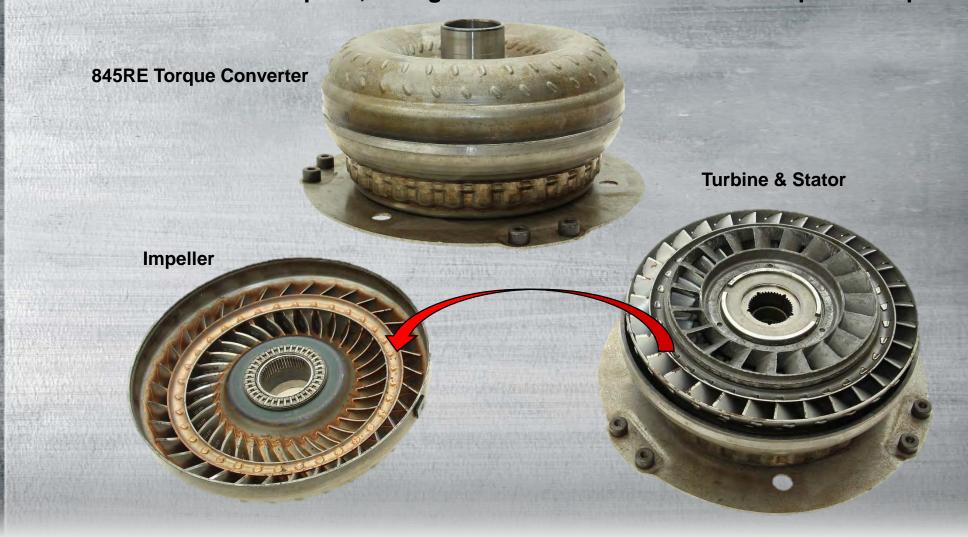
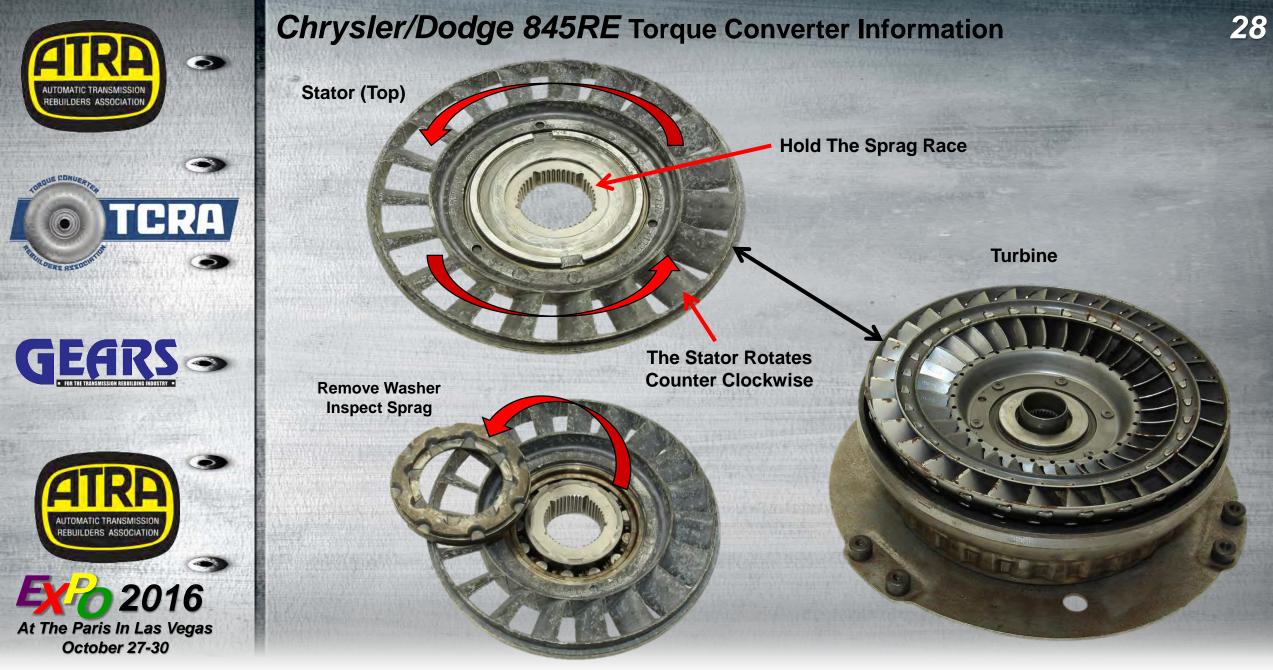
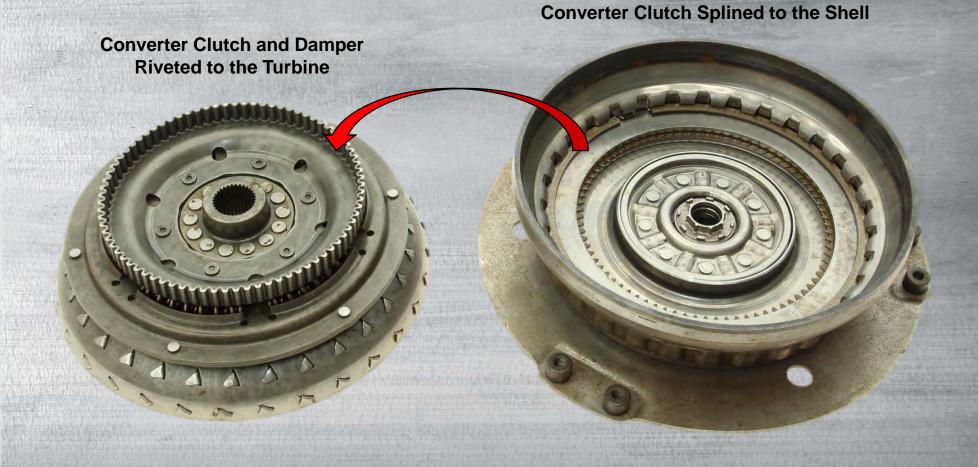
Chrysler/Dodge 845RE Torque Converter Information

The 845RE torque converter is using a "clutch drum" type of torque converter clutch.

This clutch has one steel plate, a single two sided friction disk and a pressure plate.

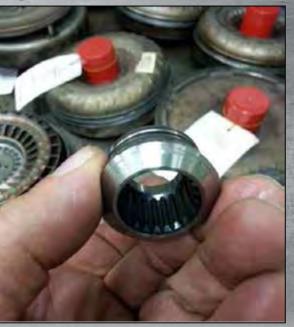
Breaking Off

U660E TCC Slip or No Move Condition

If there is any wear in this area it could cause a TCC slip code. The problem is not so much that the smooth area is wearing out, instead they're breaking off causing a no move condition.
