The 80- 20 Rule

Bob Warnke

TCRA

Diagnositics and Control of TC Clutch:

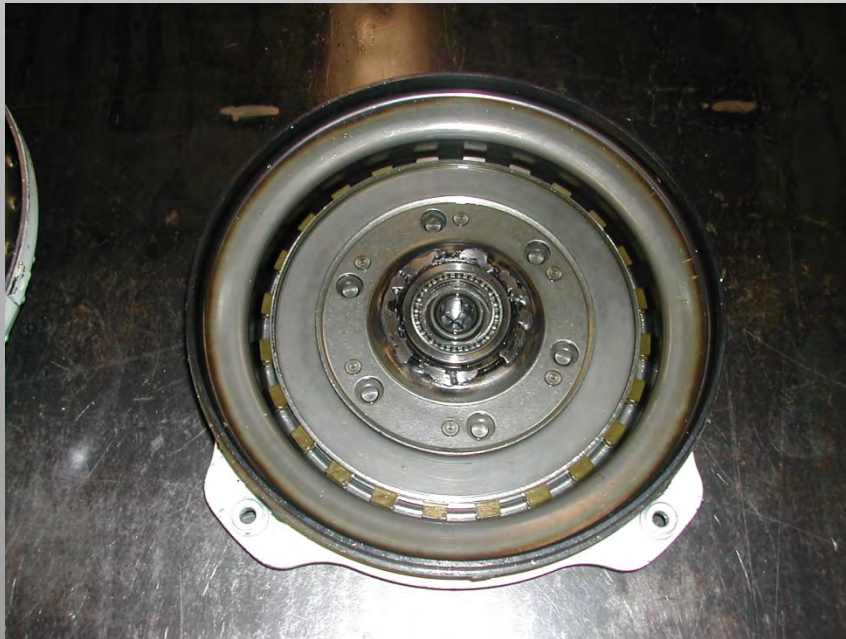
**ZF 6 HP- 26 – Two path.
Friction loaded**

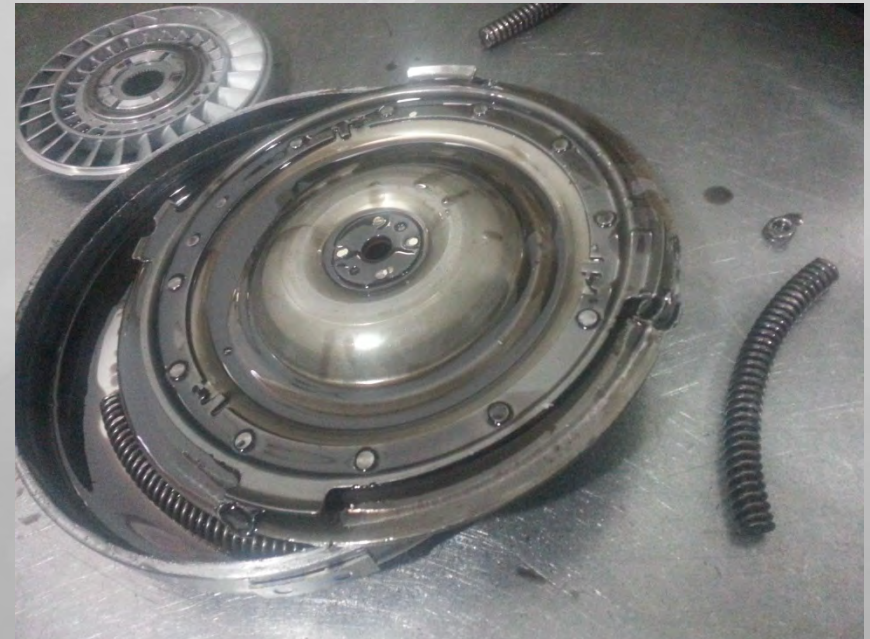
**Ford 6F35-Two path
Floating piston**

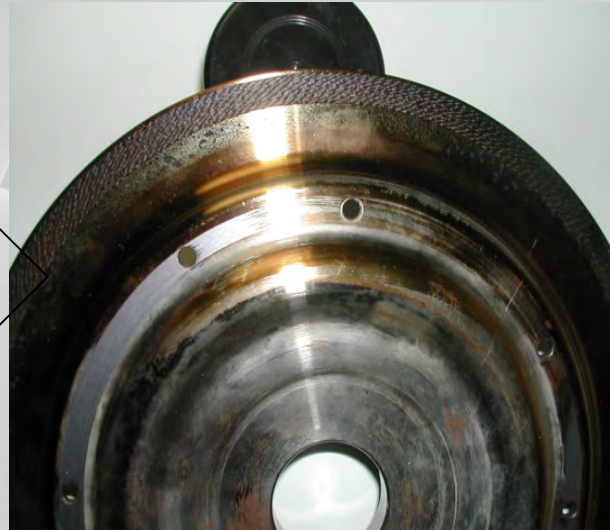
Excess slip or poor pressure control = heat.

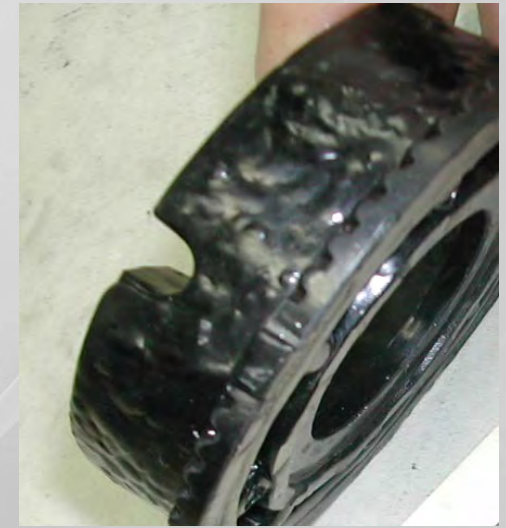
Poor flow, excess tolerance = inefficiency.& heat.

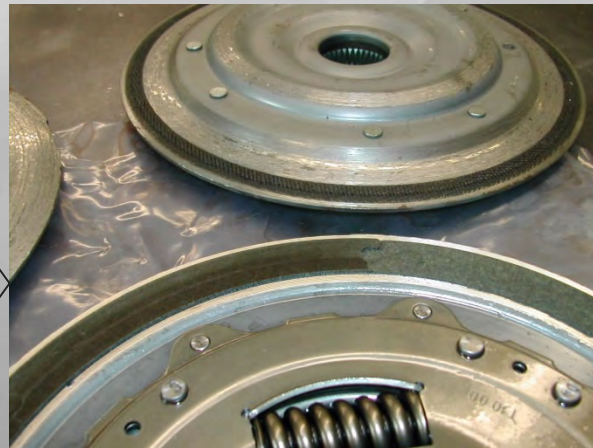
Excess apply pressure = piston distortion & lining failure.

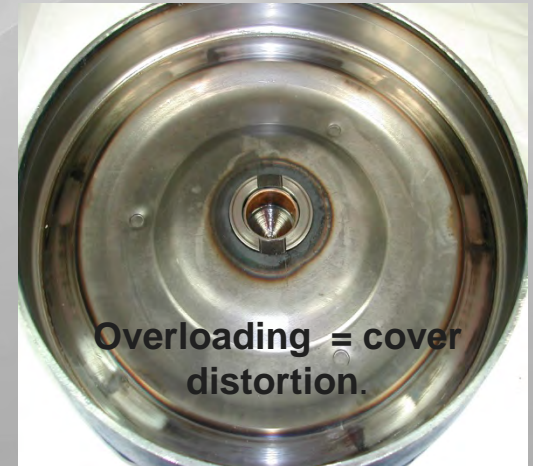
Overloading = cover distortion.

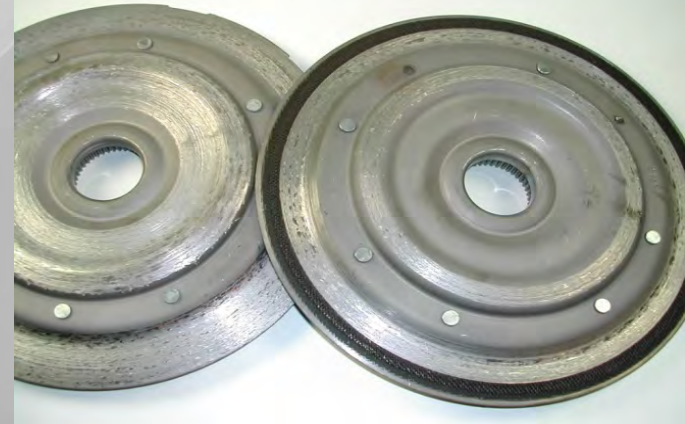
Excess apply psi. = Bent TC piston

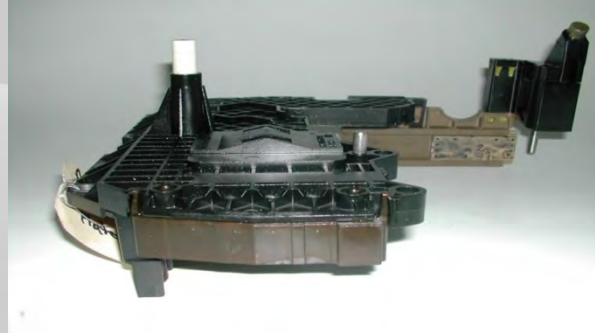
Audi- ZF 6, TCM, Contamination and terminal solder issues.

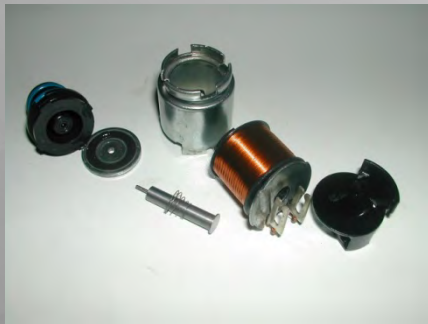
6T30, solenoid contamination

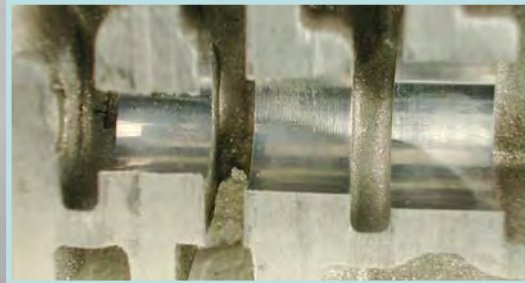
Valve bore wear

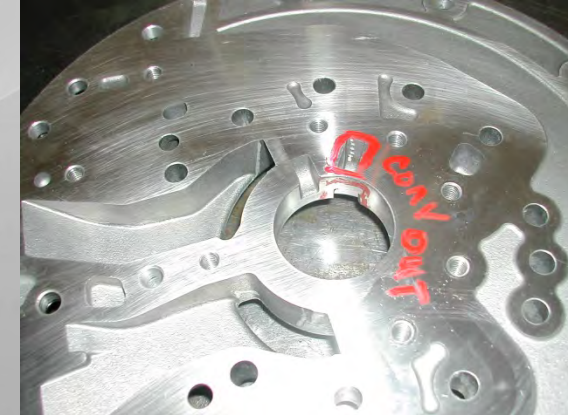
ZF 6- Pump circuit cross leaks.

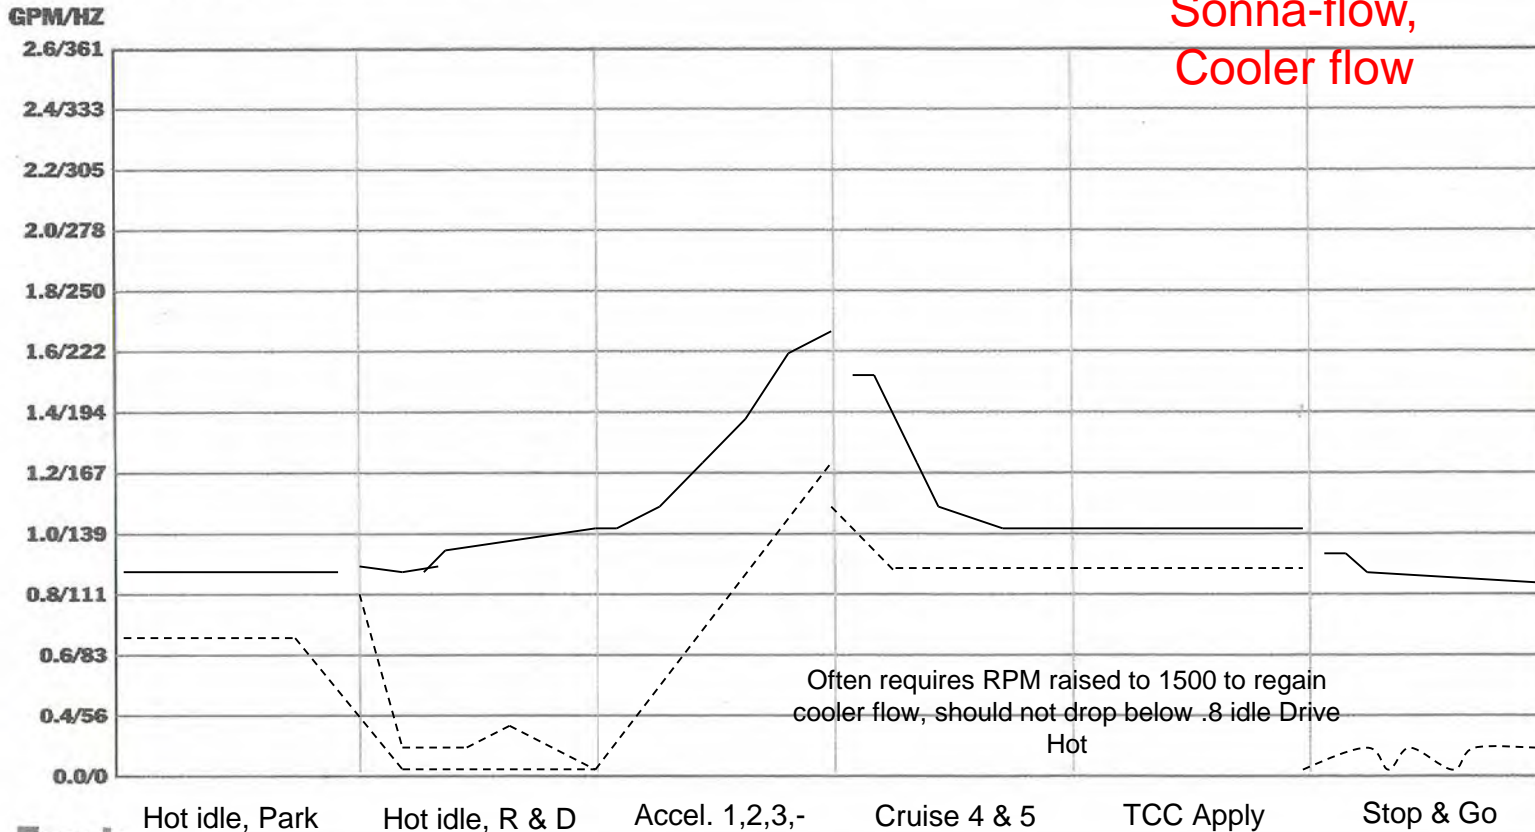
Figure 7 **Sonnax Lube Regulated PR Valve, Corrected Low Flow Condition**

APPLICATION: HONDA 4 & 5 speeds, Odyssey Illustrated.

Event: Hot idle, Park Hot idle, R & D Accel. 1,2,3,- Cruise 4 & 5 TCC Apply Stop & Go

Notes: Prior to Sonnax line to lube pressure regulator valve -90892-04K, operating temperature high 240-360f.

_____ After valve body upgrades -180f. Maximum Concerns, TCC lining failure, overheat code, TC 740 Code, TCC shudder

Honda; Line to lube pressure regulator valve.
Honda utilizes a three path converter.

The Sonnax lube regulated PR valve 98892-04K corrects the low flow condition by allowing the internal relief valve to provide flow to converter before converter charge circuit is fully open.

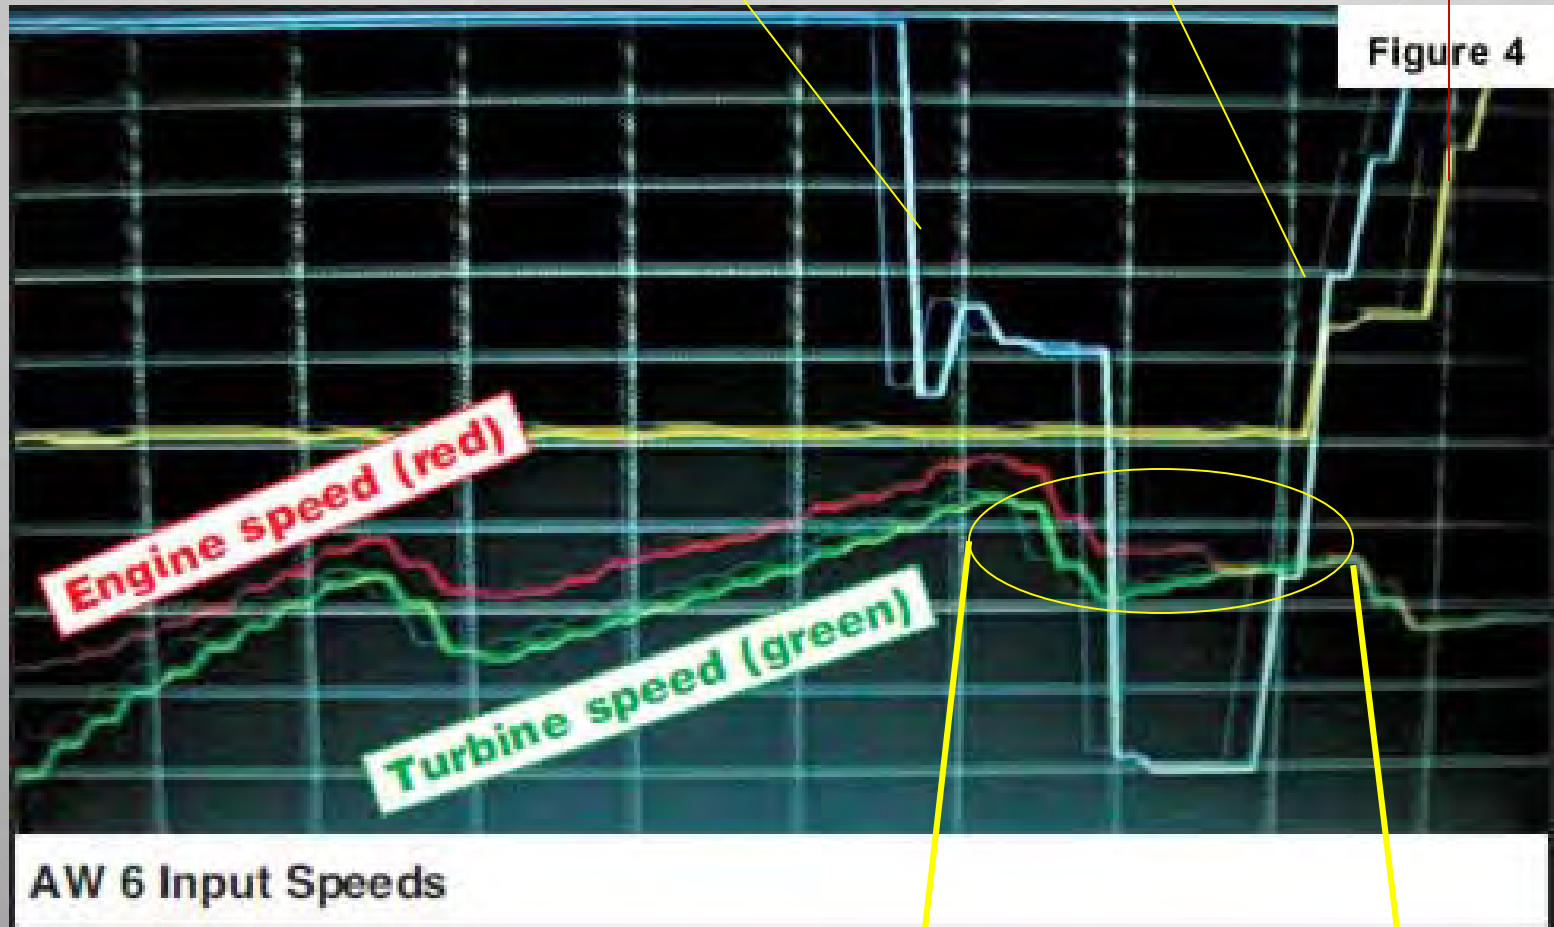
During the shift ,TC slip is opened.

After shift ,TC is closed.

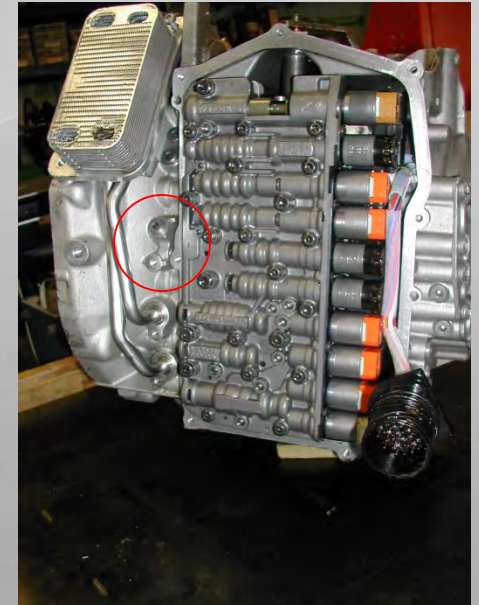
ZF 9 HP48- Converter Release Pressure Test Data

Converter Release Oil, ZF9HP45 '15 Jeep Cherokee 3.2 ltr.

Converter flow is required to control heat.
The pump and valves control pressure and flow.

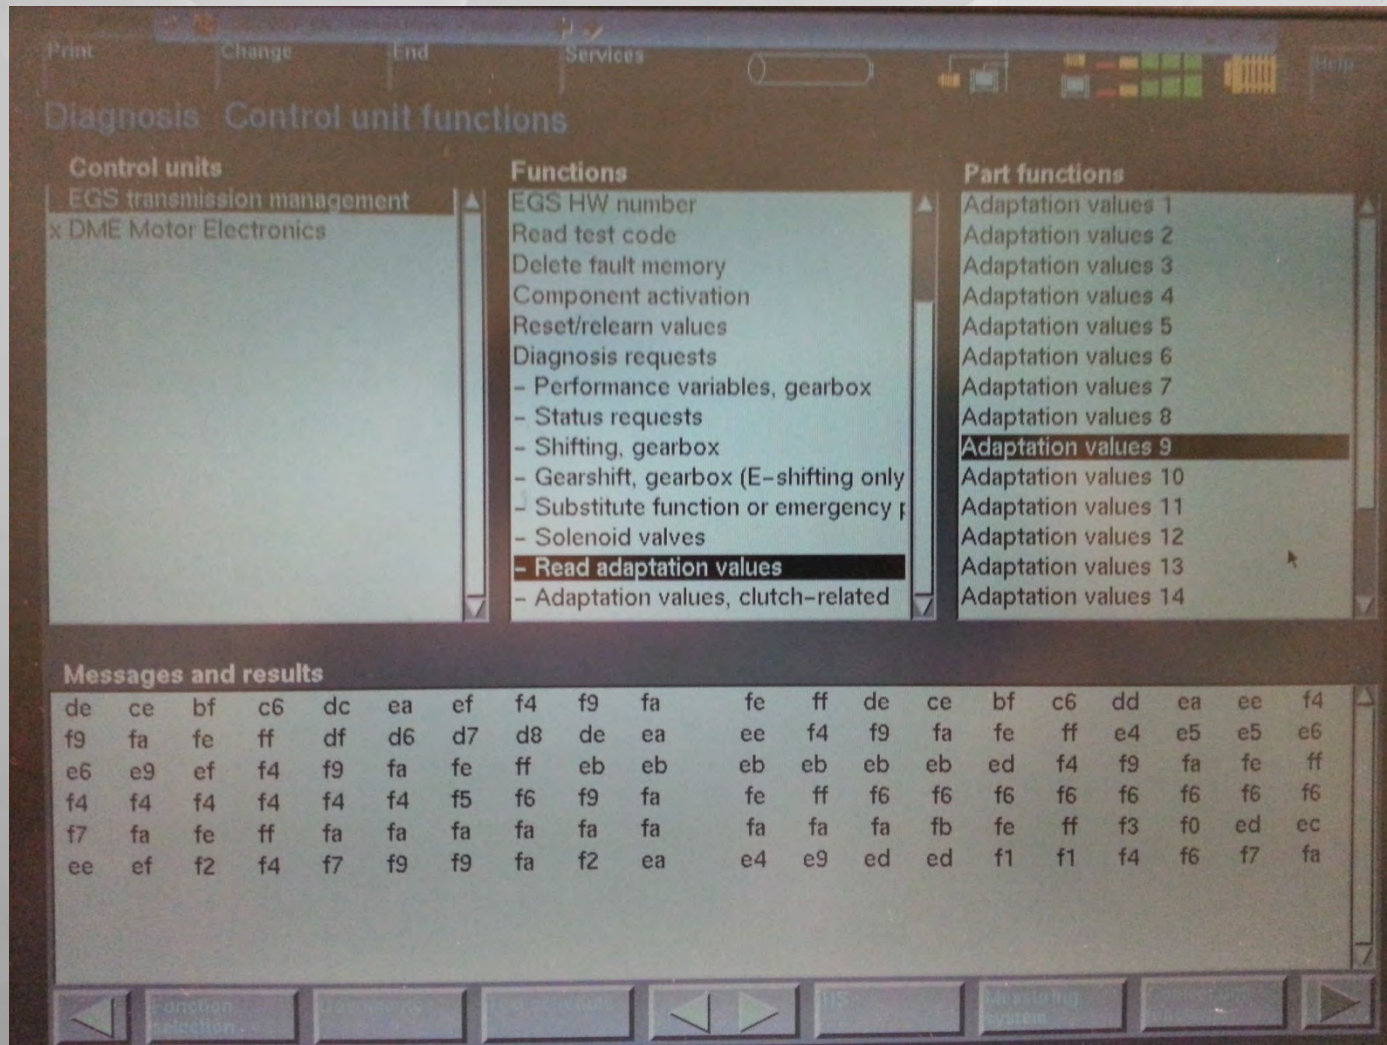
Example of ZF 6, TCM Adaption

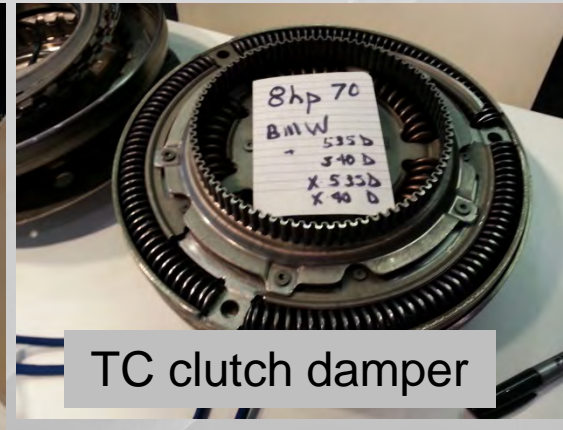
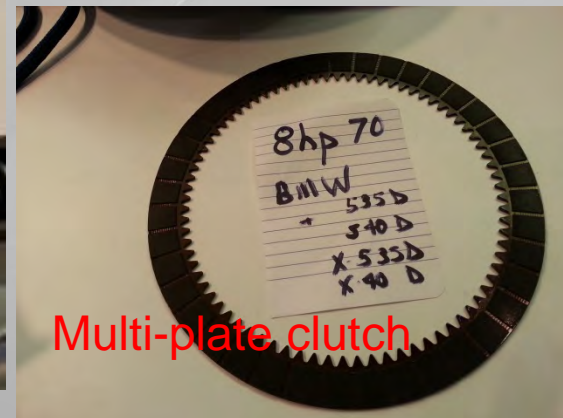
ZF 8 HP 70/80 Converter

Dodge 2500 truck and BMW 5/X series

This is a three path converter, clutch is within the cover

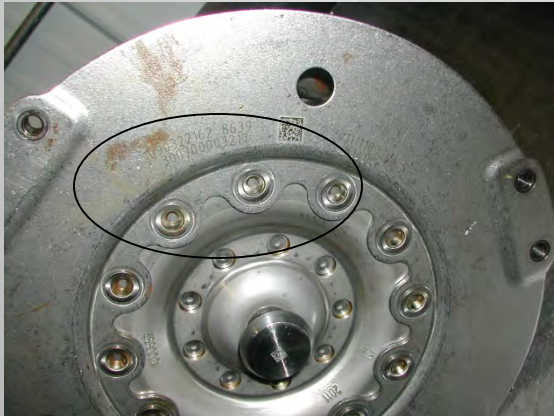
ZF 8 HP 45/70

Dodge, Jeep 2011 >

Three Path Converter

- ZF 8 HP could have the optional A clutch dis-engagement (neutral at stop). The units will have a nitrogen accumulator in the pan. This charges lube and pump pressure at idle in drive. This type of system will also affect converter load at idle, as the A clutch is brought back on. NVH will be a “point of concern” on this as well as other units using Neutral in Drive.

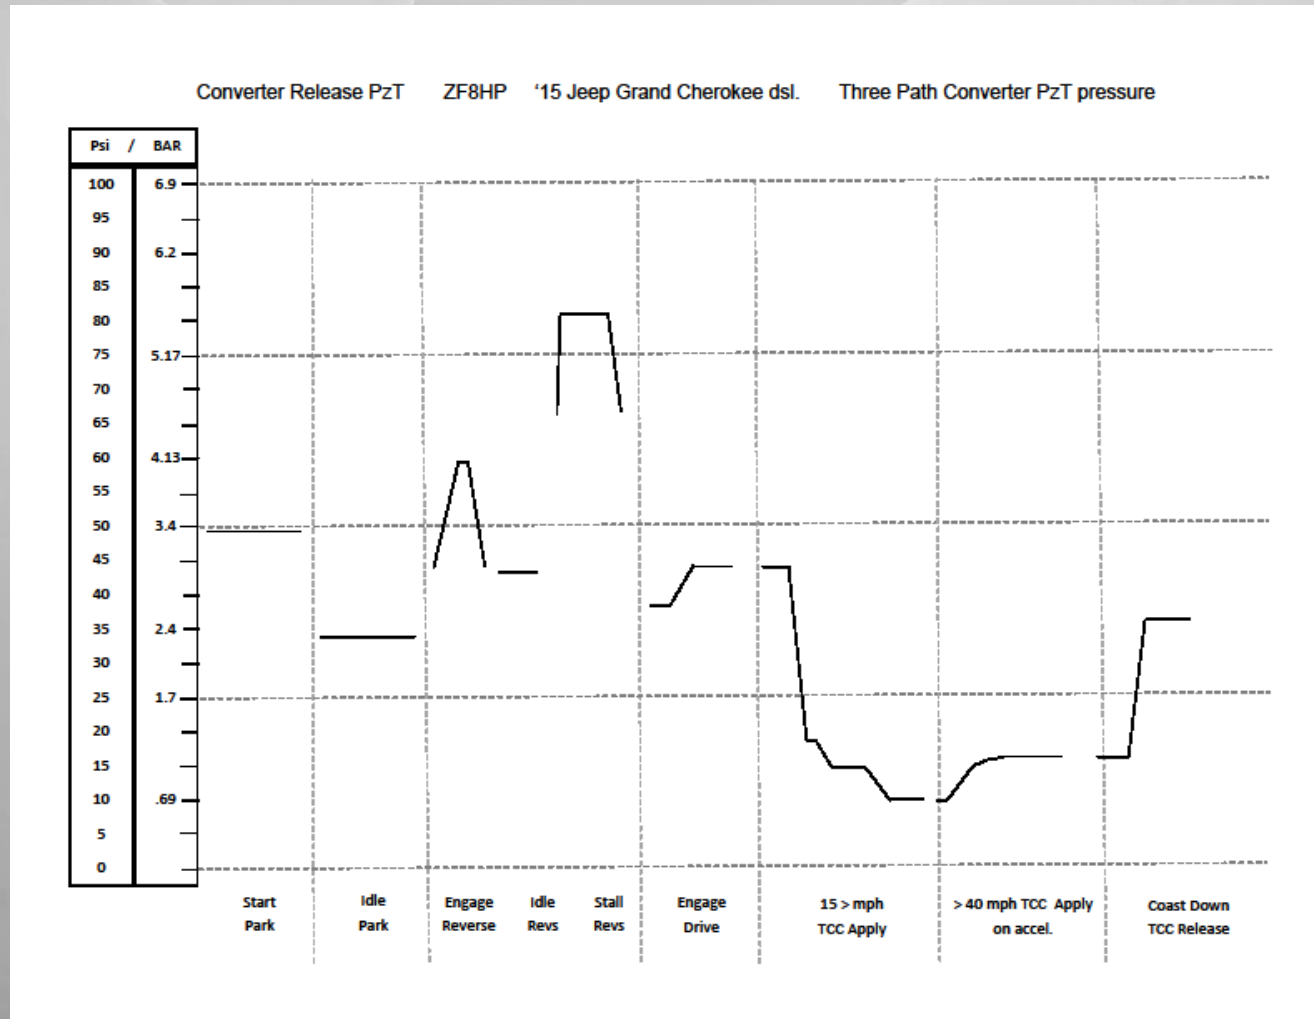
ZF 8- Converter charge pressure. Pz T

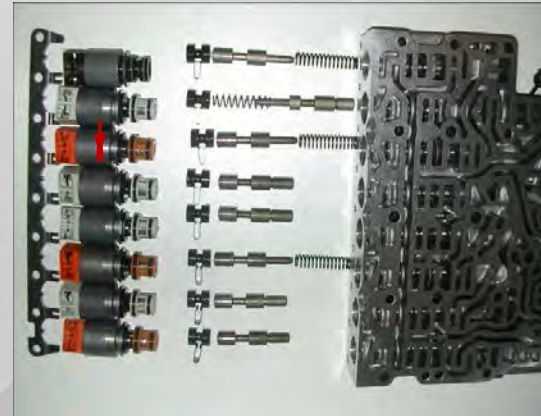
ZF 8 HP 45

Noted problems:
Solenoid failure, Clutch regulator and solenoid regulator bore wear.

No valve here
in this
application.

Yellow Painted heads, remove VB from case.

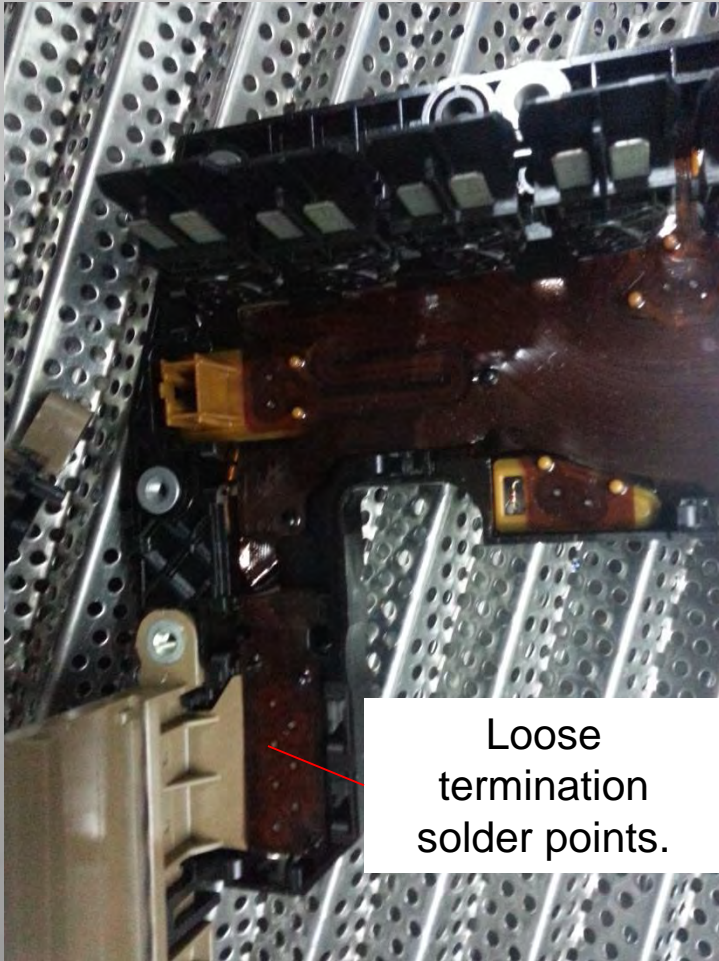
ZF 8 TCM Issues

Loose
termination
solder points.

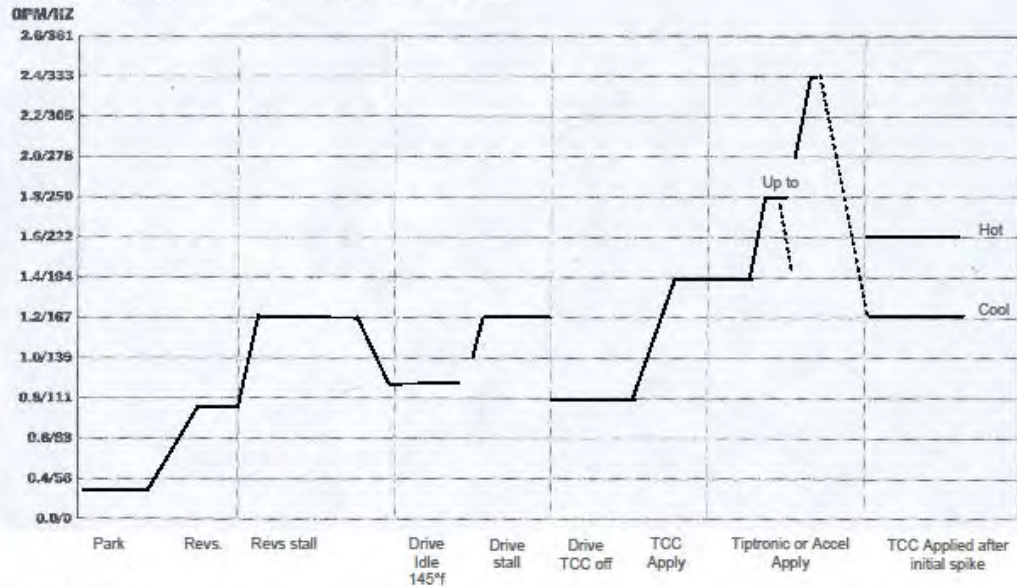
6T40 Cooler flow

APPLICATION: 6T40 (2012– Chev. Cruise)

Condition: Normal cooler flow.

Notes: Return cooler line enters rear of the case. TCC solenoid ramp on just after 1-2 shift. TCC remains applied on Coast down shifts until 3-2 or 2-1. Depending on load, applied TCC may have a regulated slip of 20-80 rpm! TCC control strokes first. TCC regulator controls slip rate.

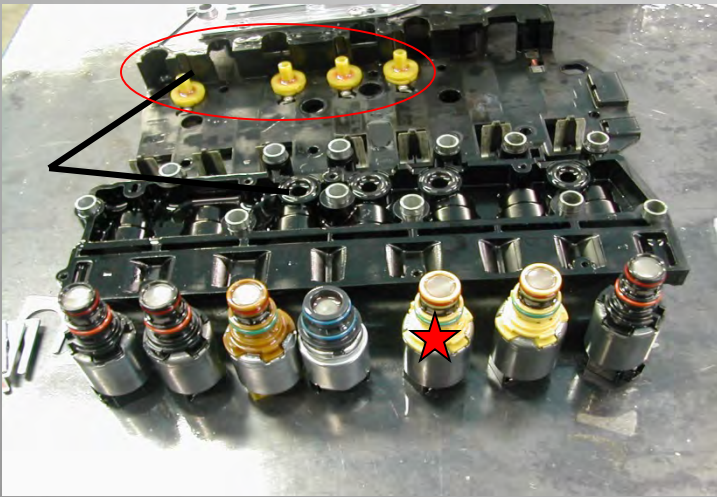
Gen I, Late thimble and o-rings.
Star is TCC solenoid

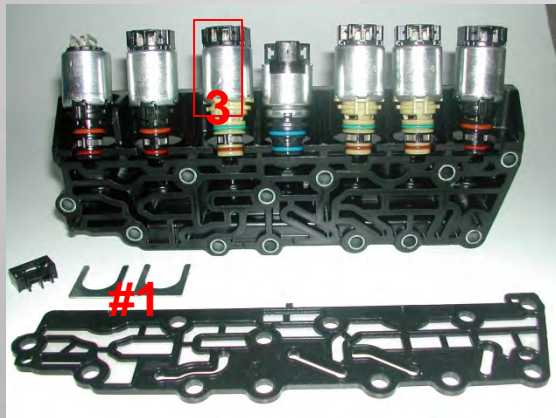
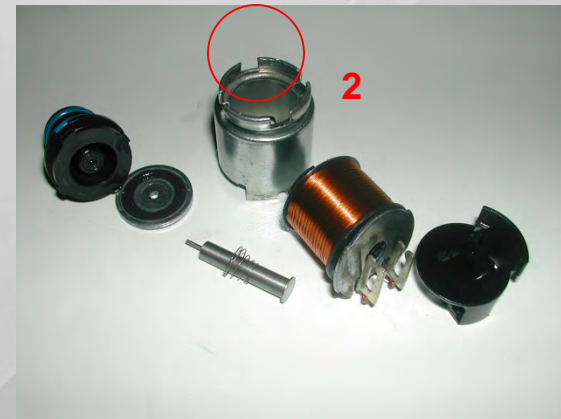
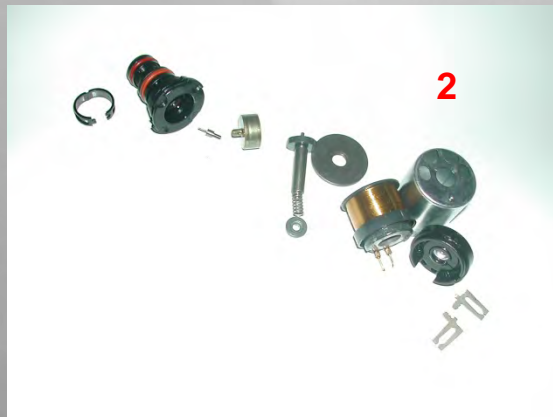
6T40/50 Solenoid Components

Contamination is a problem when the 3 5 Rev waive plate breaks.

1. Solenoid retainers can be pulled out, once the gasket is removed.
2. Solenoids can be opened to clean, by bending back the crimp on the can.
3. Solenoids are coded. Each flow rate number on the canister, is programmed into the TCU. Exchanging requires adaption and/or re-flash.

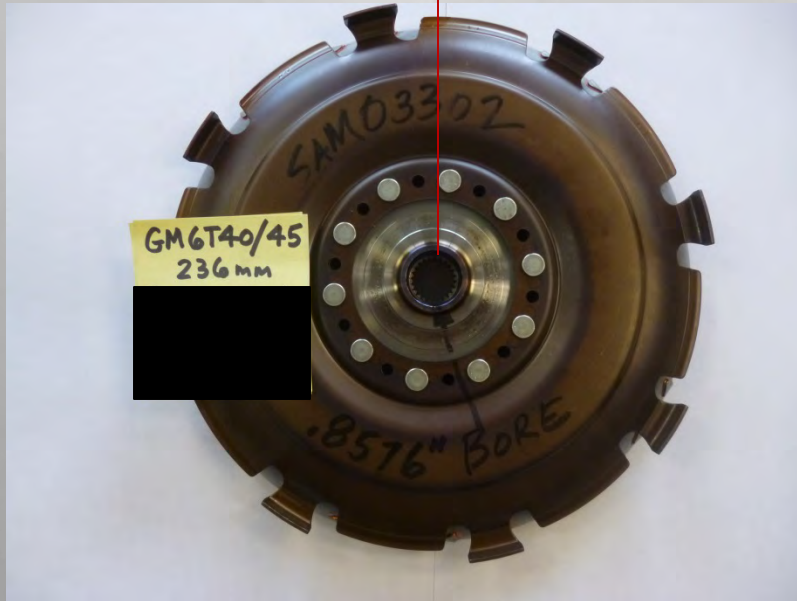
6T30/40 No TCC application and or Code 741: Post repair, metal clad seal damage

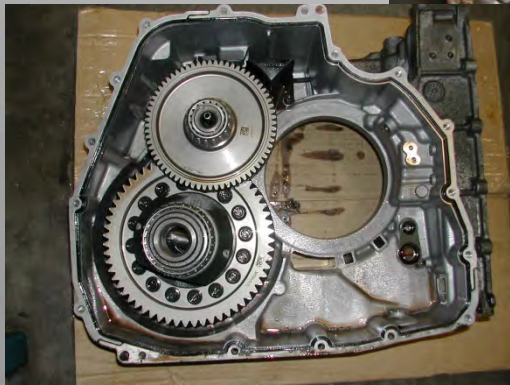
6T70 Pressure

6T70: Line Pressure Specifications

Requested (kPa via Line solenoid:	Desired Line tap psi.:
0	50-130
200	100-130
400	160-190
600	220-250
1000	270-300

Known causes of low line pressure:

Contamination of the relief ball in the pump.

Pump outlet to case seal leaking.

Mis-assembly of pump drive chain.

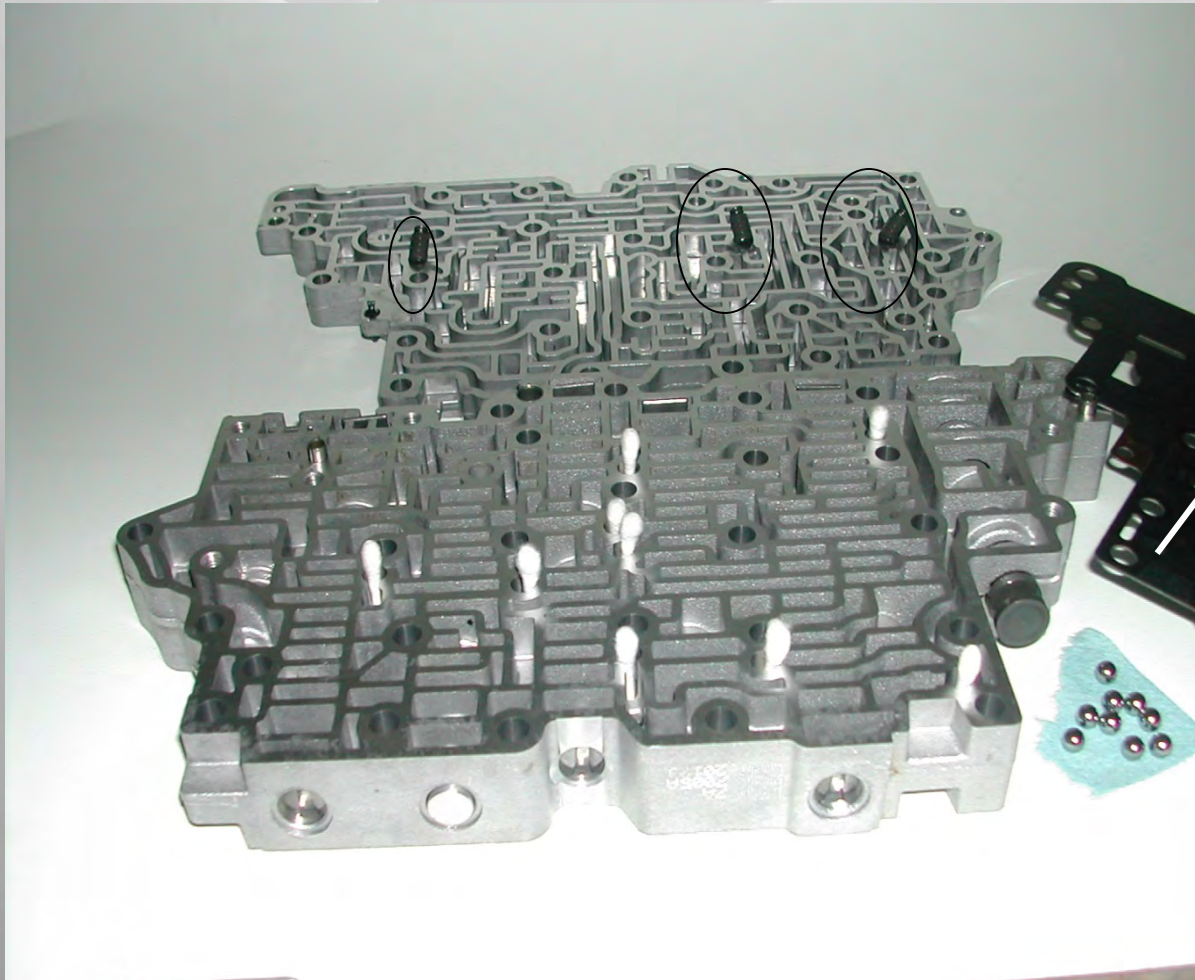
6T70, Gen 1

9 check balls at the pins.

3 actuator feed accumulator pistons within the circles. .

Look for gasket damage due to check ball contact here.

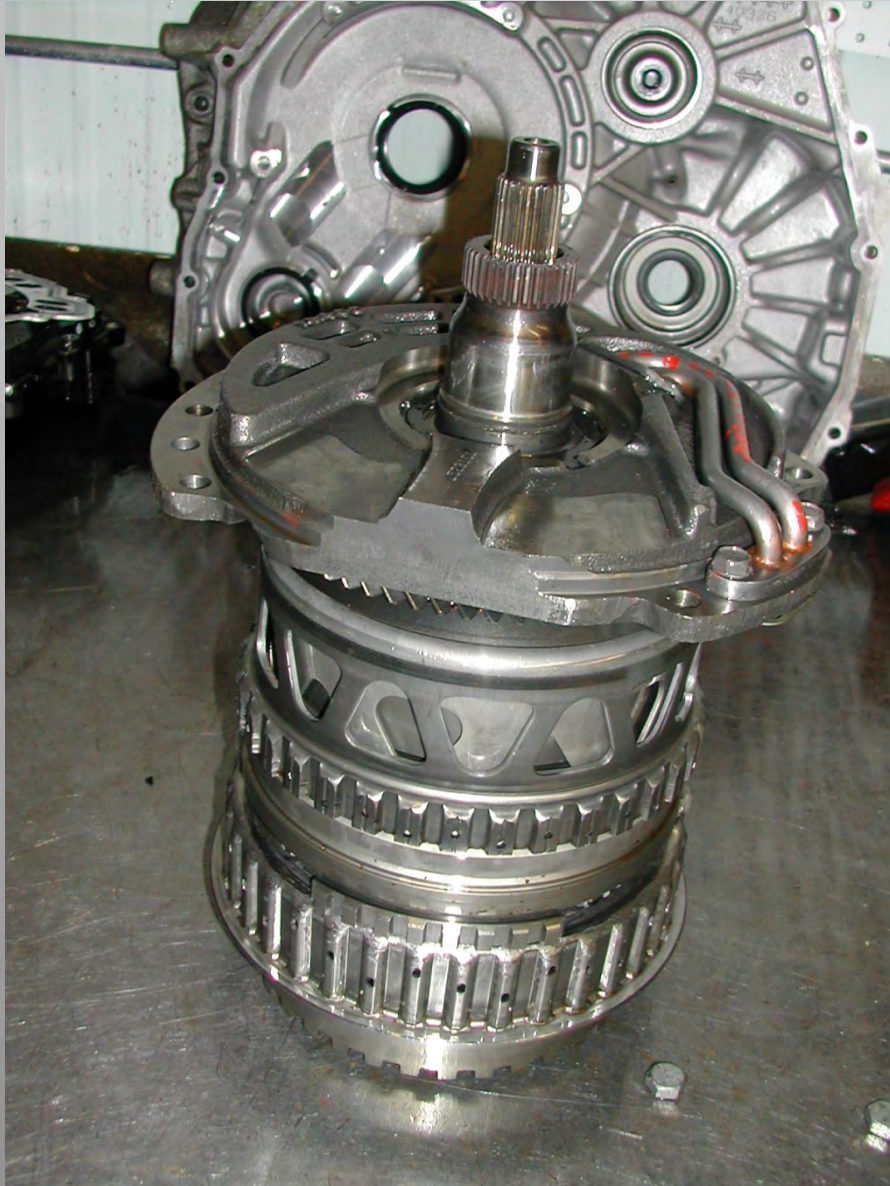
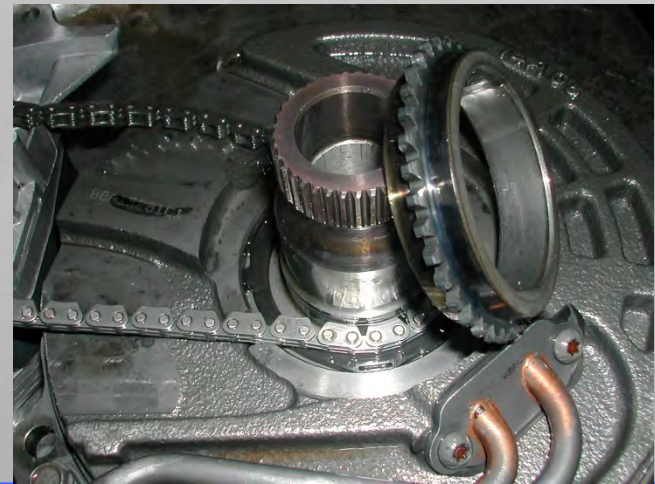
6T70-

Pump drive relationship to converter/apply charge oil.

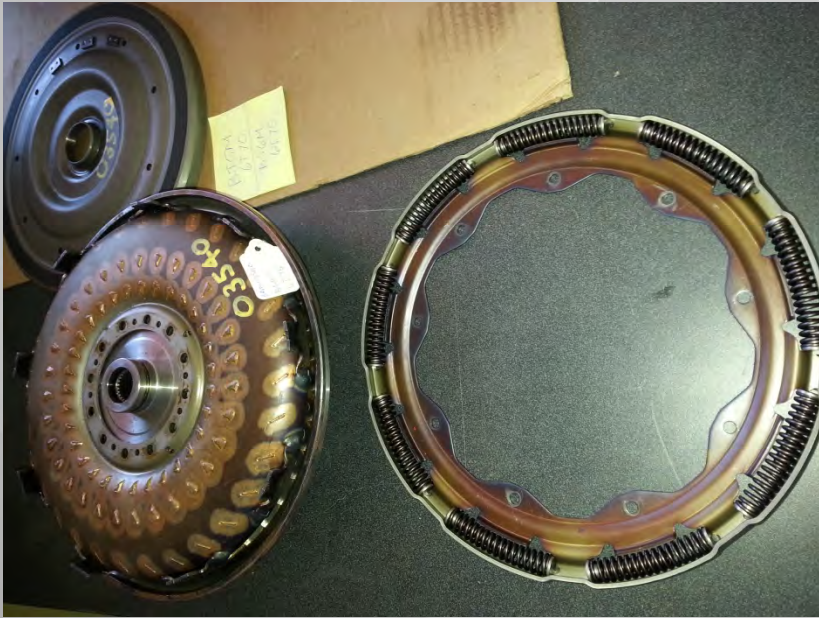
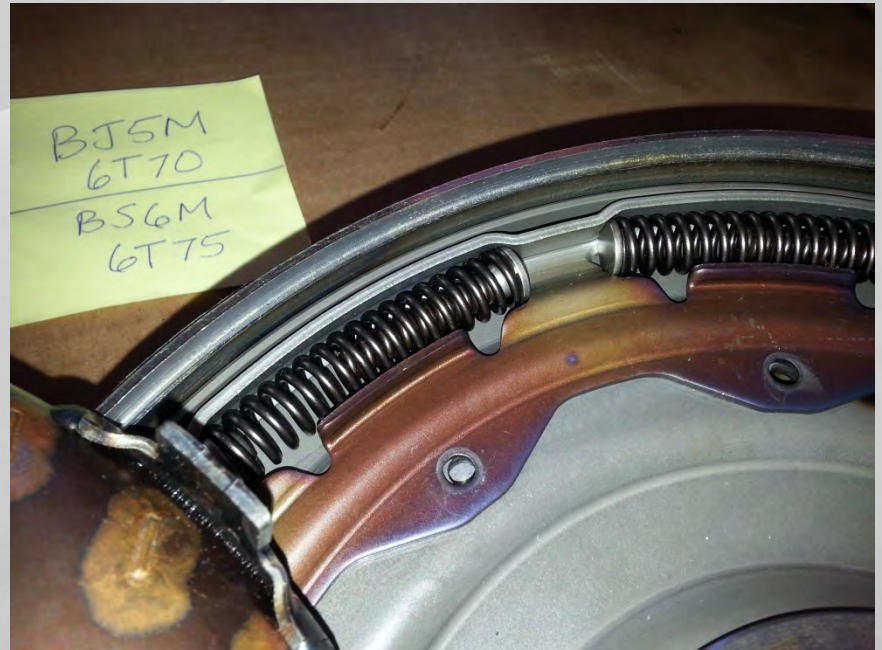
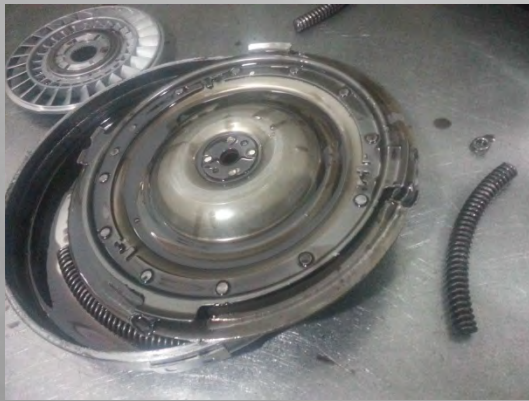
Converter Damper Issues

6T70/75 Damper- Top
Ford 6F50 Bottom left.
Note: The spring seat failure.

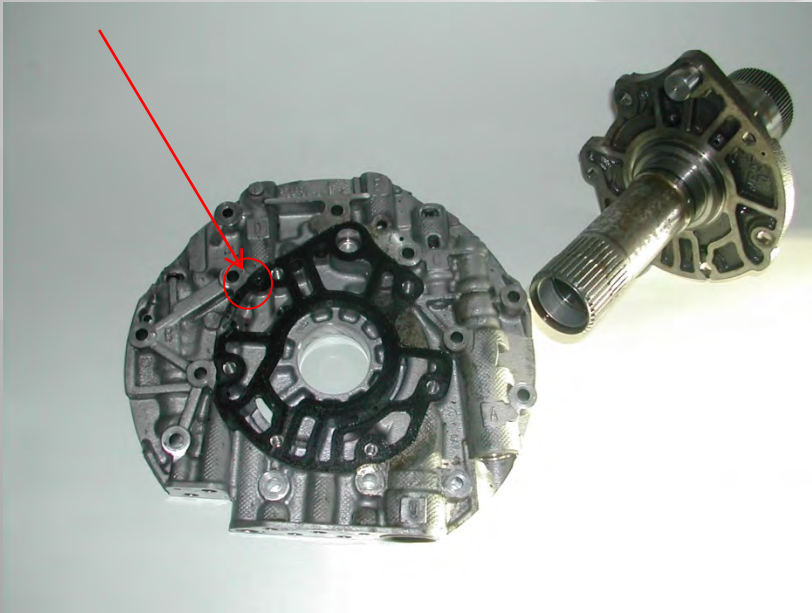
GM 6L50/80/90

Complaint: Overheat, TCC slip codes

Orifice plug missing from under this hole.
Known to fall out if stator is removed.

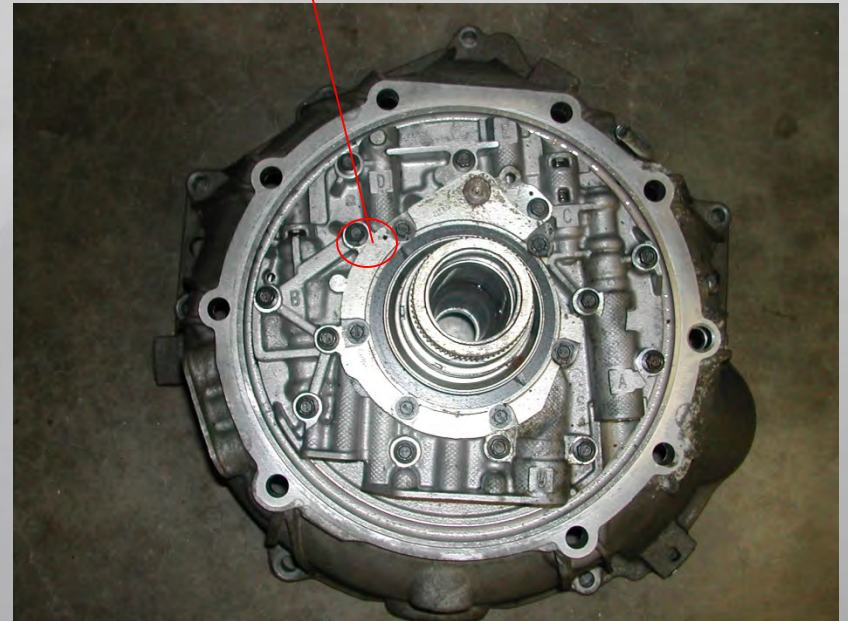
6L45/90 - Pump valves.

Known bore wear.

TCC Control, tends to stick

Line psi. relief

Converter feed limit. Control of release pressure, not TC apply pressure, nor slip rate!

Pressure regulator valve and bore wear = High or erratic pressure and reduced converter charge.

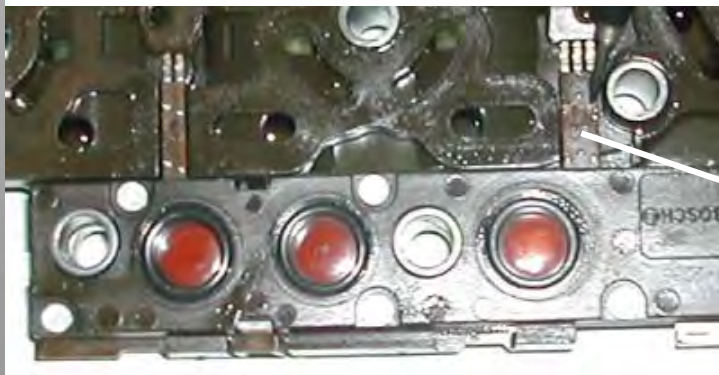
Ohm-meter probe tip, resting in pin-hole.

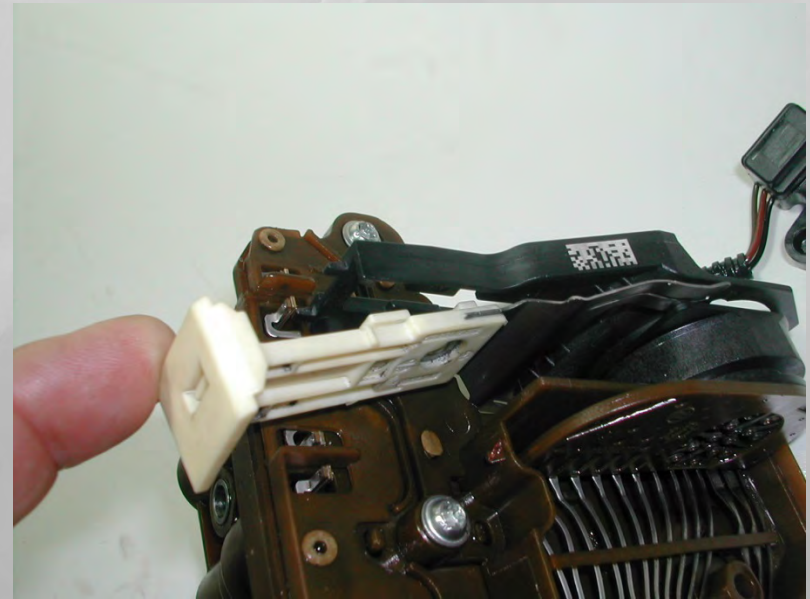
Connector locking tab is removable. Reports of these breaking, so save your cores!

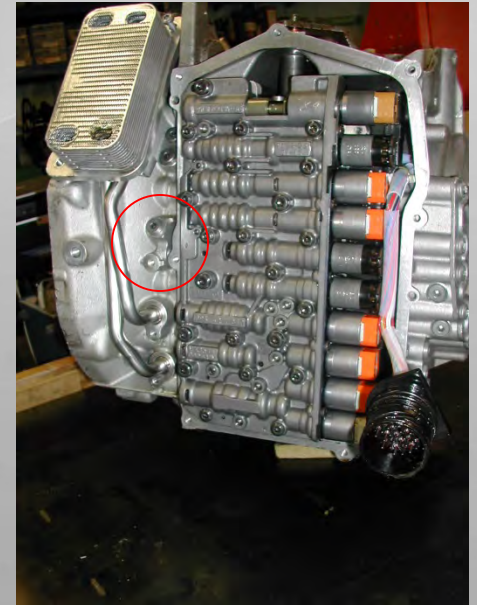
ZF 9 HP48- Converter Pressure Test Data

Converter Release Oil, ZF9HP45 '15 Jeep Cherokee 3.2 ltr.

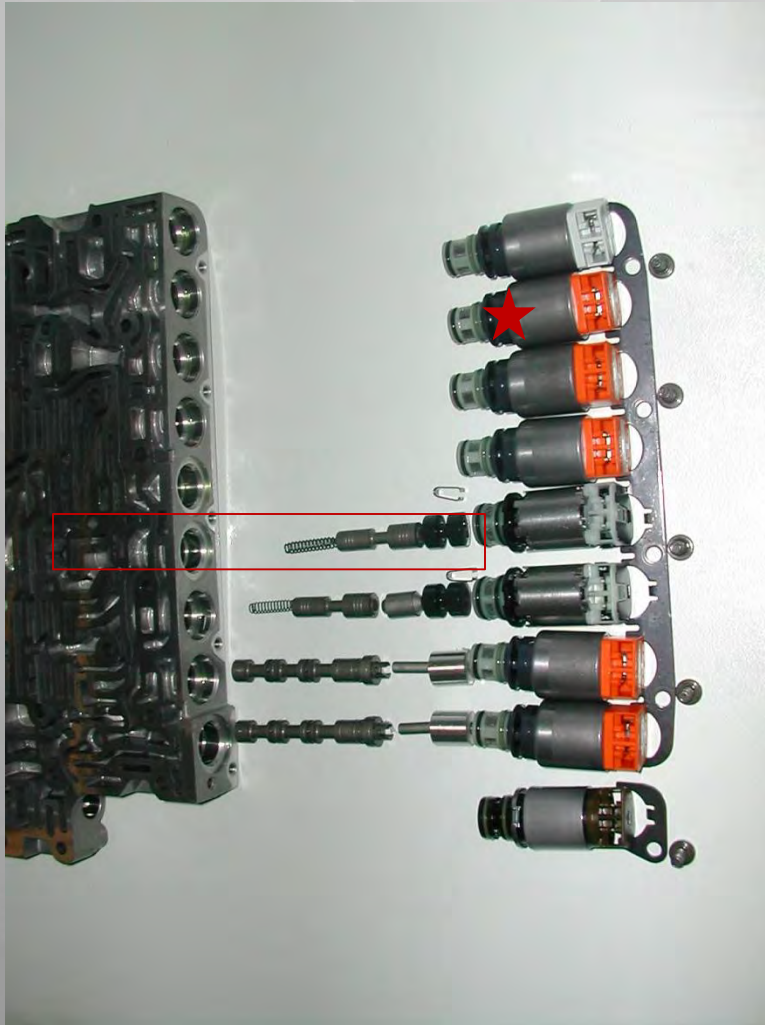
ZF 9 HP 48, Manual park type

Solenoid Identification, (Top down):

Sys: Solenoid, System Pressure

TCC, Converter clutch control. ★

B solenoid- Rear driving clutch-on in 3,5,9, Rev

E solenoid- Front driving clutch-on in 4 to 9.

A solenoid- Dog clutch, Front- on 1 to 7.

F solenoid- Dog clutch, Rear- on all, except 5 to 9

D solenoid- Rr. Large brake.- on all except 2 to 6

C solenoid- Rr. small brake- on 2,6,8 & braking

LHM solenoid- limp home sold.

Valve identification, (Top down)

Lockup clutch regulator

E clutch valve

A clutch valve

F clutch valve

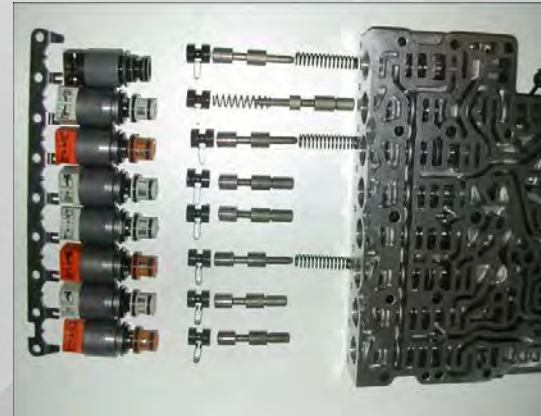
ZF 8 HP 45

Yellow Painted heads, remove VB from case.

ZF 8 HP Mechatronic TCC factors:

WK- Is the TCC solenoid

Red; Valves in the ZF8, that affect TC control and TC apply.

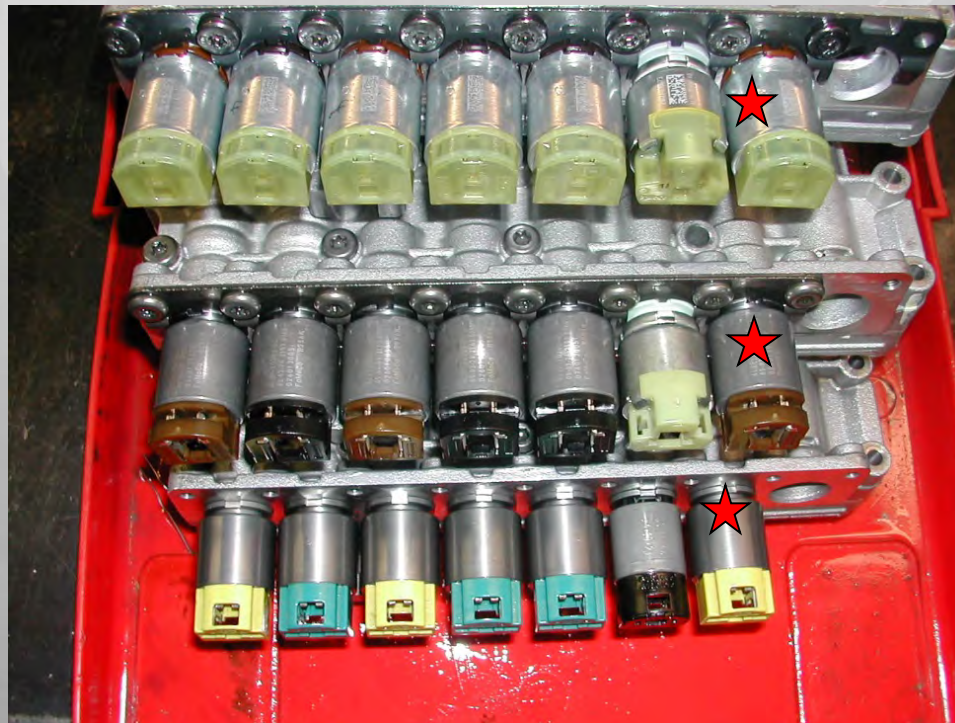
- Ford 6R80, 2010> Top Mechatronic
- Ford 6R60, 2006 > 2010, Middle.
 - ZF6 HP M version, Lowest
 - TC solenoid has a star on it.

The flow rate between Ford and ZF Bosch solenoids, are not the same.

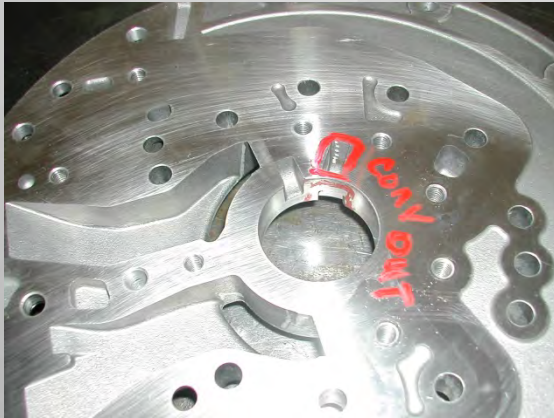
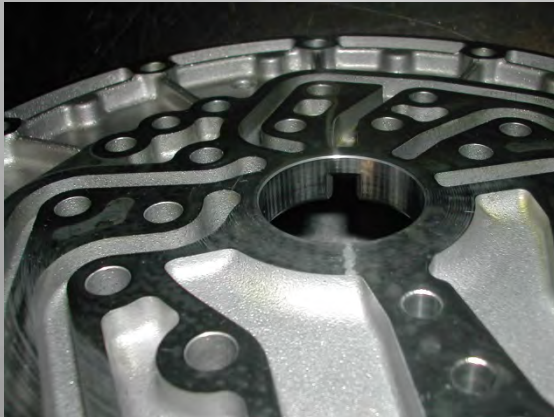
6HP19/21 Pump and Stator warpage and cross leaks will require inspection as service life is extended.
Circuits in red paint control TCC apply and release.
